## AIR QUALITY MONITORING MONTHLY MONITORING REPORT CARNWATH ROAD RIVERSIDE (CARRR) OCTOBER 2018

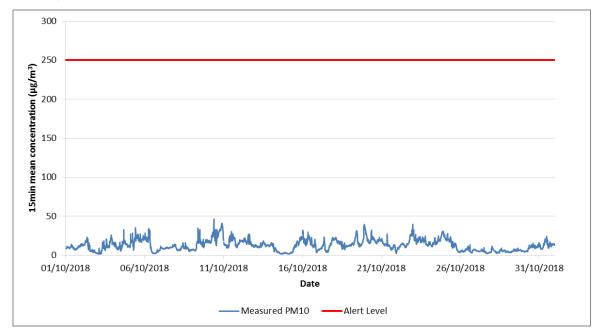
Figure 1 Graph of 15-min PM<sub>10</sub> Concentrations at CARRR/AA/1: October 2018

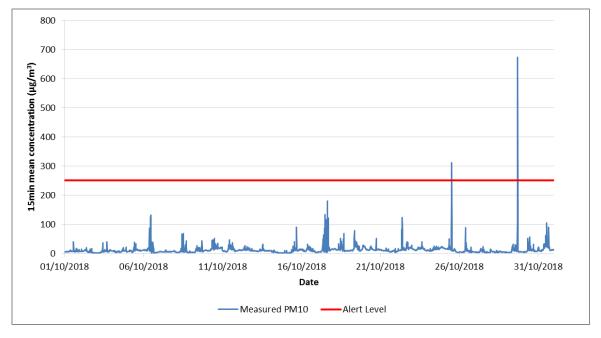
## Figure 2 Graph of 15-min PM<sub>10</sub> Concentrations at CARRR/AA/2: October 2018

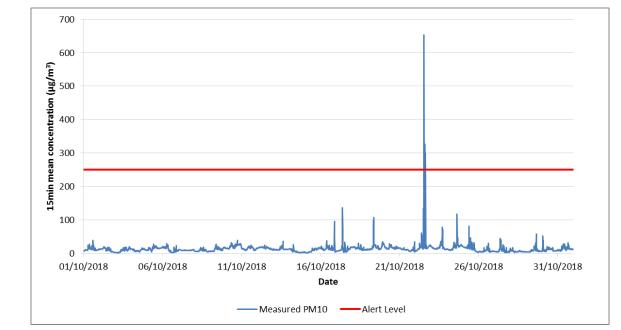
Figure 3 Graph of 15-min PM<sub>10</sub> Concentrations at CARRR/AA/3: October 2018

Alert ID	Source of Dust	
CARRR/AA/3_W43_1	On receiving initial alert it was identified that the monitor had been temporarily lowered to allow access for works local to the area, the monitor is being moved back once the set up works have taken place today. The works in question were checking / installation of monitoring points and further electrical cabling It is also noted various vehicles were parked adjacent to site idling Dampening down on site on haul route adjacent to monitor; however idling vehicles outside site opposite monitor. london.org website checked pollution is expected to remain 'Low'	
CARRR/AA/3_W43_2		
CARRR/AA/3_W43_3		
CARRR/AA/2_W43_1		
CARRR/AA/2_W44_1	Dampening down on site on haul route adjacent to monitor. Increase of vehicles outside site opposite monitor rush hour period, Carnwath road begins to get busy. Other than what

was observed cause unknown. No dust was observed on		
	site from works activities nor idling vehicles were observed
