# Development Consent Order

## Environmental Statement

Doc Ref: **6.2.26**

### **Volume 26: Beckton Sewage Treatment Works appendices**

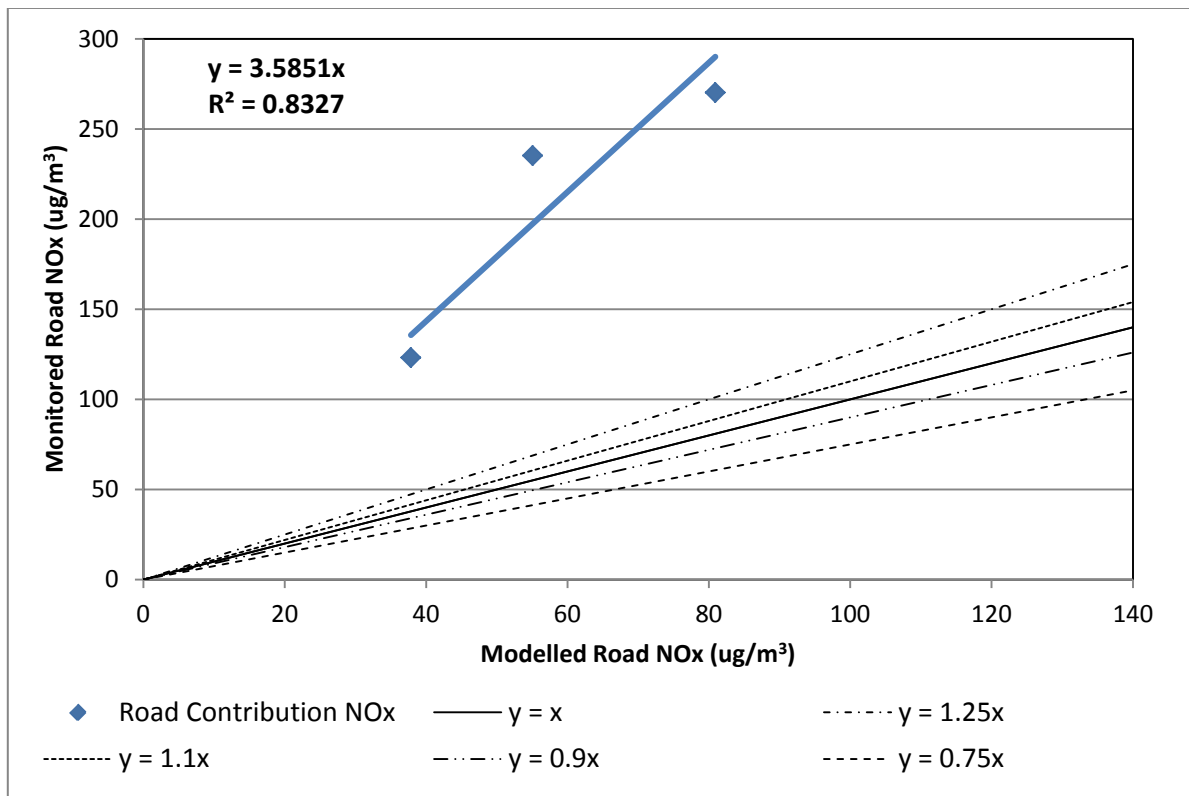
**Vol 26 Plate B.1 Air quality – monitored road NO<sub>x</sub> vs. modelled road NO<sub>x</sub>**

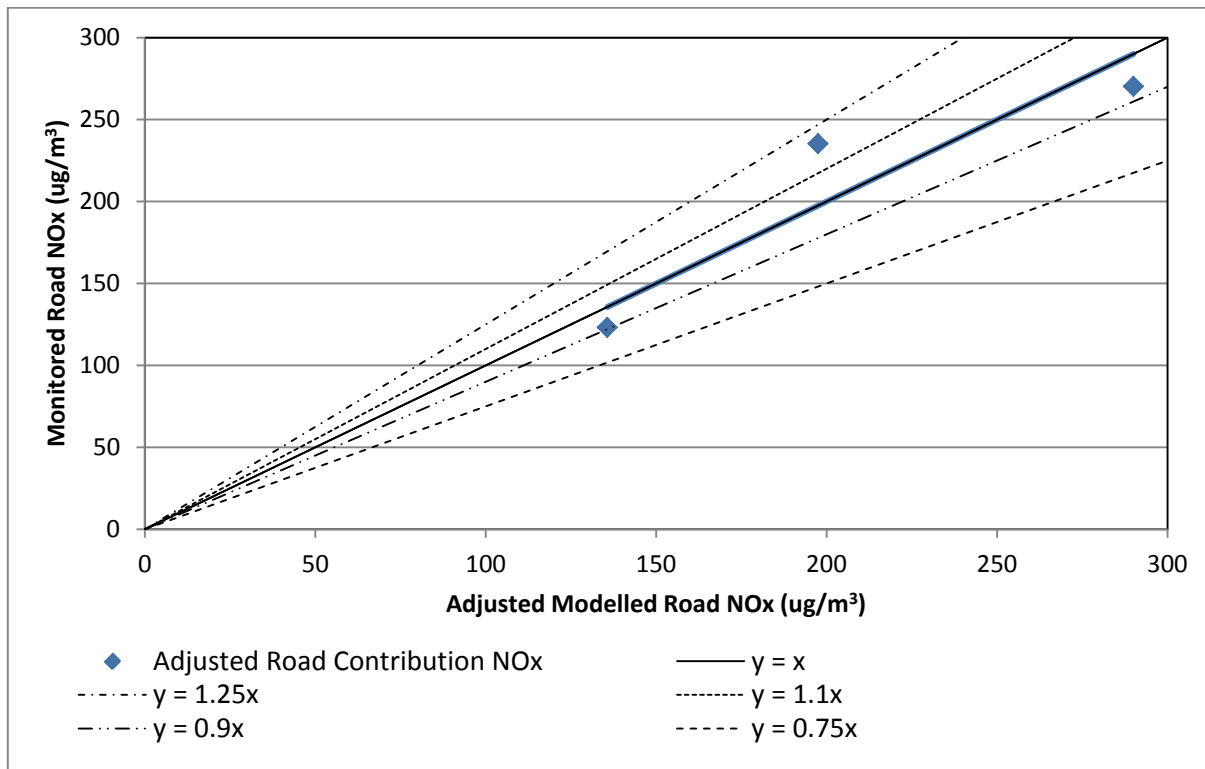
**Vol 26 Plate B.2 Air quality – monitored road NO<sub>x</sub> vs. adjusted modelled road NO<sub>x</sub>**

- B.1.4 Applying the NO<sub>x</sub> adjustment factor and then calculating NO<sub>2</sub> concentrations, as shown in Vol 26 Plate B.2, provides better overall agreement between actual and predicted data. The subsequent linear regression calculation for monitored versus modelled total NO<sub>2</sub>, as shown in Vol 26 Plate B.3, indicated that all three modelled concentrations were within 10% of the measured value.

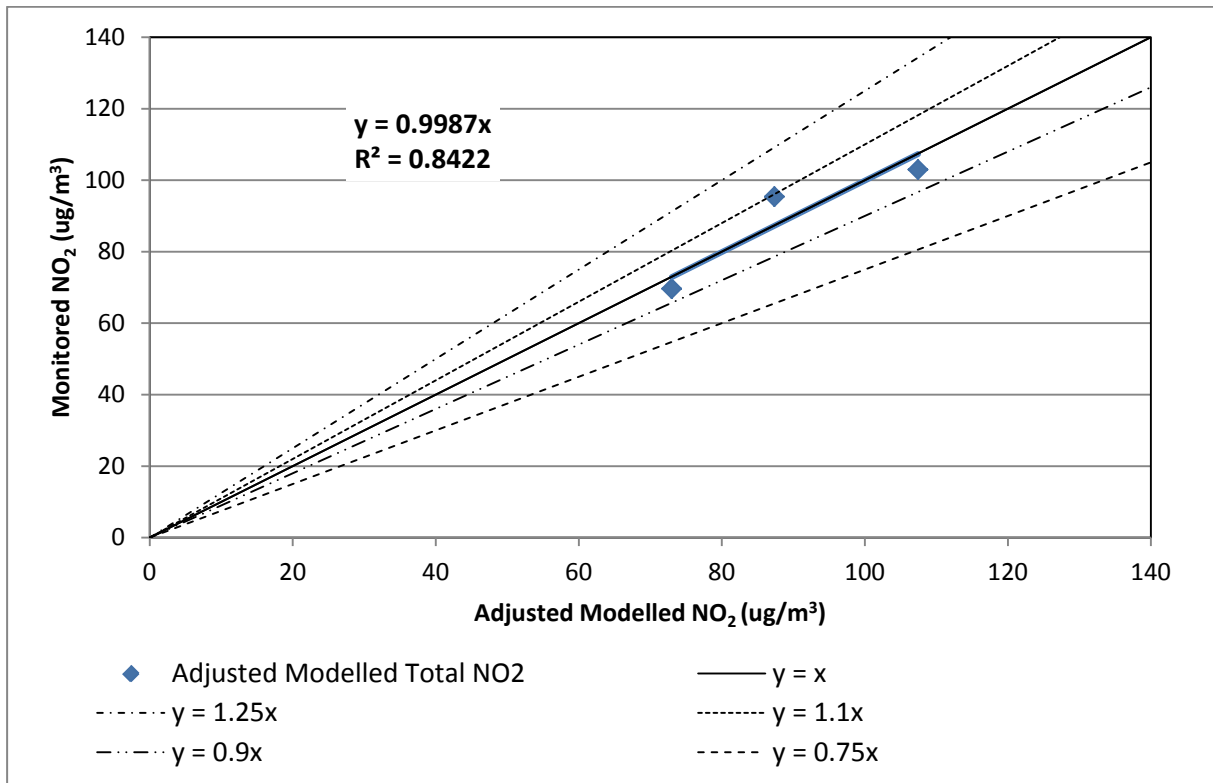
**Vol 26 Plate B.3 Air quality – total monitored NO<sub>2</sub> vs. total adjusted modelled NO<sub>2</sub>**

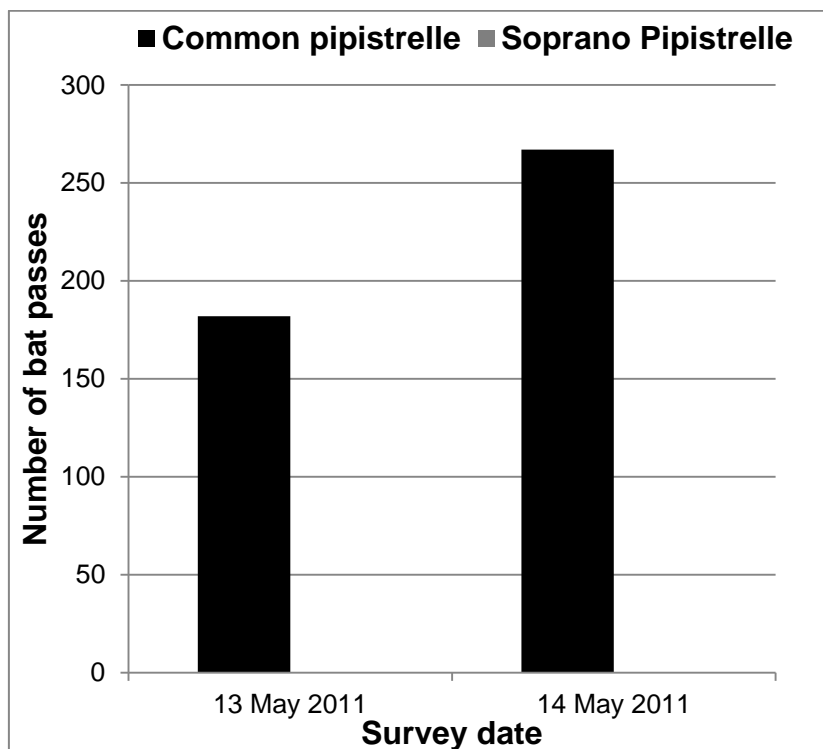
### Vol 26 Plate D.1 Terrestrial ecology – bat passes recorded during remote recording surveys at three locations at Beckton STW

- D.1.24 The bat triggering (remote recording) surveys were undertaken on 13 and 14 May 2011 in suitable weather conditions (Vol 4 Table D.2).
- D.1.25 The remote recording surveys undertaken at the Beckton Sewage Treatment Works site recorded one species of bat at Location one (northeast of Site B); common pipistrelle (*Pipistrellus pipistrellus*). A maximum number of bat passes of 267 was recorded on 14 May 2011 (see Vol 4 Plate D.1).

- D.1.43 Peak activity of common pipistrelle was observed during the bat triggering survey on 14 May 2011 with 267 passes recorded. All of the bat passes for this species were recorded off-site from around midnight. Therefore it can be determined that the survey area is being used as a foraging and/or commuting resource rather than for roosting purposes.

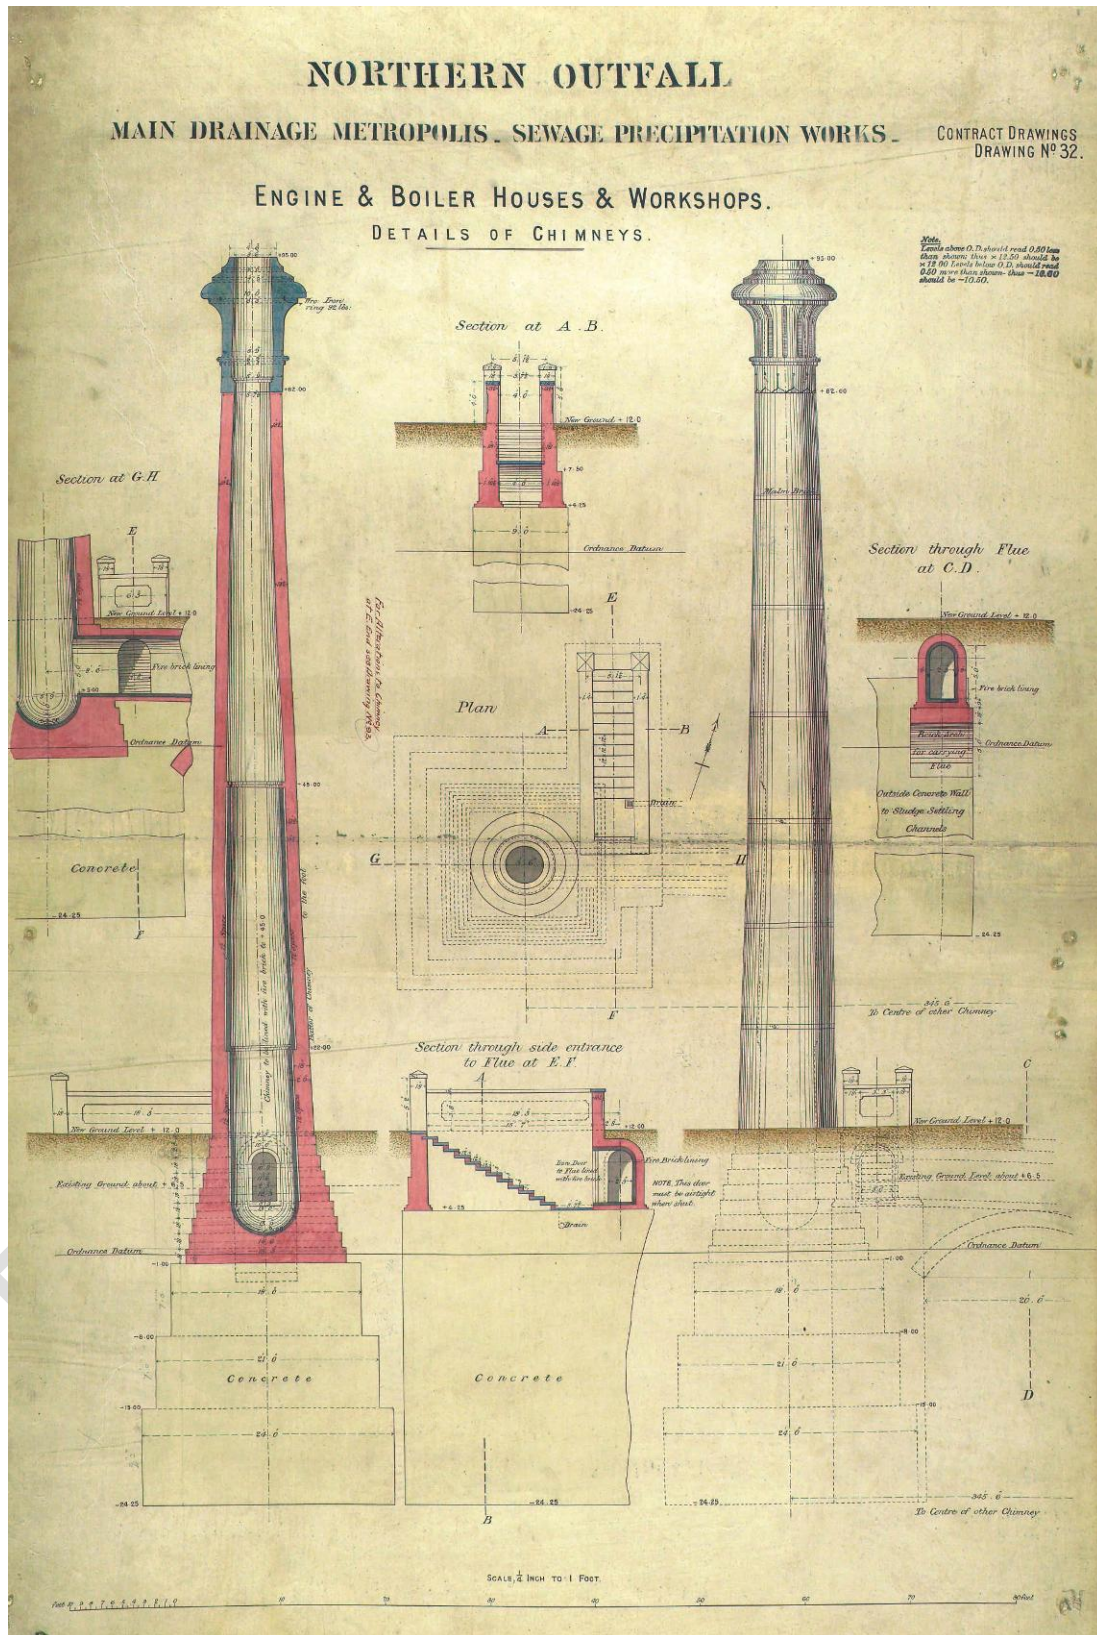
**Vol 26 Plate E.9 Historic environment – Section through the chimney (HEA 1a); grade II listed and temporarily dismantled (Thames Tunnel ‘Abbey Mills Book’ 32 Vol 2, p47).**

- E.4.22 Sir Joseph Bazalgette's London sewage system, one of the greatest pieces of Victorian civil engineering, was constructed in the later 19<sup>th</sup> century. It forms one of the project-wide themes and is discussed in more detail in Vol 3. The hugely ambitious system was constructed from the mid 1850s as a response to the appalling social conditions created by the growth of London during the industrial revolution. The original BSTW works (**HEA 1c**) at the terminus of the Northern Outfall Sewer (**HEA 1b**) were established by 1864 although there are no available plans of the complex. In the 1880s, the BSTW complex changed from the simple reservoir function of storing then releasing raw sewage into the Thames, to a sewage treatment works. This entailed a significant amount of building and construction to implement the processing of sewage, including the construction of extensive reservoir tanks and aeration lanes, to northeast of Site A and the north of Site B. The principal buildings from this second phase of development in the late 1880s included the Engine House (**HEA 1d**) and boiler house chimney (**HEA 1a**). The latter is grade II listed and has been temporarily removed and is due to be reinstated at its original location. The 'Old' Engine House was recently demolished following archaeological building recording. Archive plans show that the Engine House (Vol 26 Plate E.6) was broadly set in a 'T' shape plan with a workshop projecting north from it, constructed on steel 'I' section columns set on deep piles (Vol 26 Plate E.7). The boiler house chimney (Vol 26 Plate E.9) was situated to the east of this and constructed on a deep, stepped concrete base with a submerged flue to the boiler house. Immediately south of the chimney was a pair of sludge settling tanks, possibly overflows from the main settling trenches (Vol 26 Plate E.9 and Vol 26 Plate E.10).

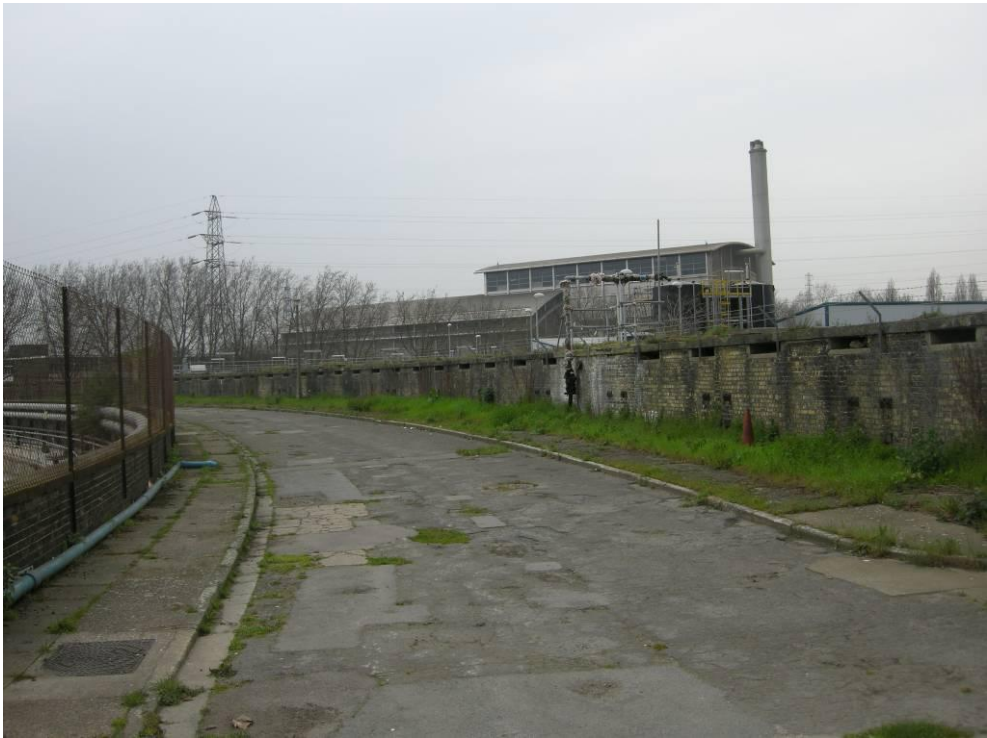
**Vol 26 Plate E.19 Historic environment – 19th century wall (HEA 30) located to the northeast of Site Area B, from southeast corner of the boundary, looking northwest, standard lens**

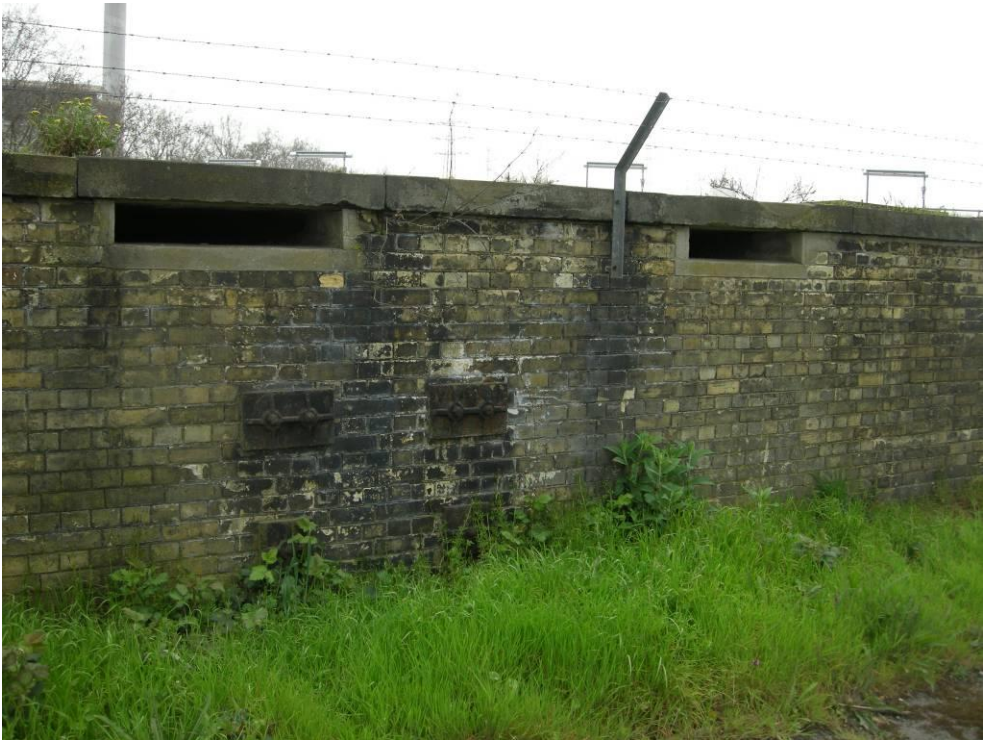
**Vol 26 Plate E.20 Historic environment – 19th century wall (HEA 30) located to the northeast of Site Area B, from the northeast corner of the boundary, looking east, standard lens**
