Thames Water Utilities Limited

Environmental Statement

Doc Ref: **6.2.14**

Volume 14: Kirtling Street appendices

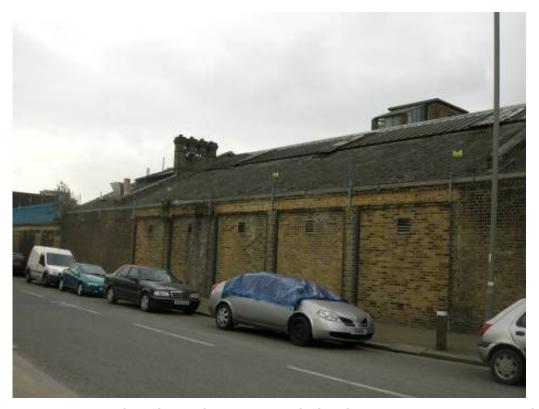
Vol 14 Plate E.9 Historic environment – brick built complex of T. & W. Farmiloe Ltd, Est. 1886 on Kirtling Street, this may be one of the earliest surviving parts of the complex; standard lens, looking southwest

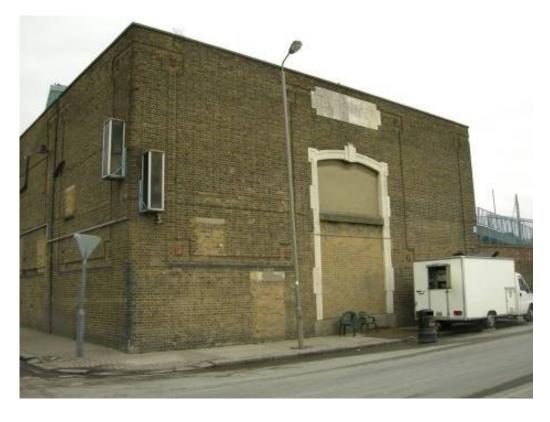
Vol 14 Plate E.10 Historic environment – distinctive entrance to the Farmiloe complex; standard lens, from Cringle Street looking north-east

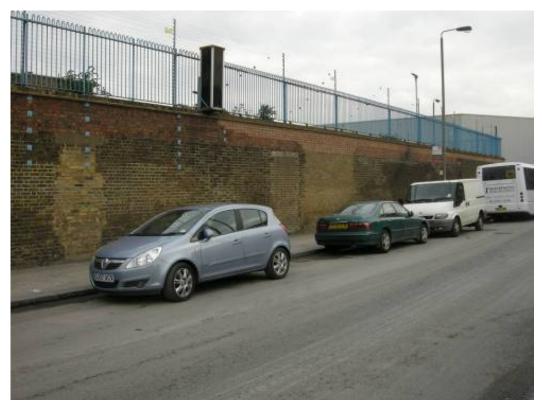
Vol 14 Plate E.11 Historic environment – blocked entrances to the Farmiloe complex (south wall); standard lens, from Cringle Street looking east

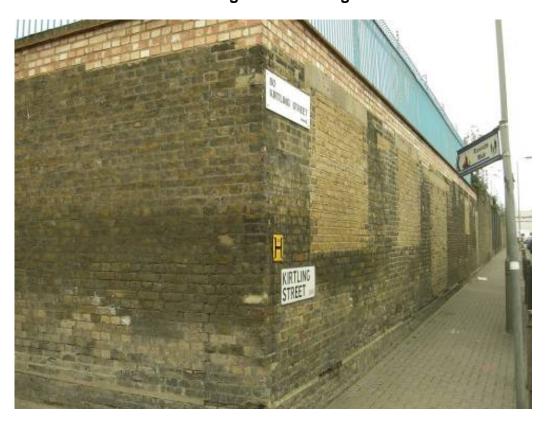
Vol 14 Plate E.12 Historic environment - blocked windows/doorway of the Farmiloe complex east wall; standard lens, from the corner of Cringle Street and Kirtling Street looking north

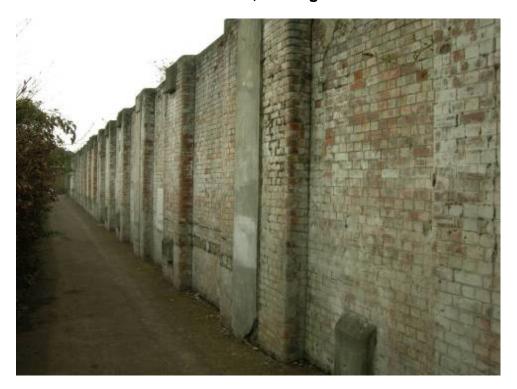
Vol 14 Plate E.13 Historic environment – east façade of the former warehouse wall close to the river likely to be associated with the Farmiloe complex; standard lens, looking south

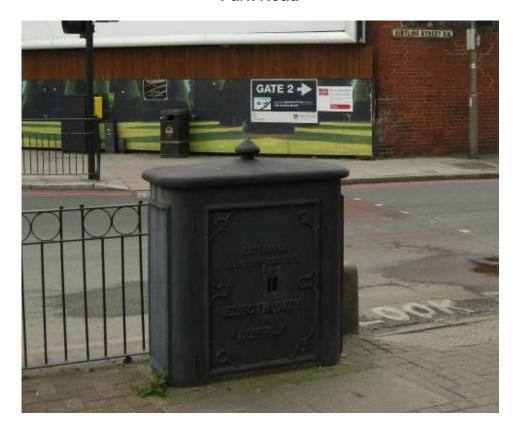
Vol 14 Plate E.14 Historic environment – Early electricity supply box with decorative panel and finial (HEA 1F); standard lens, looking north-west on the corner of the junction between Kirtling Street, Nine Elms Lane and Battersea Park Road

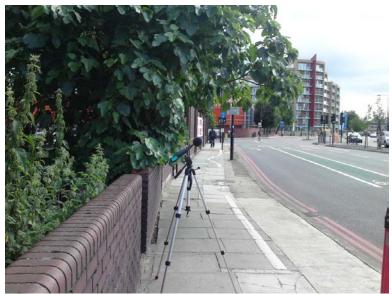
Note: On public footpath alongside Nine Elms Lane, looking southwest

G.1.15 The following plates (Vol 14 Plate G.1 to Vol 14 Plate G.5) illustrate the noise measurement locations.

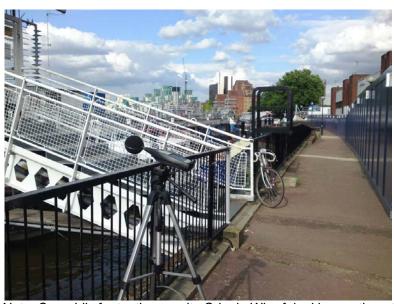
Vol 14 Plate G.2 Noise measurement location KST02

Note: On public footpath opposite Cringle Wharf, looking northeast

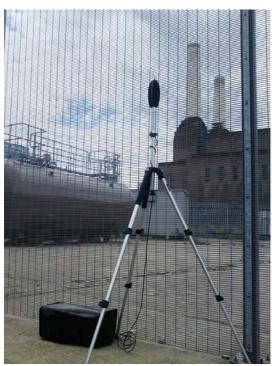
Vol 14 Plate G.4 Noise measurement location KST04

Note: Within private grounds of Cringle Street Pumping Station, looking west

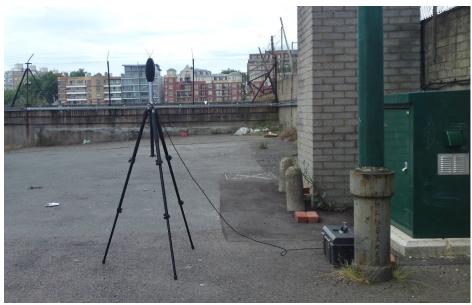
Vol 14 Plate G.5 Noise measurement location HEA02

Note: Within Heathwall Pumping Station, looking north towards River Thames

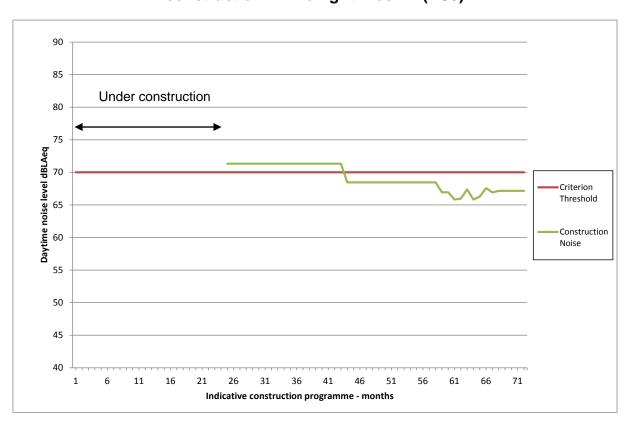
Vol 14 Plate G.10 Average monthly daytime noise level over duration of construction – Riverlight Block A (KS5)

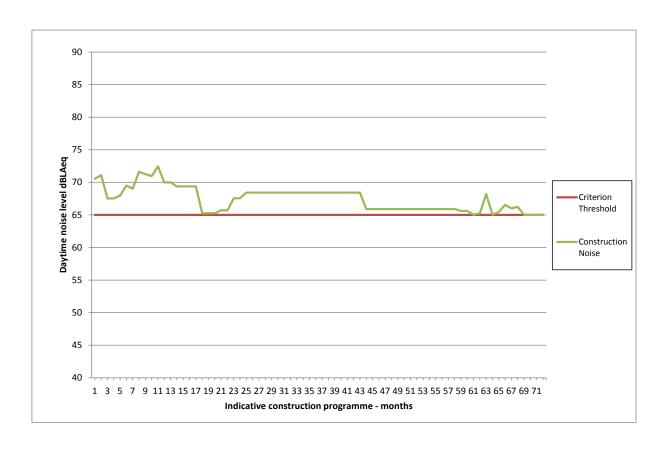
Vol 14 Plate G.14 Average monthly daytime noise level over duration of construction – Battersea Power Station, Block PS (KS9)
