**AIR QUALITY MONITORING MONTHLY
MONITORING REPORT
NOVEMBER 2017**

**CARNWATH ROAD RIVERSIDE
(CARRR)**

TIDEWAY

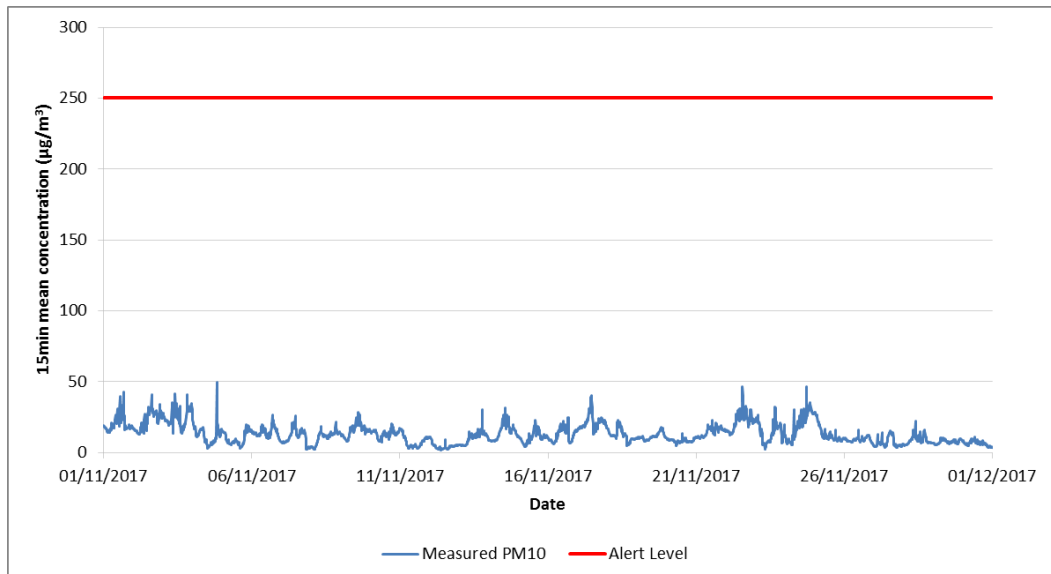
Figure 1 Graph of 15-min PM₁₀ Concentrations at CARRR/AA/1: November 2017

Osiris Monitor ID	Average PM ₁₀ Concentration (µg/m ³)	Data Capture (%)	Number of Exceedances of the 15-Minute PM ₁₀ Alert Level of 250 µg/m ³ .
CARRR/AA/1	13.0	100	0
CARRR/AA/2	19.4	100	3
CARRR/AA/3	12.7	100	0
CARRR/AA/4	16.5	100	2
CARRR/AA/5	11.0	99.8	0

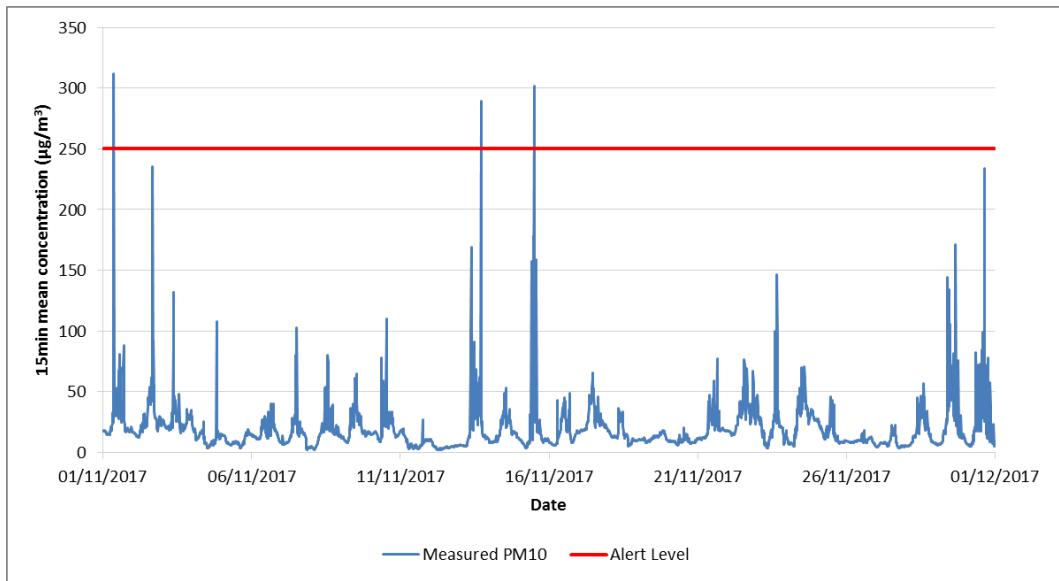
Figure 2 Graph of 15-min PM₁₀ Concentrations at CARRR/AA/2: November 2017

- Data capture for the month was 100% at sites CARRR/AA/1, CARRR/AA/2, CARRR/AA/3 and CARRR/AA/4. Data capture was 99.8% at CARRR/AA/5; and
- There were three exceedances of the 15-minute PM₁₀ alert level of 250 µg/m³ at CARRR/AA/2, and two exceedances at CARRR/AA/4.

2.3.1 There were three exceedances of the 15-minute PM₁₀ alert level of 250 µg/m³ at CARRR/AA/2, and two exceedances at CARRR/AA/4. A summary of these occurrences is shown in Table 3 below.

CARRR/AA/2_W46_2	CARRR/AA/2	15/11/2017	12:00	301.4	<p>The exact cause of the exceedance was unknown. Works onsite at the time near the monitor comprised of steel fixing within the acoustic shed.</p> <p>All activities were being managed in relation to dust management locally and all haul routes dampened down.</p> <p>Outside of site the northern hoarding approx. 15m away from the monitor location was having the artwork placed on it. The works although did not include significant dust producing activities.</p>
CARRR/AA/4_W45_1	CARRR/AA/4	10/11/2017	10:15	420.0	<p>Works occurring in the area were trimming back and removal of shrubbery within 3m of the monitor, placement of river walk slabs and installation of hoarding.</p> <p>The river walk slab replacement works (RW926) consisted of a base layer of</p>

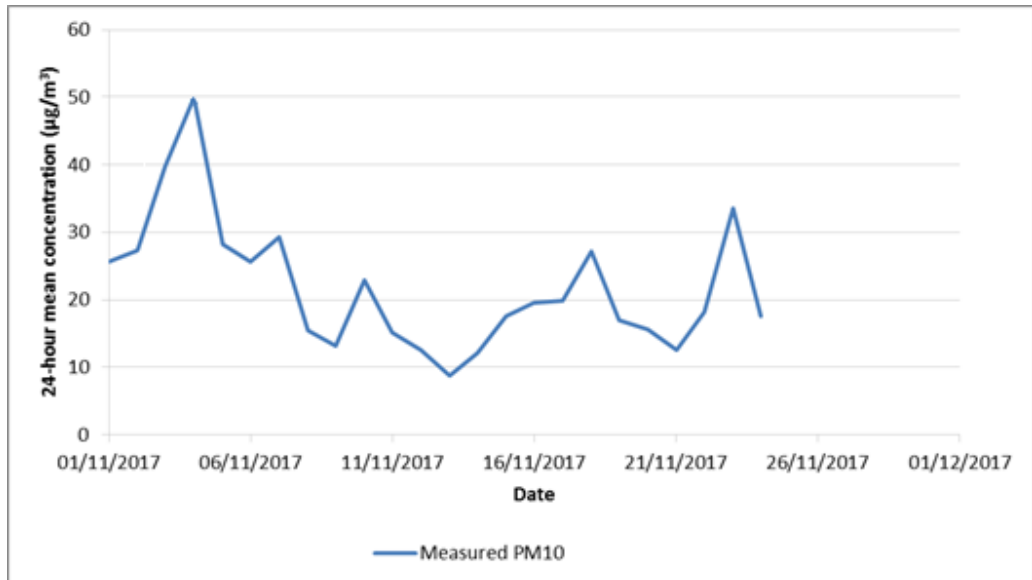
Figure 6 Graph of 24-hour mean PM₁₀ (µg/m³) at Philpot Square: November 2017

Site	Statistic	PM ₁₀	NO ₂
CARRR/CM/1	Period Data Capture (%)	80.0 ^a	96.8
	Period mean (µg/m ³)	21.9	35.3

^a Data capture for PM₁₀ was low due to technical faults with the monitoring equipment.

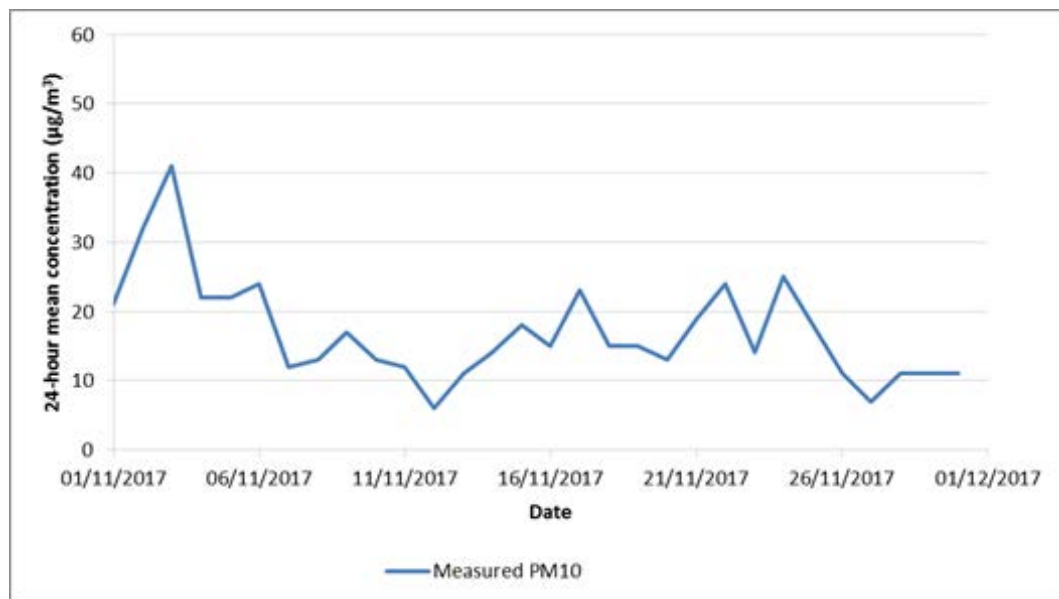
Figure 8 Graph of 24-hour mean PM₁₀ (µg/m³) at Wandsworth Putney: November 2017

- 4.1.3 The average PM₁₀ concentration at Wandsworth Putney during this period was 17.0 µg/m³, which was lower than the average concentrations at Carnwath Road set out in Table 5. Figure 8 shows elevated concentrations at the start of November, which reflects trends observed at the Philpot Square CMU. This trend is part of a broader 'Guy Fawkes 2017' episode of high PM₁₀ observed towards by the LAQN.

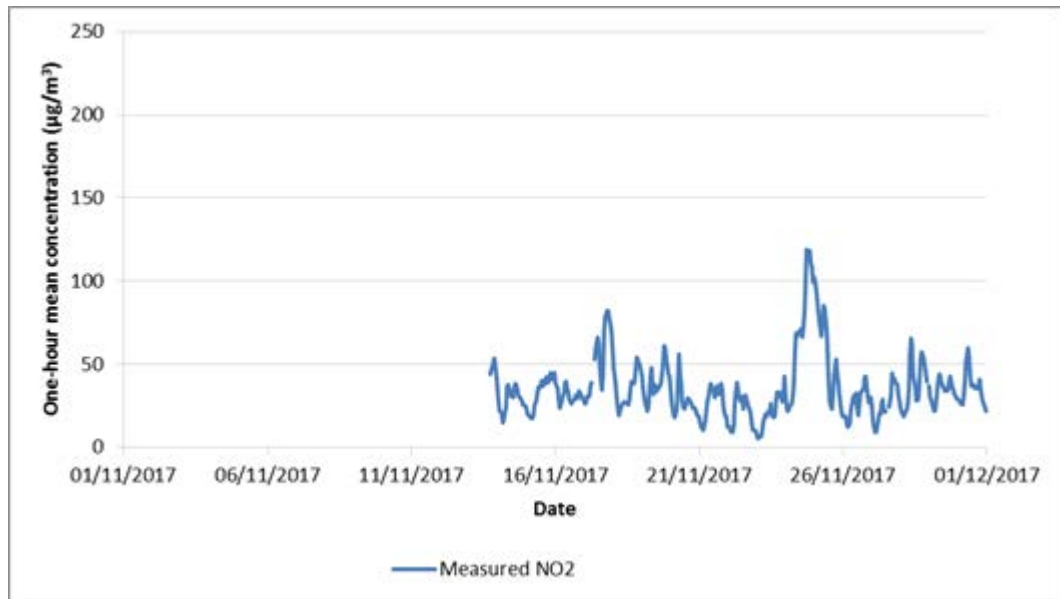
Figure 9 Graph of 1-hour mean NO₂ (µg/m³) at Wandsworth Putney: September 2017

- 4.2 The average NO₂ concentration at Wandsworth Putney during this period was 35.5 µg/m³, which is consistent with measurements from the Philpot Square CMU out in Table 5. Despite the low data capture, the NO₂ concentrations plotted in Figure 9 show similar trends to those observed at Carnwath Road, with elevated concentrations observed on the 25th November.

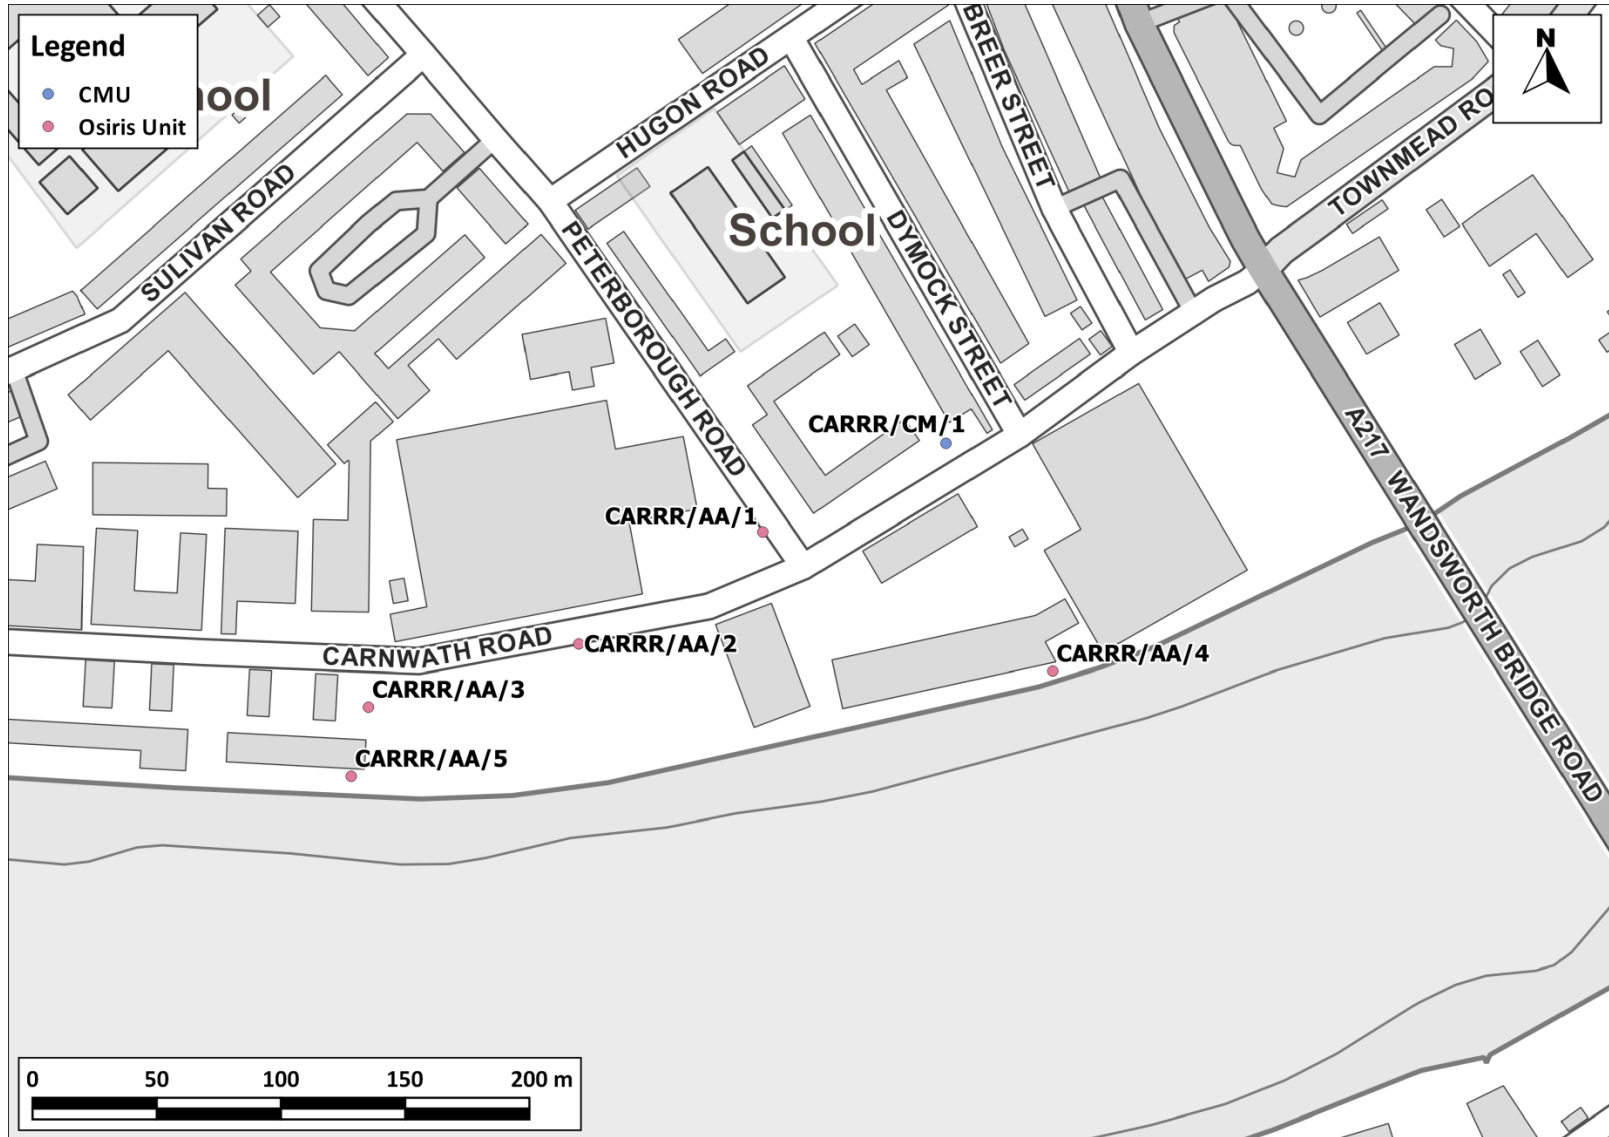
Figure B.1 Osiris Air Quality Monitor Location Plan

- B.1.1 There are five Osiris monitors installed at CARRR, in the following locations:
- CARRR/AA/1: Osiris monitor fitted to a lamppost on Peterborough Road. An anemometer (wind speed and direction sensor) is attached to this monitor.
 - CARRR/AA/2: Osiris monitor fitted to a lamppost on Carnwath Road.
 - CARRR/AA/3: Osiris monitor fitted to a lamppost on the redirected Thames Path west of the CARRR site.
 - CARRR/AA/4: Osiris monitor fitted to hoarding on the eastern boundary of the work site.
 - CARRR/AA/5: Osiris monitor fitted to hoarding adjacent to works at River Wall 922.
- B.1.2 The figure below shows the locations of the five Osiris monitors at CARRR (CARRR/AA/1, CARRR/AA/2, CARRR/AA/3, CARRR/AA/4 and CARRR/AA/5).
- B.1.3 The location of the Continuous Monitoring Unit (CMU) at Philpot Square is shown as CARRR/CM/1.
