AIR QUALITY MONITORING MONTHLY MONITORING REPORT CARNWATH ROAD RIVERSIDE (CARRR) JANUARY 2019

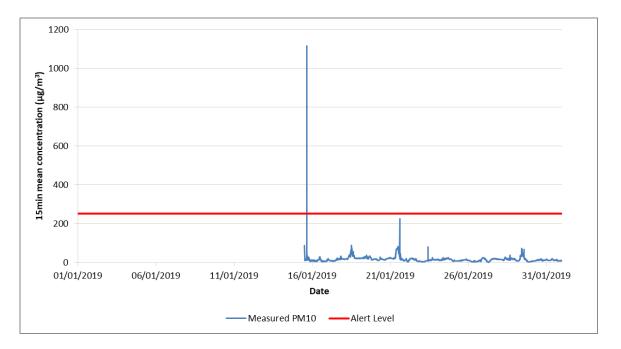
Figure 2 Graph of 15-min PM₁₀ Concentrations at CARRR/AA/2: January 2019

Alert ID	Source of Dust	
CARRR/AA/2_W 3_1	Monitor being worked and maintained to be put back online
