# Development Consent Order

# Application for Development Consent

## Environmental Statement

### **Volume 4: Acton Storm Tanks appendices**

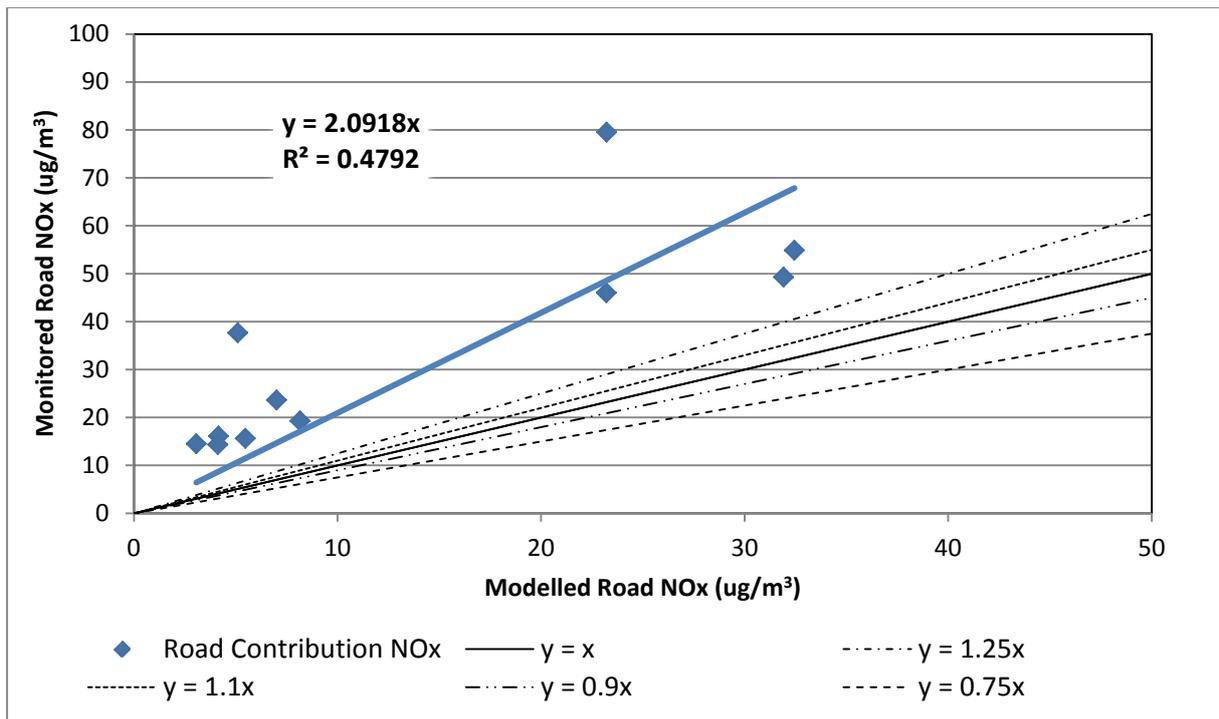
**Vol 4 Plate B.1 Air quality - monitored road NO<sub>x</sub> vs. modelled road NO<sub>x</sub>**

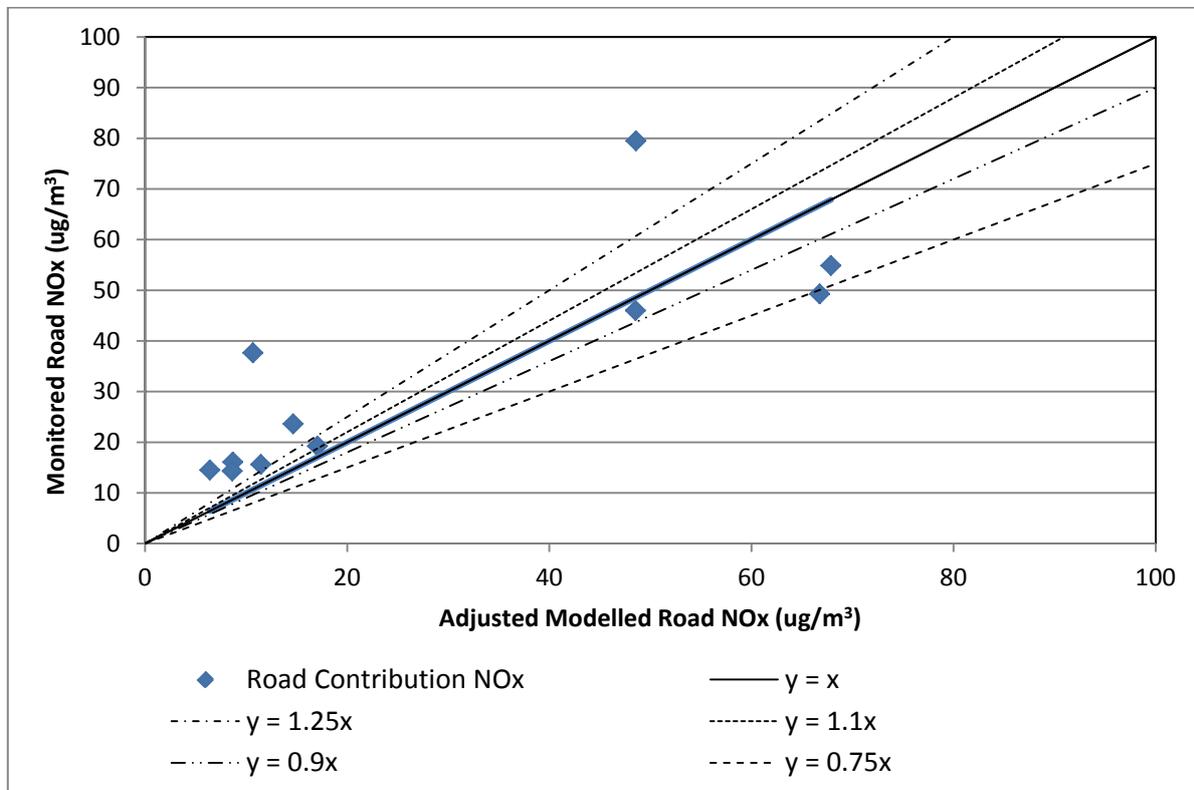
**Vol 4 Plate B.2 Air quality – monitored road NO<sub>x</sub> vs. adjusted modelled road NO<sub>x</sub>**

- B.1.4 Applying the NO<sub>x</sub> adjustment factor and then calculating NO<sub>2</sub> concentrations, as shown in Vol 4 Plate B.2, provides better overall agreement between actual and predicted data. The subsequent linear regression calculation for monitored versus modelled total NO<sub>2</sub>, as shown in Vol 4 Plate B.3, indicated that nine of the eleven modelled concentrations were within 10% of the measured value and all are within 25% of the modelled value.

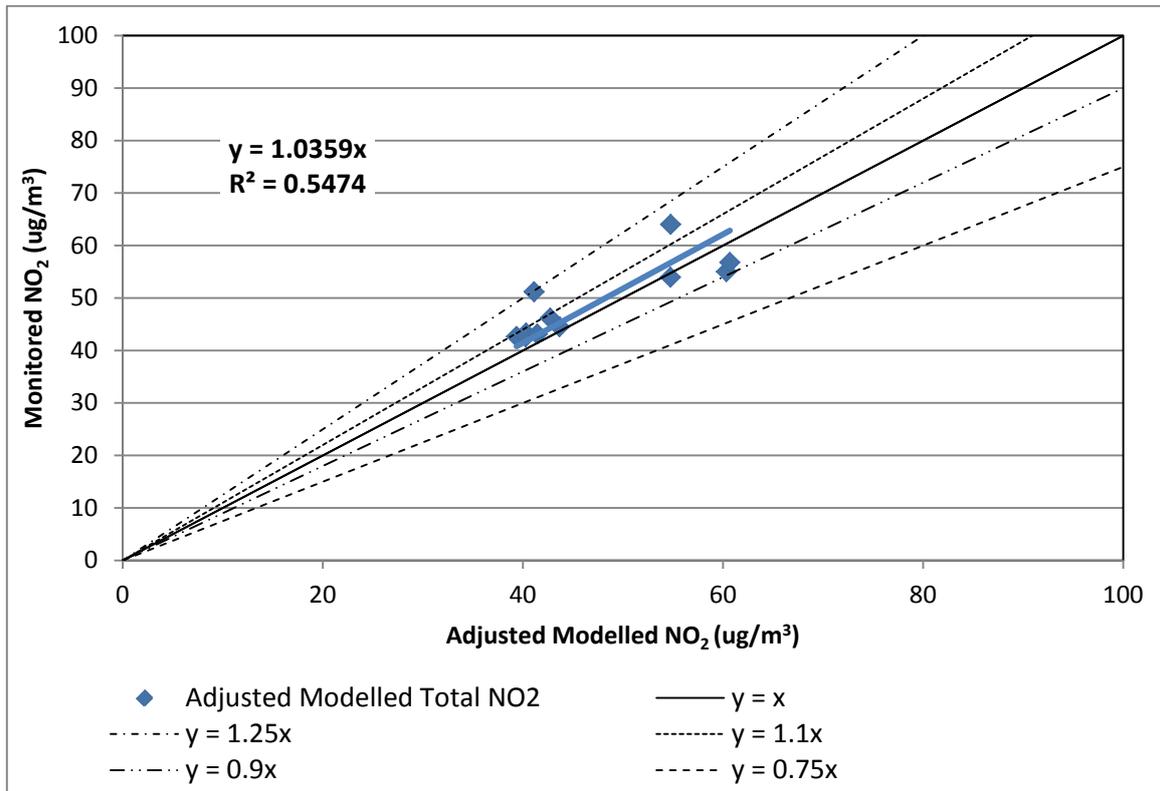
**Vol 4 Plate B.3 Air quality – total monitored NO<sub>2</sub> vs. total adjusted modelled NO<sub>2</sub>**

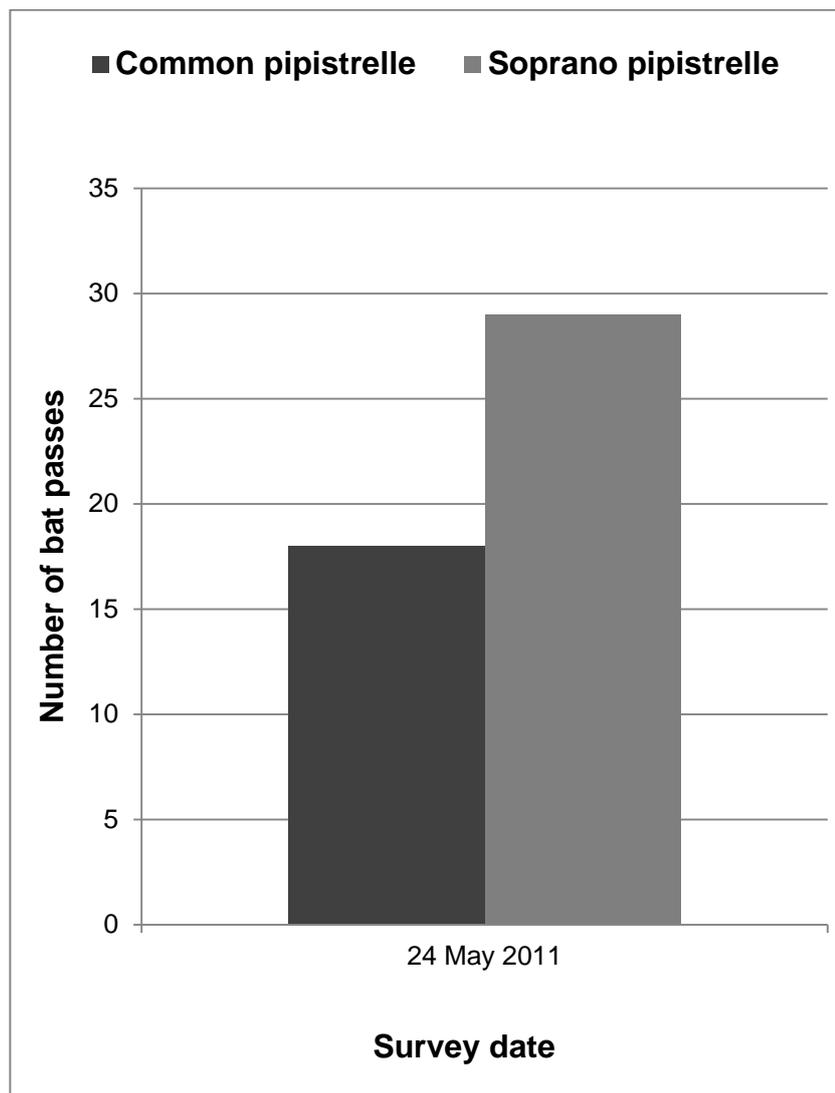
**Vol 4 Plate D.1 Terrestrial ecology – bat passes recorded during remote recording surveys at one location at Acton Storm Tanks site**

- D.1.15 The bat triggering (remote recording) surveys were undertaken on the 24 May 2011 in suitable weather conditions (Vol 4 Table D.2).
- D.1.16 The remote recording survey undertaken at Acton Storm Tanks site recorded two species of bats using the site, common pipistrelle, (*Pipistrellus pipistrellus*) and soprano pipistrelle (*Pipistrellus pygmaeus*). A total of 18 common pipistrelle and 29 soprano pipistrelle passes were recorded (see Vol 4 Plate D.1). Some of these bat passes were recorded close to sunset indicating a possible roost site.

- D.1.21 The site is used for foraging by common and soprano pipistrelle bats.
- D.1.22 During the remote recording survey low numbers of common pipistrelle bats were recorded, some of these being close to dawn when bats return to their roost sites for the day. However, no common pipistrelle bats were observed entering the building on site or any of the residential buildings in close proximity to the site during the dawn activity survey. Therefore, it is considered unlikely that there is a roost on or in close proximity to the site.

- D.1.23 The maximum number of soprano pipistrelle bat passes was 29 and this activity is considered likely to be associated with bats foraging around trees and scrub on and adjacent to the site. No records were made close to dusk or dawn, when bats leave and return to their roosts. No soprano pipistrelle bats were observed during the dawn activity survey. Therefore, no roost is suspected on or in close proximity to the site.

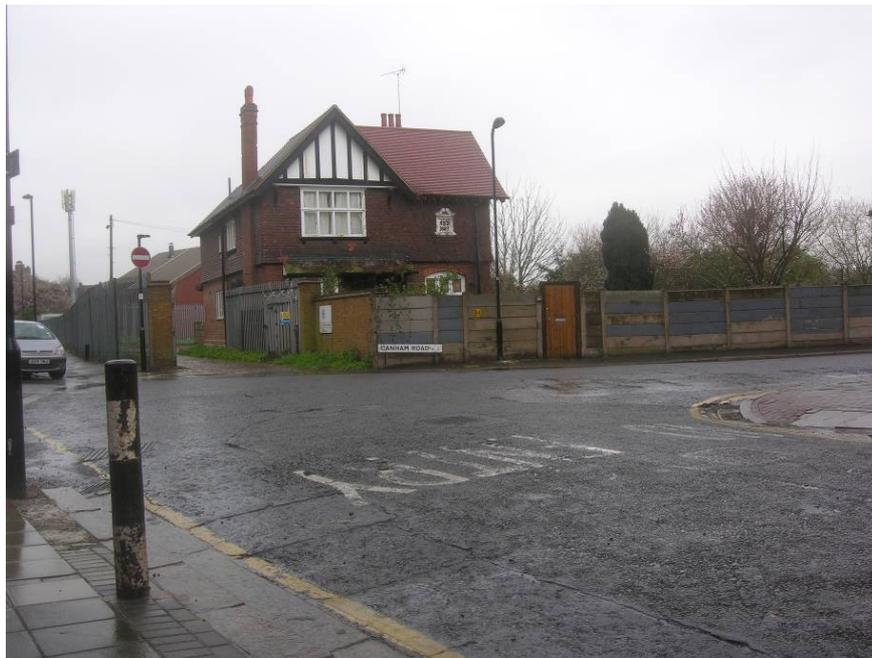
**Vol 4 Plate E.8 Historic environment – View of a house to the north, outside the site, at the corner of Canham Road and Warple Way. The stone dates the house to 1887.**

*Looking south; standard lens; MOLA; 18<sup>th</sup> March 2011*

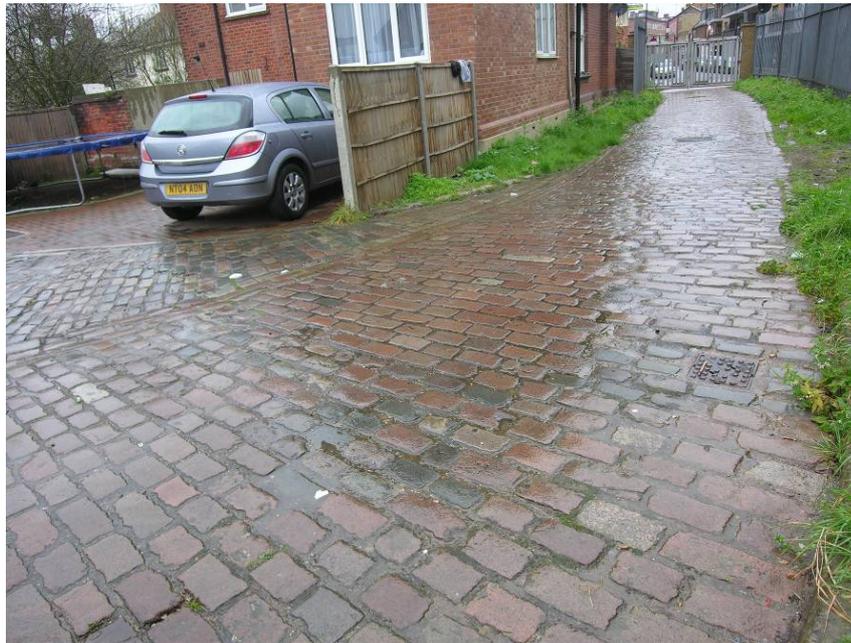
**Vol 4 Plate E.9 Historic environment – View of cobbled road surface, taken from the entrance of the site.**

*Looking northeast; standard lens; MOLA; 18<sup>th</sup> March 2011*

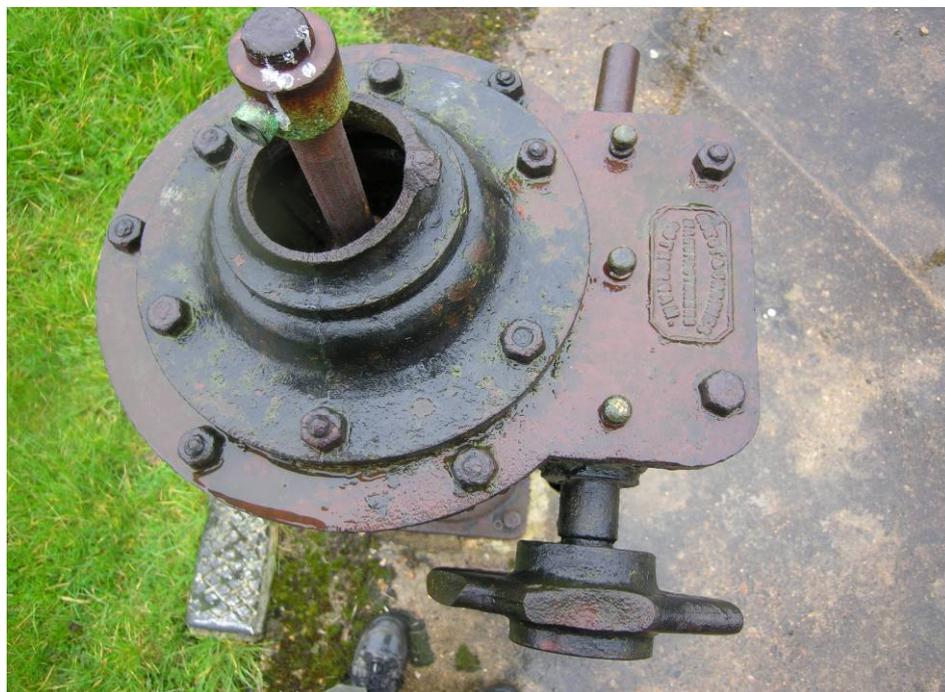
**Vol 4 Plate E.10 Historic environment – View of a piece of redundant machinery on the site. Located near the centre of the site.**

HEA Ref no.	Description	Site code/ HER ref/ List Entry Number
1	MOLA site visit in March 2011 noted upstanding remnants of the original 19th century sewage works in the form of historic machinery; cobbled access road and a granite slab naming the councillors and contractors involved in the construction.  In August and September 2011, MOLA archaeologically monitored three geotechnical boreholes, dug in the northern and southern parts of the site. This revealed modern disturbance at the southern end of the site and possible late post-medieval remains beneath modern made ground in the northern part of the site.	-
2	Beech Avenue, Bromyard Avenue. Department of Greater London Archaeology evaluation in 1991 revealed shallow features cut into the Brickearth subsoil, dating to the 19th or early 20th century. They were thought to represent clay pits associated with East Acton Brickworks.	BEA91
3	Acton Vale, near Sewage Farm. The GLHER notes the chance find of a prehistoric blade.	050396

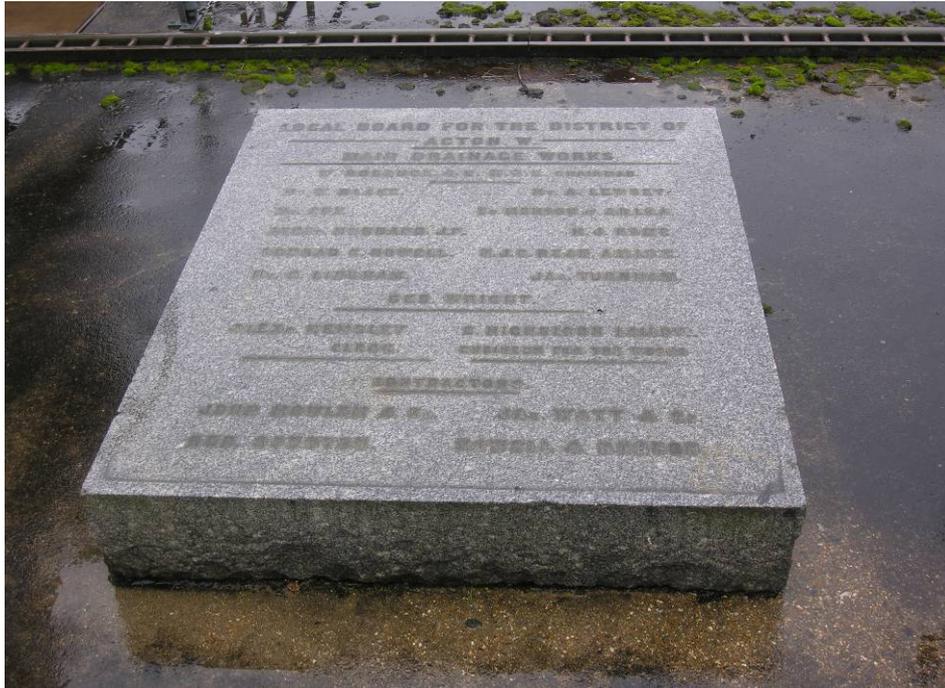
**Vol 4 Plate E.11 Historic environment – View of the inscribed granite tablet near the centre of the site.**

*Looking southwest; standard lens; MOLA; 18<sup>th</sup> March 2011*

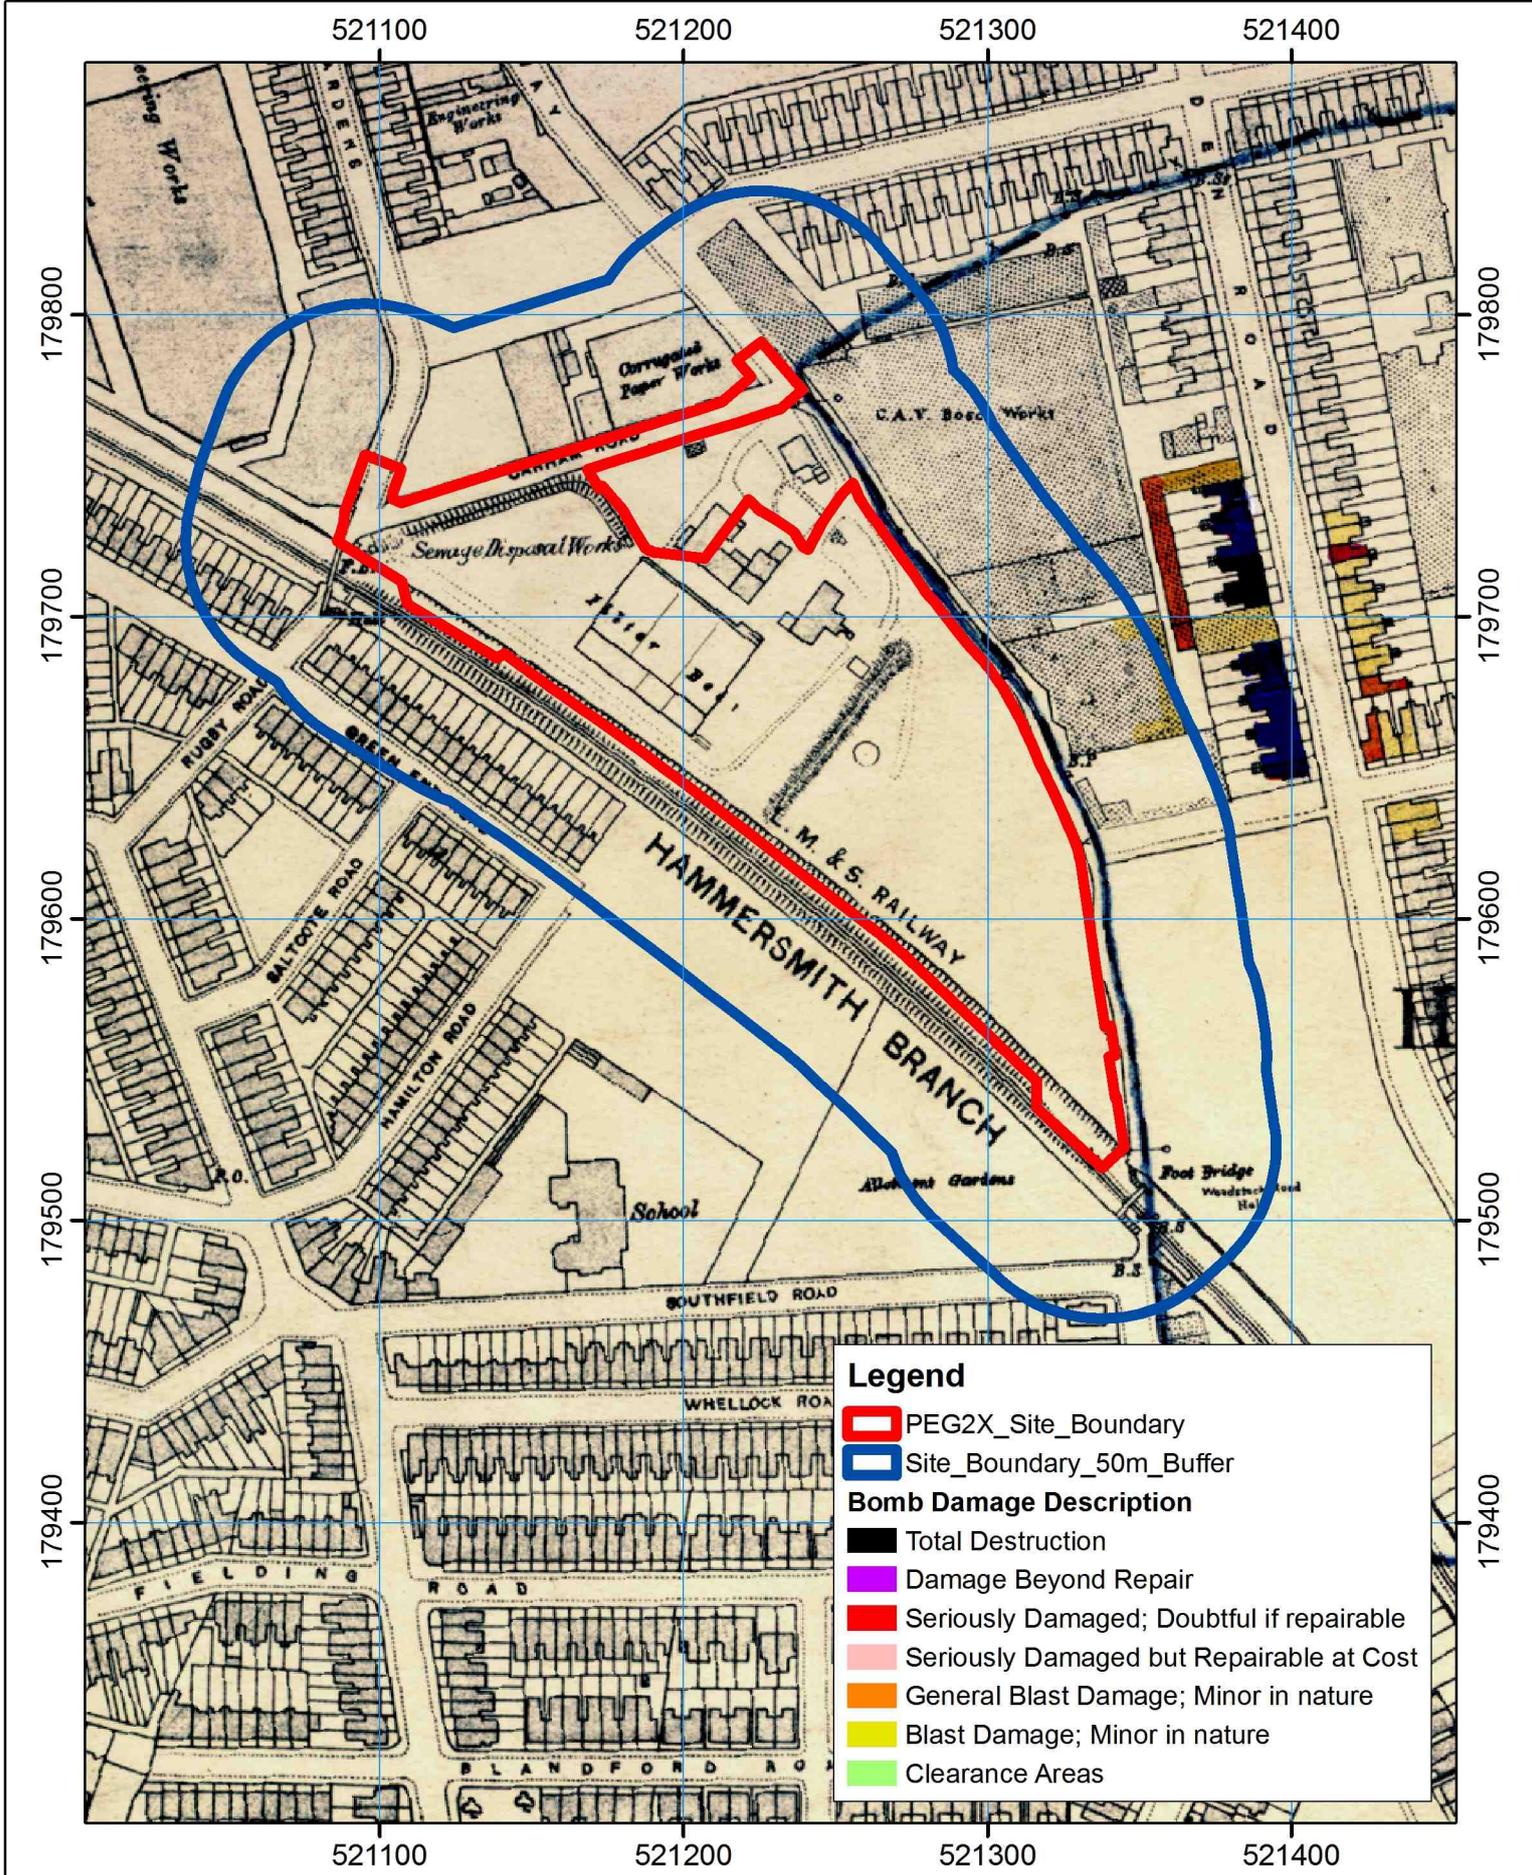
Figure 7

# Thames Tideway Tunnel - Work Area PEG2X London County Council Bomb Damage Map

WWII Bomb Damage (Figure 7)	<p><i>London County Council</i> (LCC) bomb damage maps indicate no bomb damage within the Site and only slight “blast damage” occurred within the buffered Site boundary to the north. Additionally, “total destruction” of structures by bomb damage occurred to the east of the Site.</p>
WWII HE Bomb Density (Figure 8)	<p>The Study Site is located between the <i>Acton Metropolitan Borough</i> and <i>Hammersmith Metropolitan Borough</i>, which recorded 199 HE bombs and 132 HE bombs per 1,000 acres respectively.</p> <p>This figure does not include incendiary devices, as they were often released in such large numbers that they were seldom recorded.</p>
Abandoned Bombs	<p>The Official Abandoned Bomb Register recorded no abandoned bombs on or within 1,000m of the Work Area.</p>

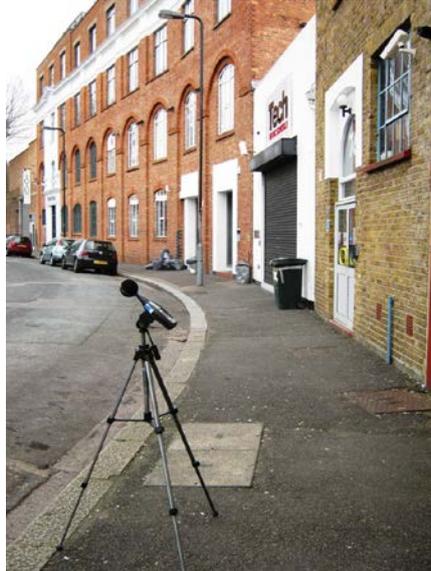
### Vol 4 Plate G.1 Noise measurement location AST01

*Note: On public footpath adjacent to Stanley Gardens, looking north*

G.1.14 The following plates (Vol 4 Plate G.1 to Vol 4 Plate G.7) illustrate the noise measurement locations.

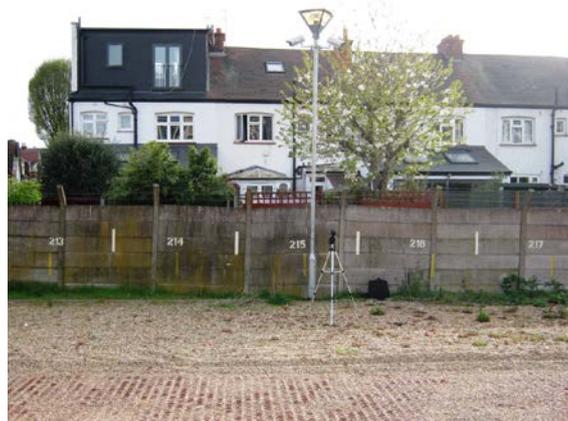
### Vol 4 Plate G.2 Noise measurement location AST02

*Note: Within private car park off Warple Way, looking southwest towards residential dwellings on Greenend Road*

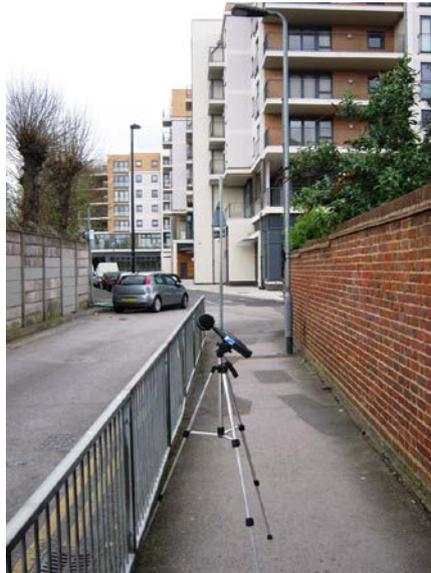
**Vol 4 Plate G.3 Noise measurement location AST03**

*Note: On public footpath adjacent to Warple Way, looking north (façade measurement)*

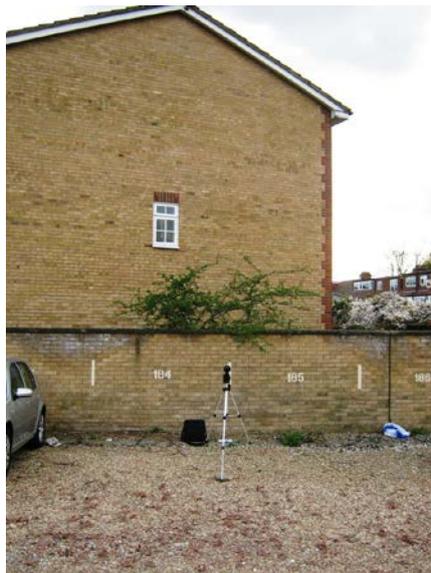
**Vol 4 Plate G.4 Noise measurement location AST04**

*Note: Within private car park off Warple Way, looking southwest towards residential dwellings on Worcester Drive*

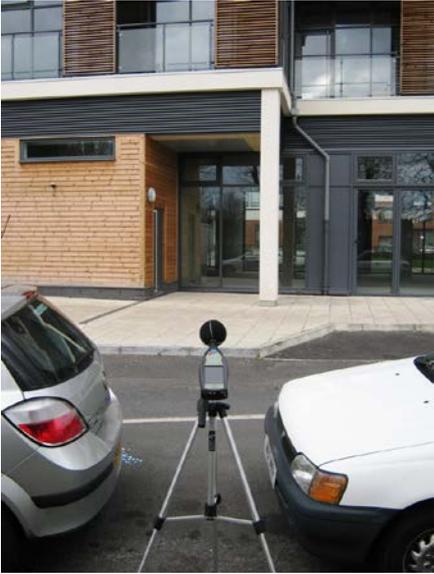
**Vol 4 Plate G.5 Noise measurement location AST05**

*Note: On public footpath adjacent to Warple Way, looking northeast towards residential flats*

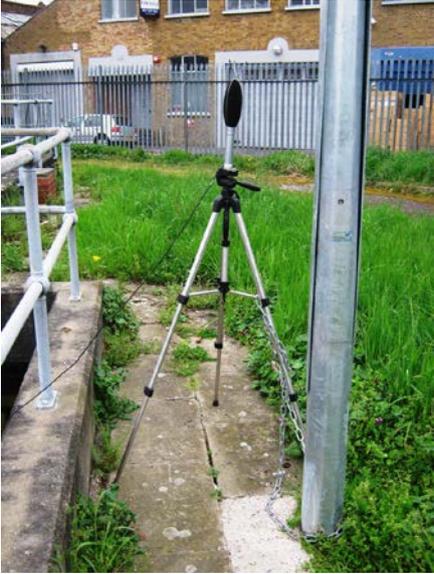
**Vol 4 Plate G.6 Noise measurement location AST06**

*Note: Within Acton Storm Tanks, looking northwest towards Canham Road*

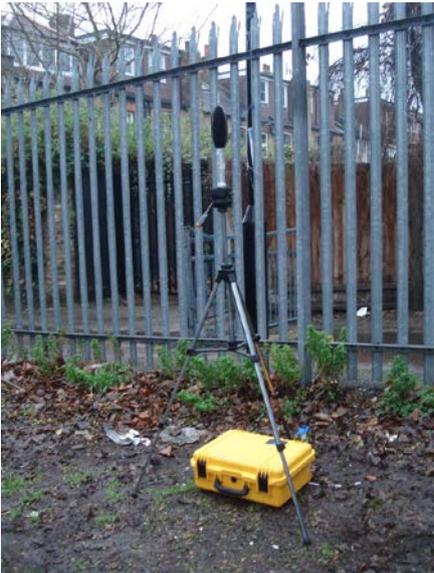
**Vol 4 Plate G.7 Noise measurement location AST07**

*Note: Within private car park off Warple Way, looking northwest towards Rugby Road*

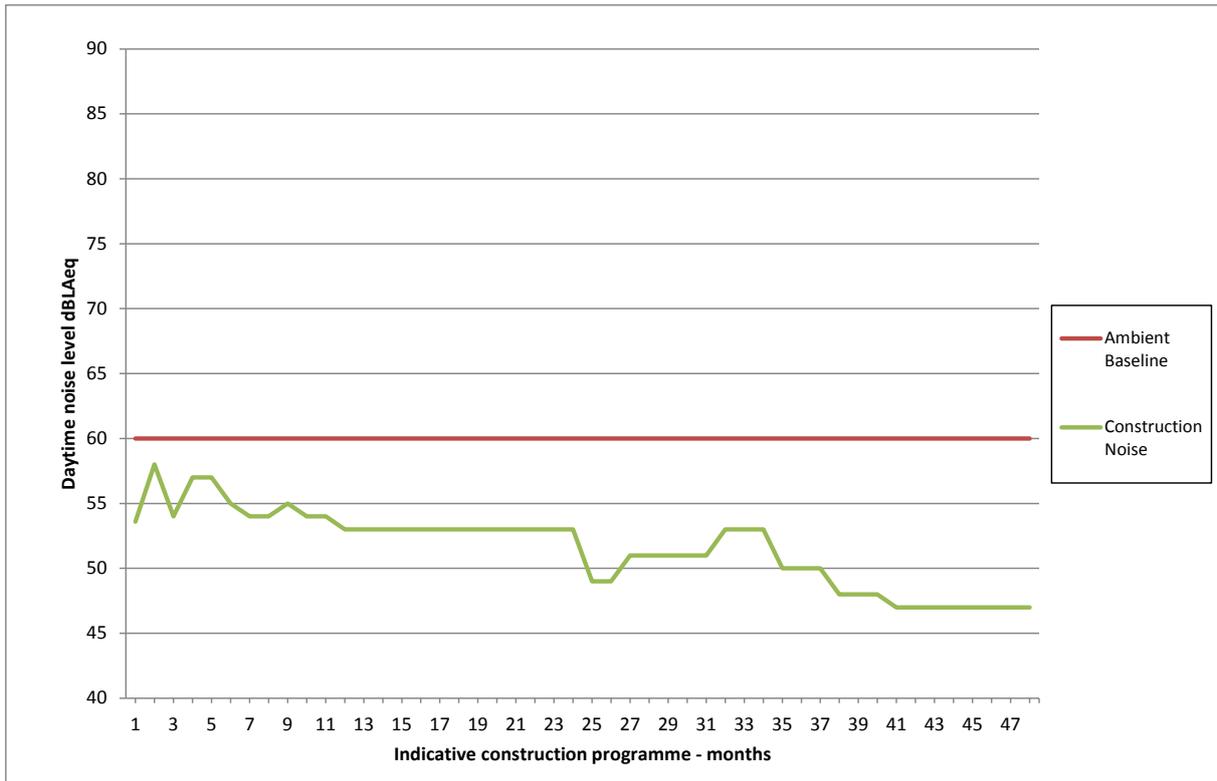
**Vol 4 Plate G.8 Average monthly daytime noise level over duration of construction – Stanley Studios (studio) (AS1)**

G.2.5 The predicted construction noise over time at each receptor is shown in the figures below. It should be noted that these representations are for the worst-case scenarios for noise exposure at the upper floors. For comparison with the construction noise, the figures also show either the potential significance criterion threshold for residential receptors, or the ambient noise level. This comparison is discussed in the main assessment text. The night-time noise levels have also been assessed for the short period of night-time works, these results are described in the main assessment text and not presented here.

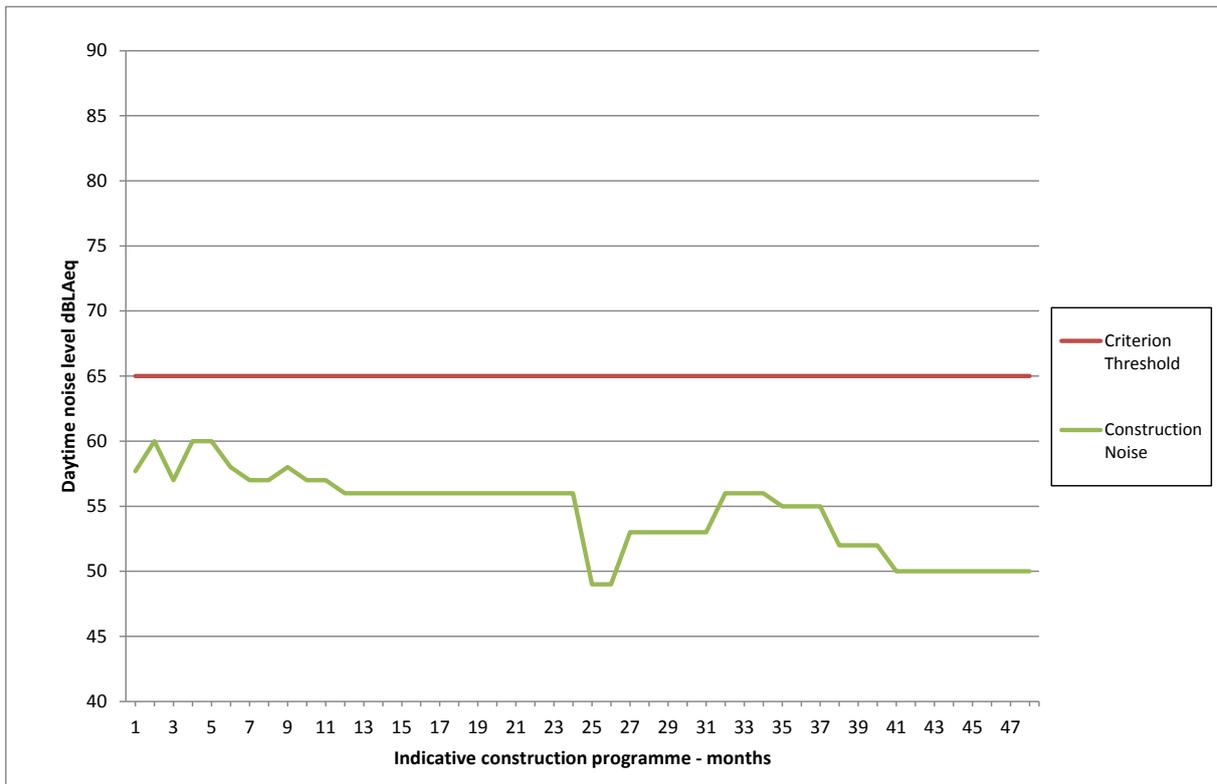
**Vol 4 Plate G.9 Average monthly daytime noise level over duration of construction – 2-12 Greenend Road (residential) (AS2)**

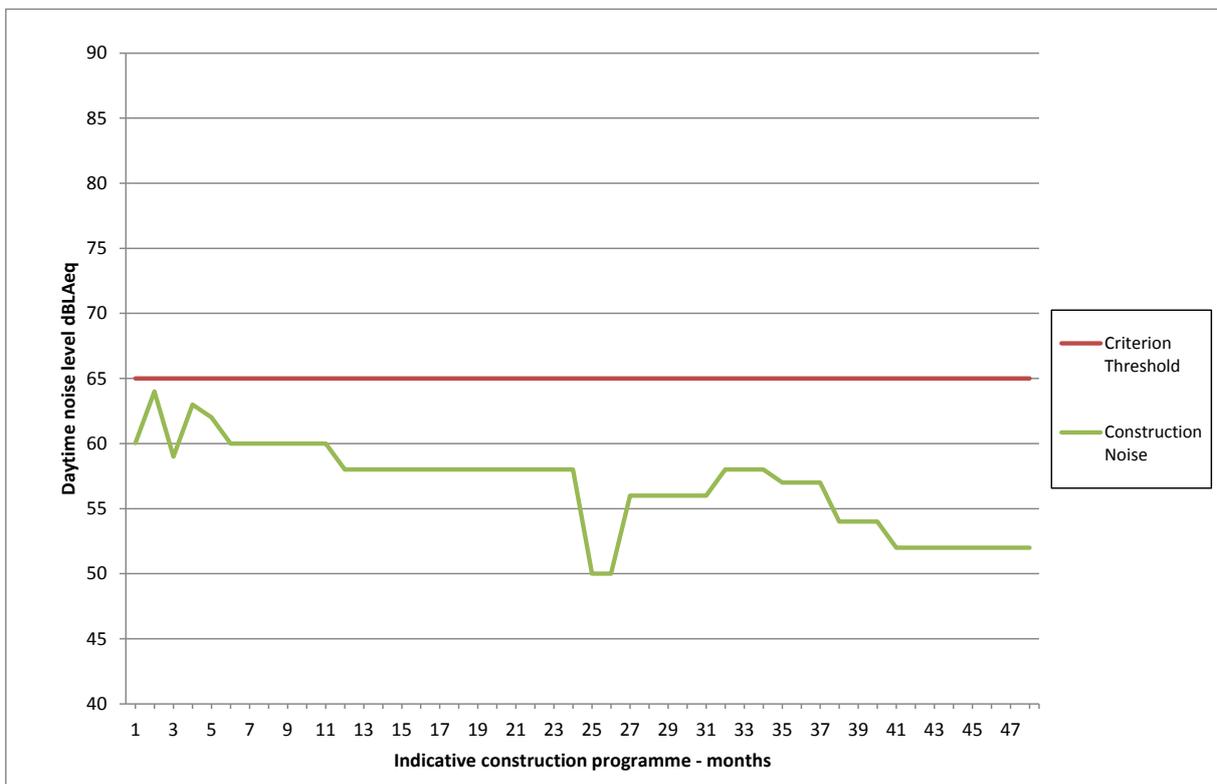
**Vol 4 Plate G.10 Average monthly daytime noise level over duration of construction - 14-26 Greenend Road (residential) (AS3)**

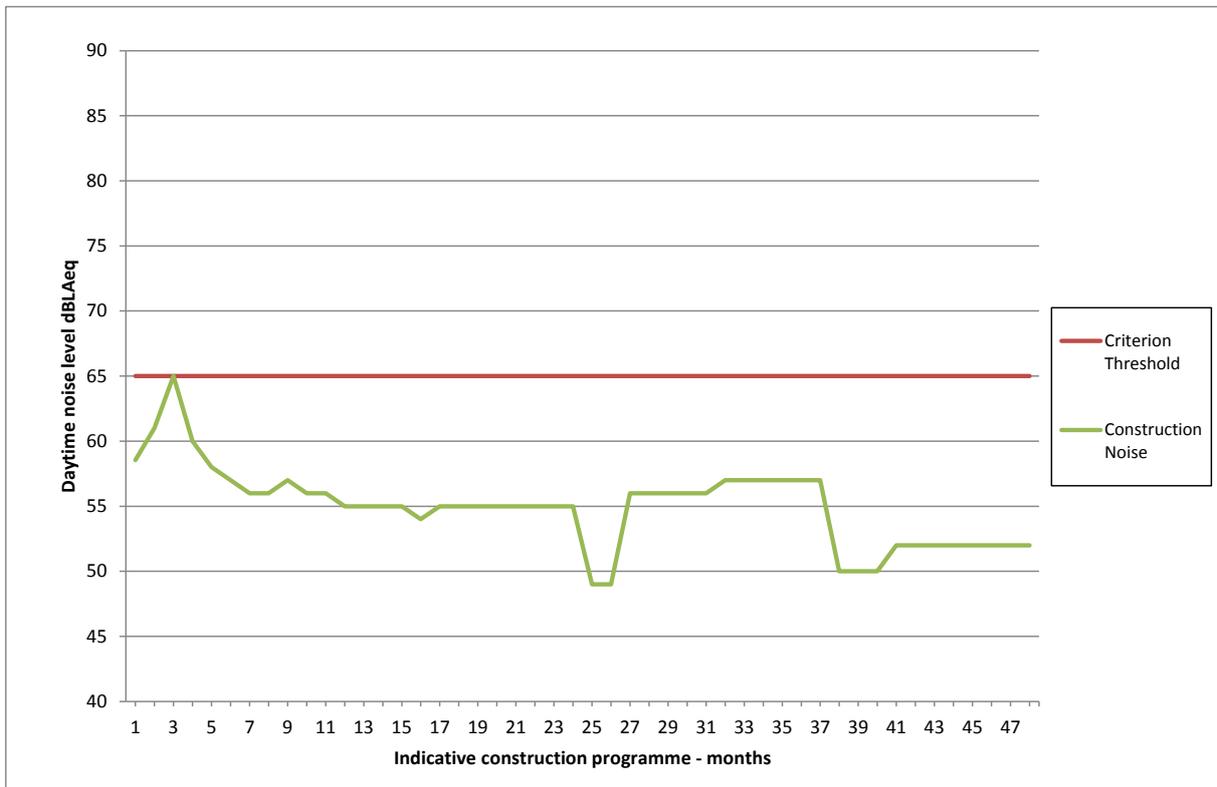
**Vol 4 Plate G.11 Average monthly daytime noise level over duration of construction – 46-54 Greenend Road (residential) (AS4)**

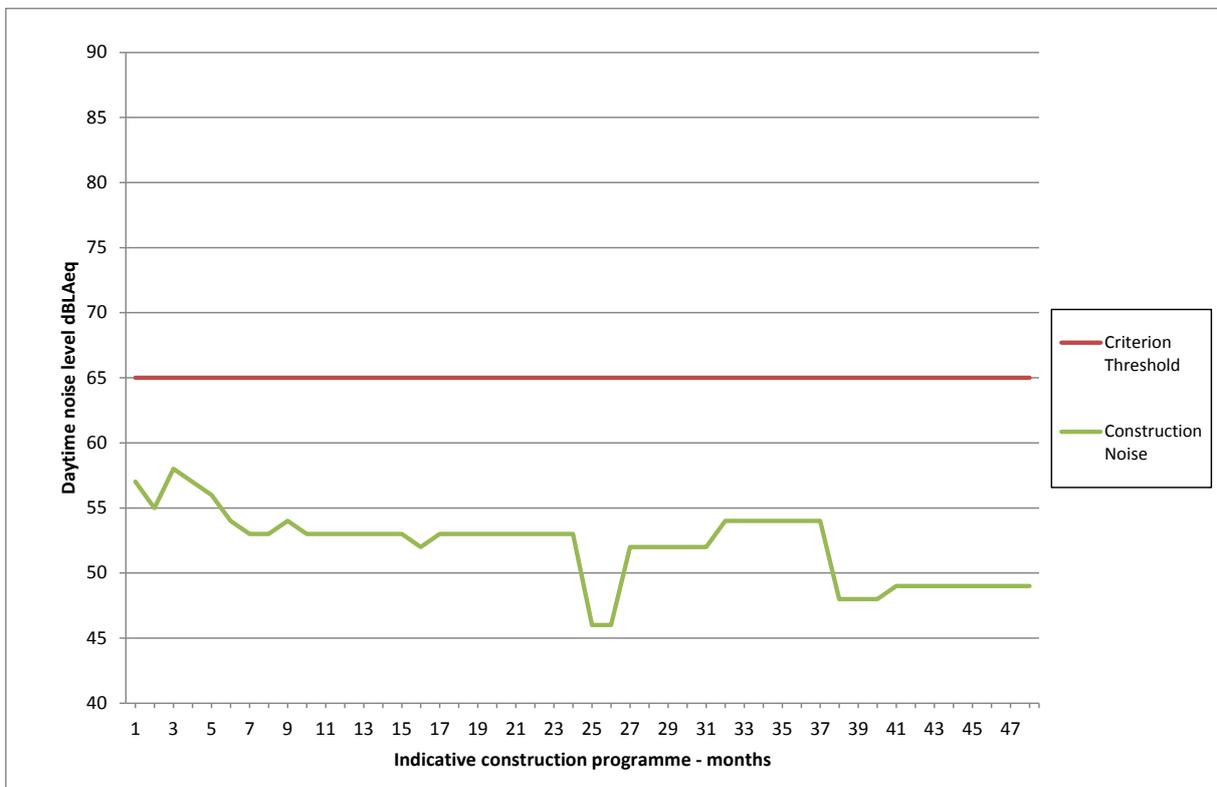
**Vol 4 Plate G.12 Average monthly daytime noise level over duration of construction – 5-8 Worcester Drive (residential) (AS5)**

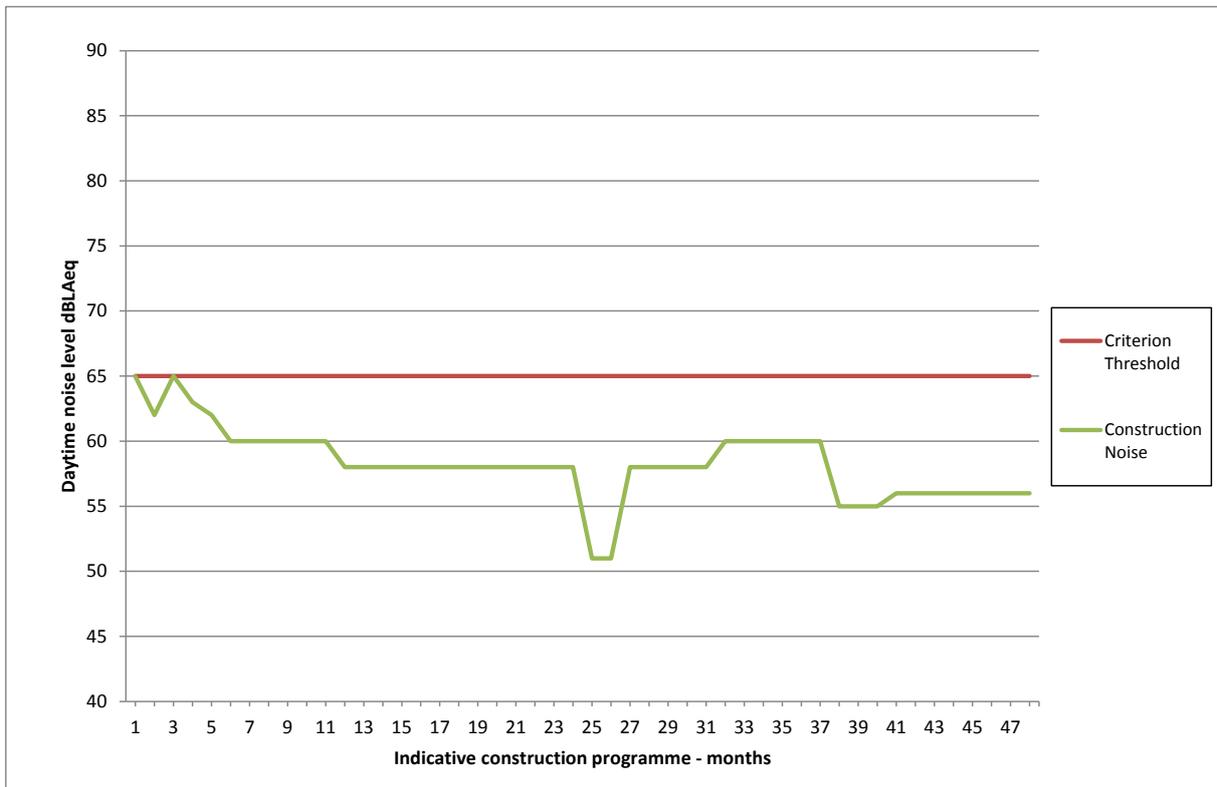
**Vol 4 Plate G.13 Average monthly daytime noise level over duration of construction –250 -269 Longford Court (residential) (AS6)**

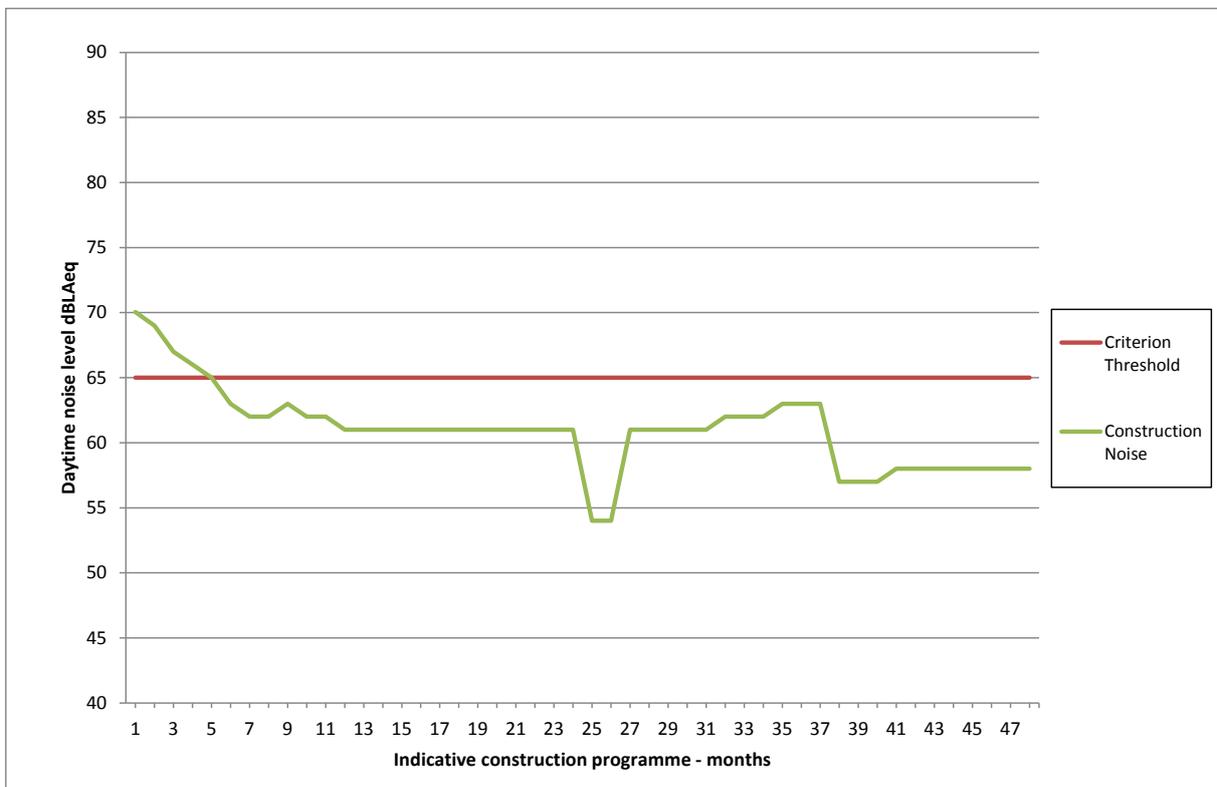
**Vol 4 Plate G.14 Average monthly daytime noise level over duration of construction –1-66 Edison Court (residential) (AS7)**

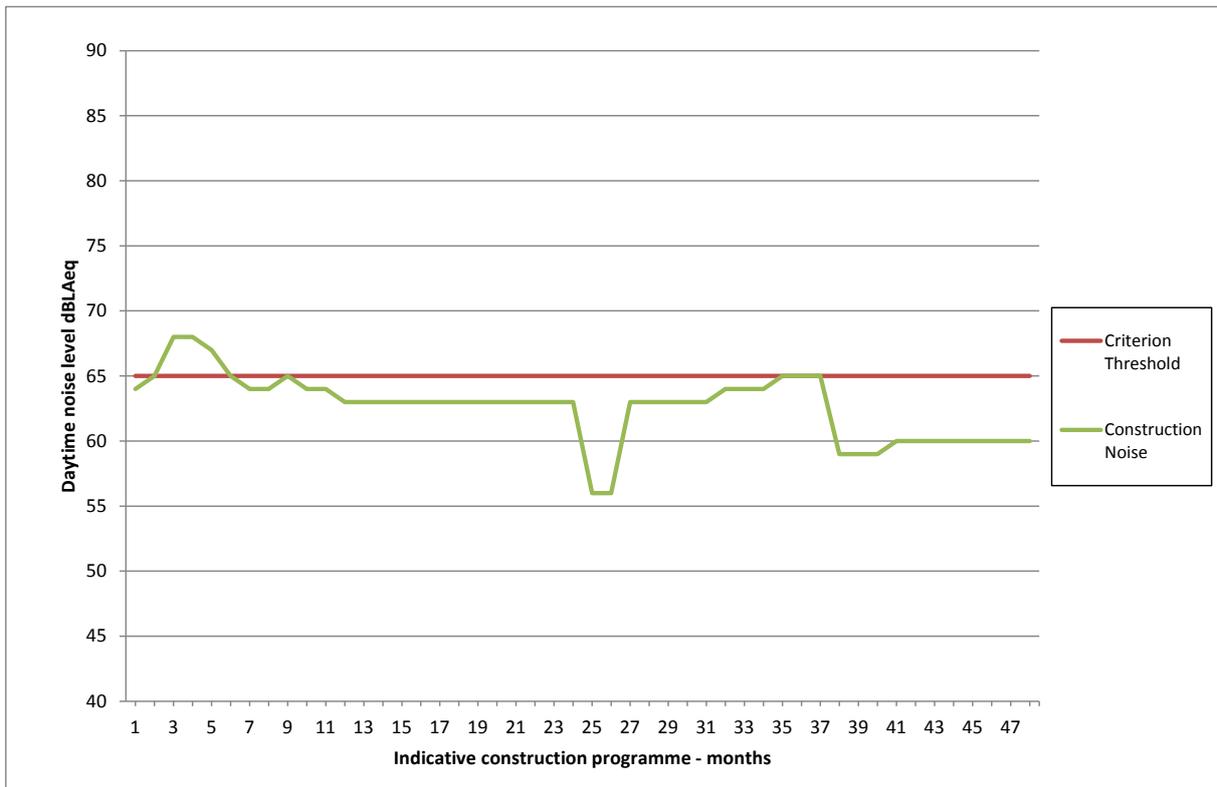
**Vol 4 Plate G.15 Average monthly daytime noise level over duration of construction –Tesla Court (residential) (AS8)**

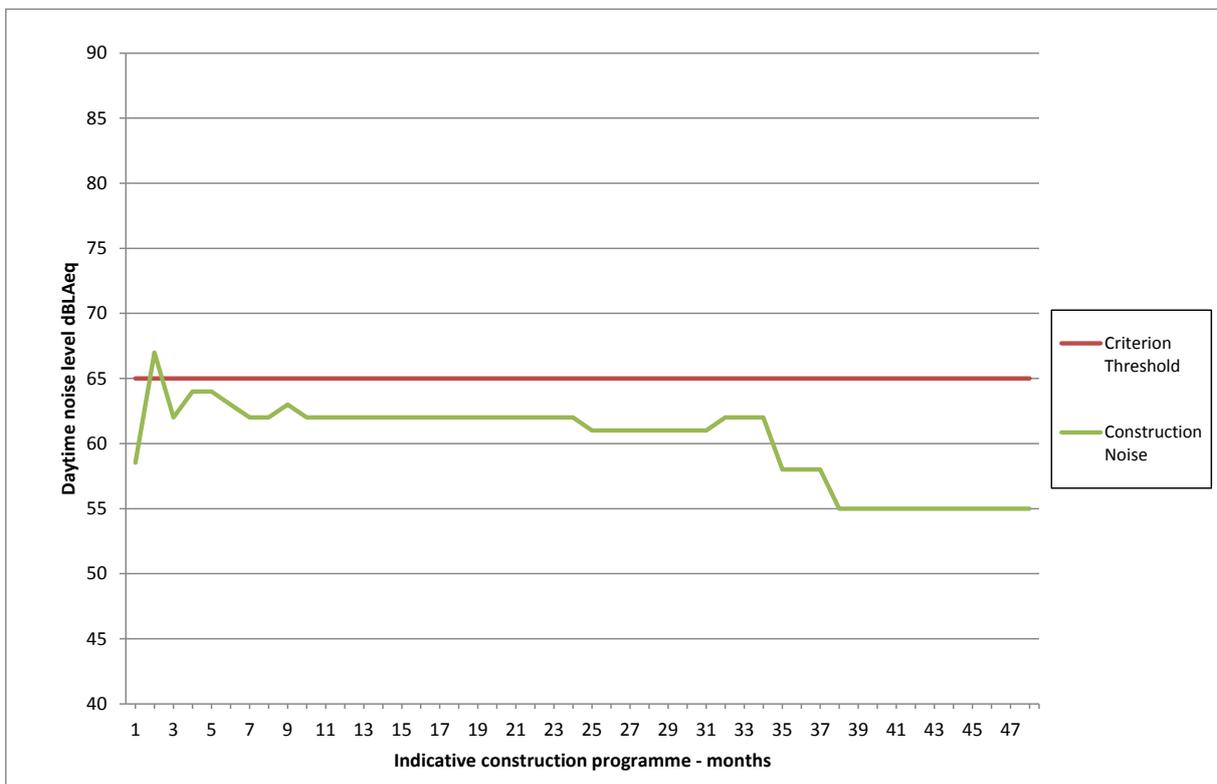
**Vol 4 Plate G.16 Average monthly daytime noise level over duration of construction –3-5 Canham Road (residential) (AS9)**

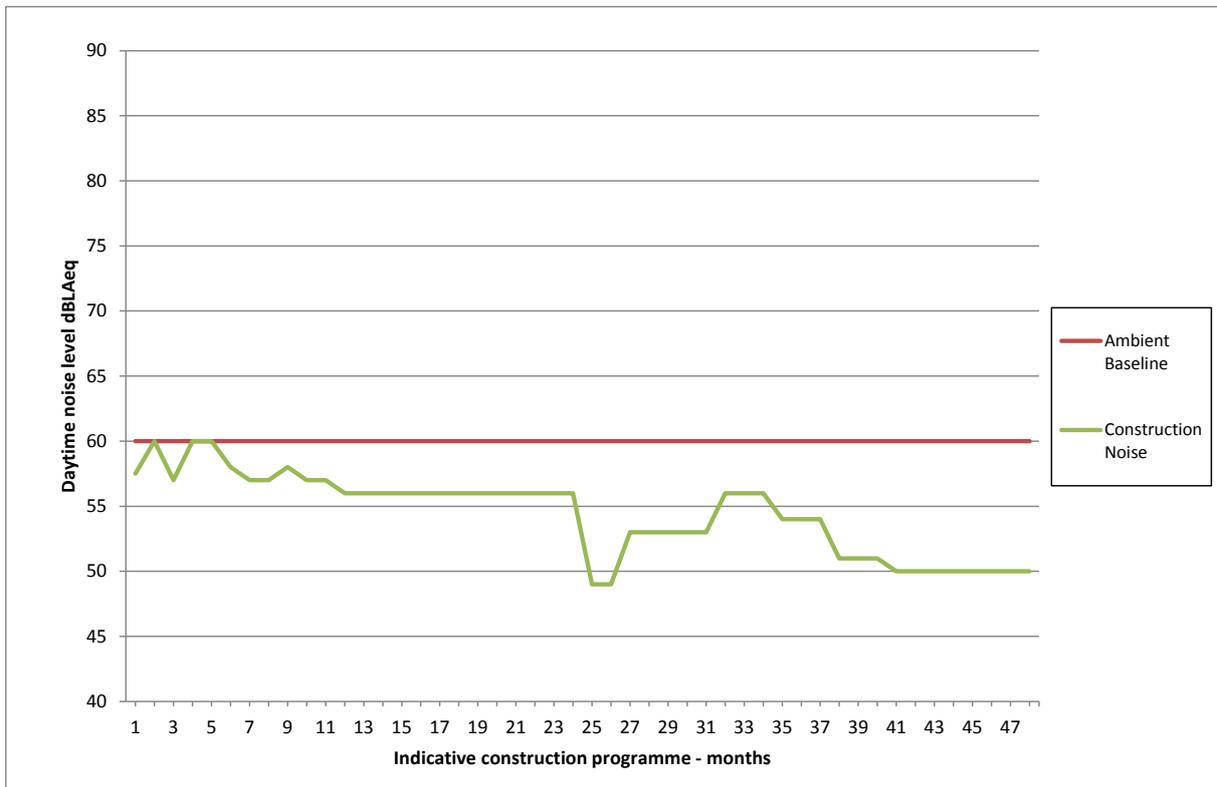
**Vol 4 Plate G.17 Average monthly daytime noise level over duration of construction –Scout Hut and Crèche (community hall) (AS10)**
