# Development Consent Order

# Application for Development Consent

## Environmental Statement

### **Volume 4: Acton Storm Tanks appendices**

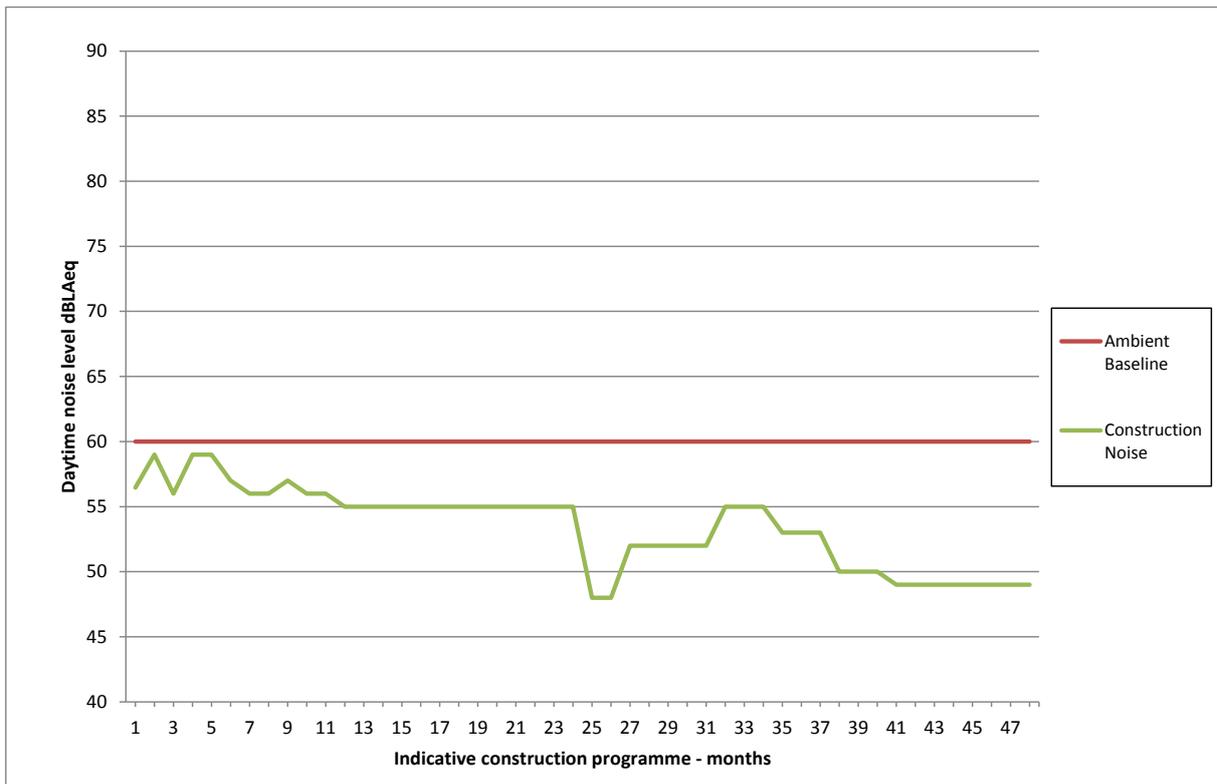
**Vol 4 Plate G.18 Average monthly daytime noise level over duration of construction –TV Studio (Acton Industrial Estate Unit 11) (AS11)**
