**Thames
Tideway Tunnel**

Environmental Statement

Doc Ref: **6.2.11**

Volume 11: Falconbrook Pumping Station appendices

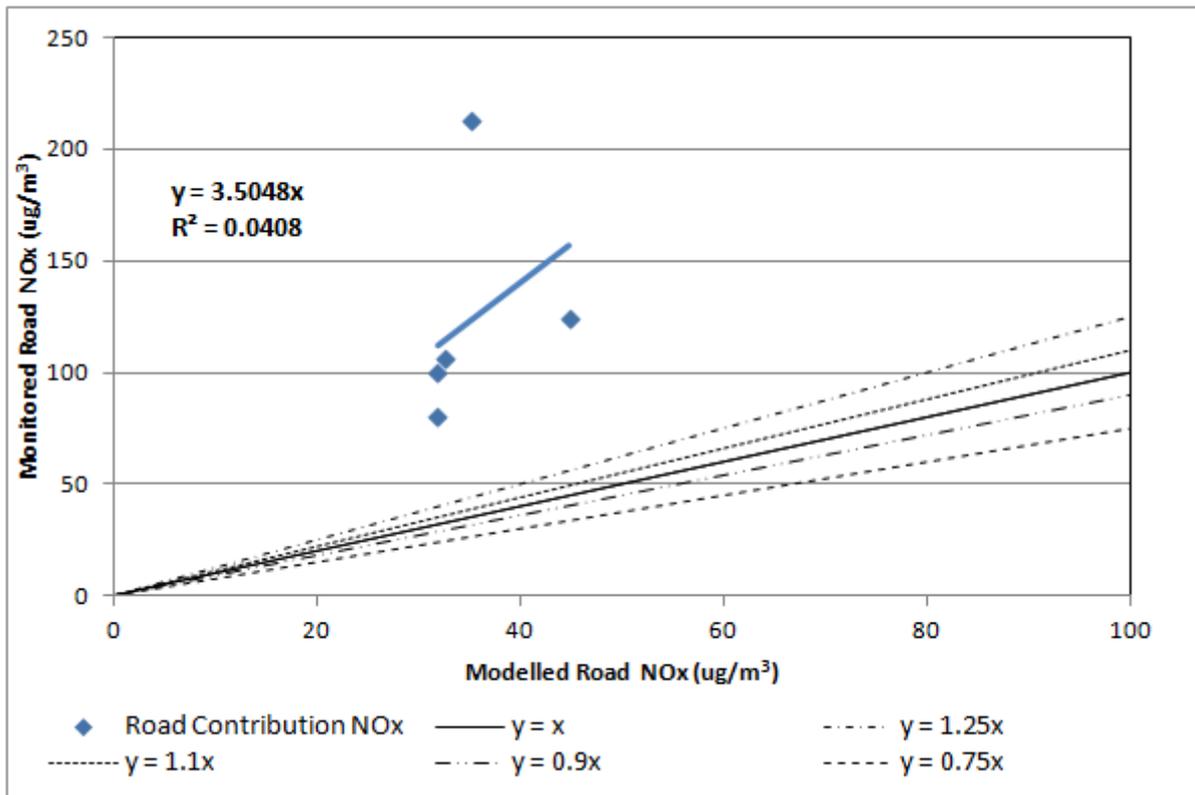
Vol 11 Plate B.1 Air quality - monitored road NO_x vs. modelled road NO_x

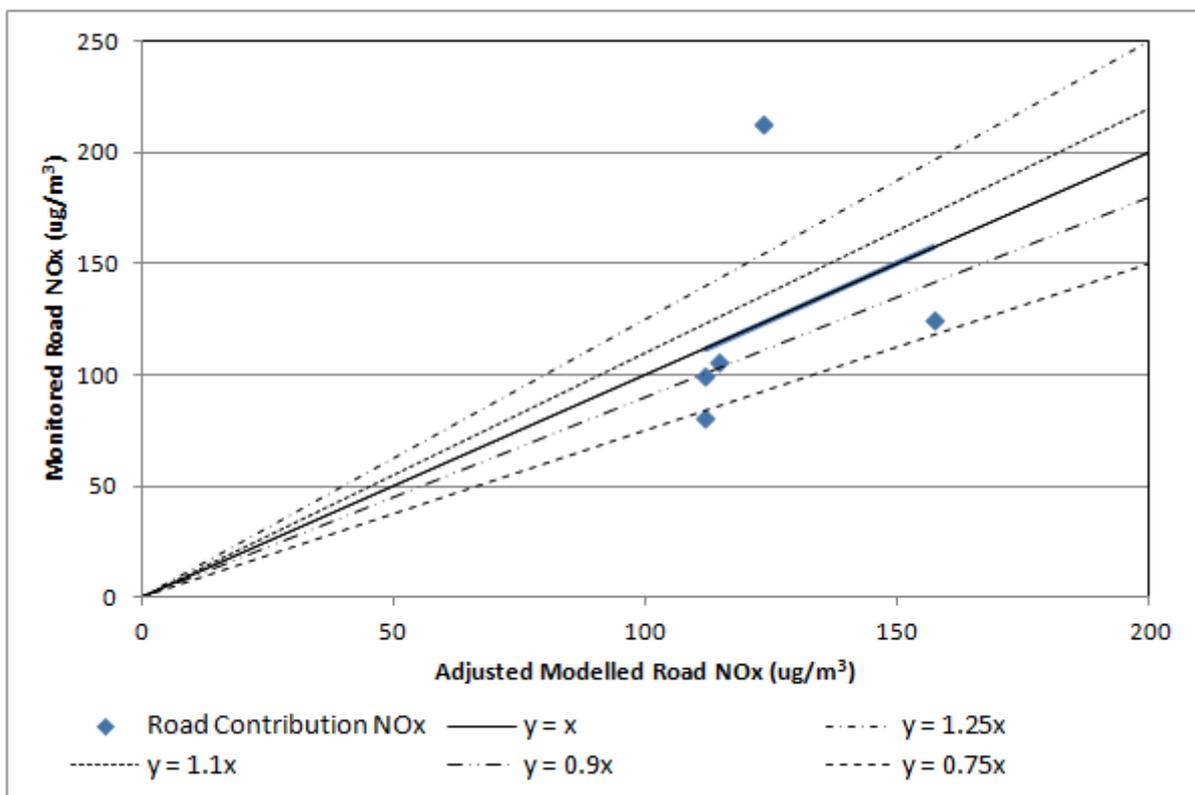
Vol 11 Plate B.2 Air quality – monitored road NO_x vs. adjusted modelled road NO_x

- B.1.4 Applying the NO_x adjustment factor and then calculating NO₂ concentrations, as shown in Vol 11 Plate B.2, provides better overall agreement between actual and predicted data. The subsequent linear regression calculation for monitored versus modelled total NO₂, as shown in Vol 11 Plate B.3, indicated that two of the five modelled concentrations were within 10% of the measured value and that all five were within 25% of the modelled value.

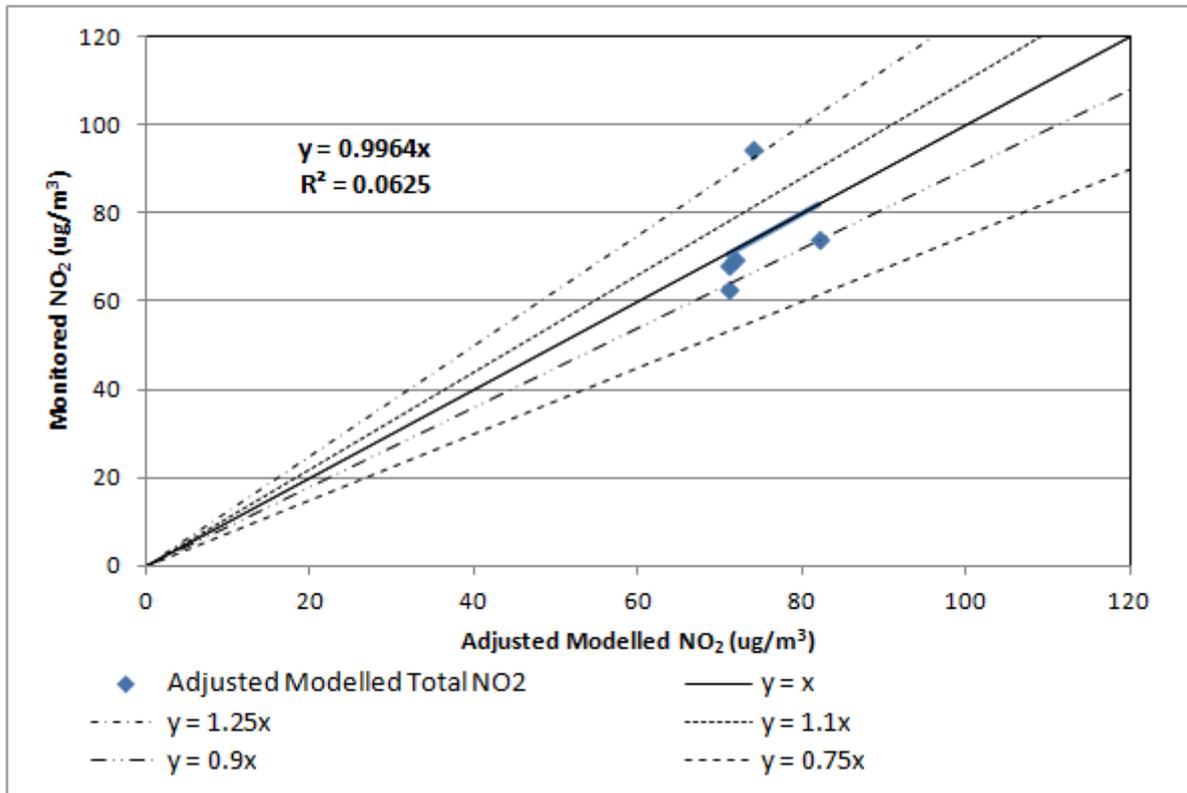
Vol 11 Plate B.3 Air quality – total monitored NO₂ vs. total adjusted modelled NO₂

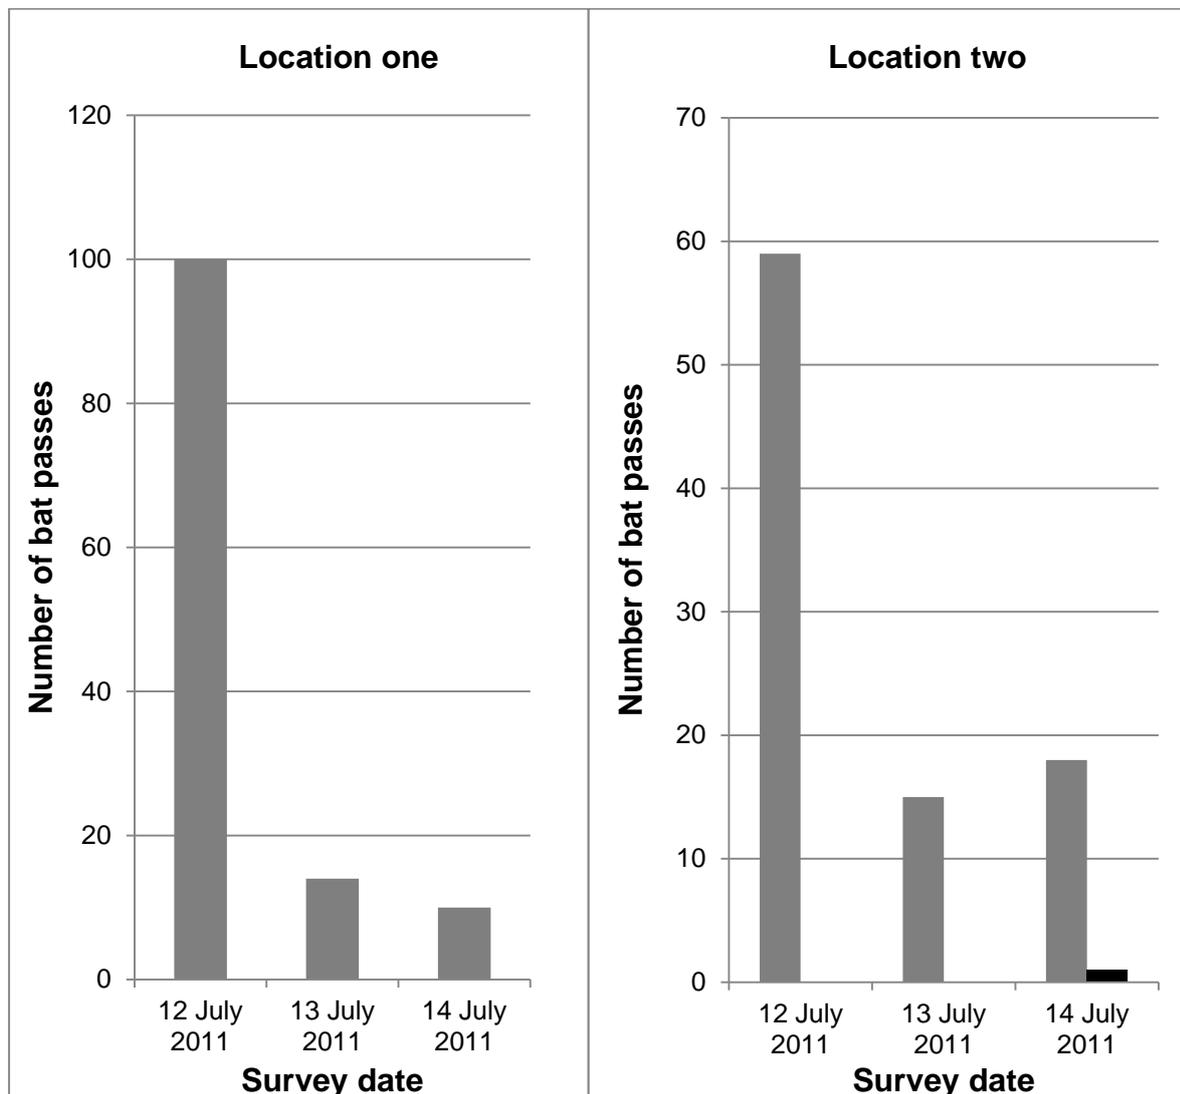
Vol 11 Plate D.1 Terrestrial ecology – bat passes recorded during remote recording surveys at two locations at Falconbrook Pumping Station.

- D.1.14 The bat triggering (remote recording) survey was undertaken over three nights between 12 and 14 July 2011 in suitable weather conditions (see Vol 11 Table D.2).
- D.1.15 The remote recording surveys undertaken at this site recorded two species of bats using the site: common pipistrelle (*Pipistrellus pipistrellus*); and soprano pipistrelle (*Pipistrellus pygmaeus*).
- D.1.16 The maximum number of common pipistrelle bat passes recorded during any one night was 100 at location one and 59 at location two, both recorded on 12 July. Lower numbers of bat passes were recorded on the other two nights at each location (see Vol 11 Plate D.1). Two passes were recorded within half an hour of sunset (28 and 29 minutes after sunset).
- D.1.17 One soprano pipistrelle bat pass was recorded on only one night (15 July 2011).

D.1.20 There was a noticeable difference in the level of common pipistrelle activity on the night of 12 July in comparison to the other two nights. Variability between survey nights is expected due to small variations in weather conditions, variability in the invertebrate foraging resource and local changes in roost usage. The variability here is likely to represent either an increase in foraging activity of the small numbers of bats present

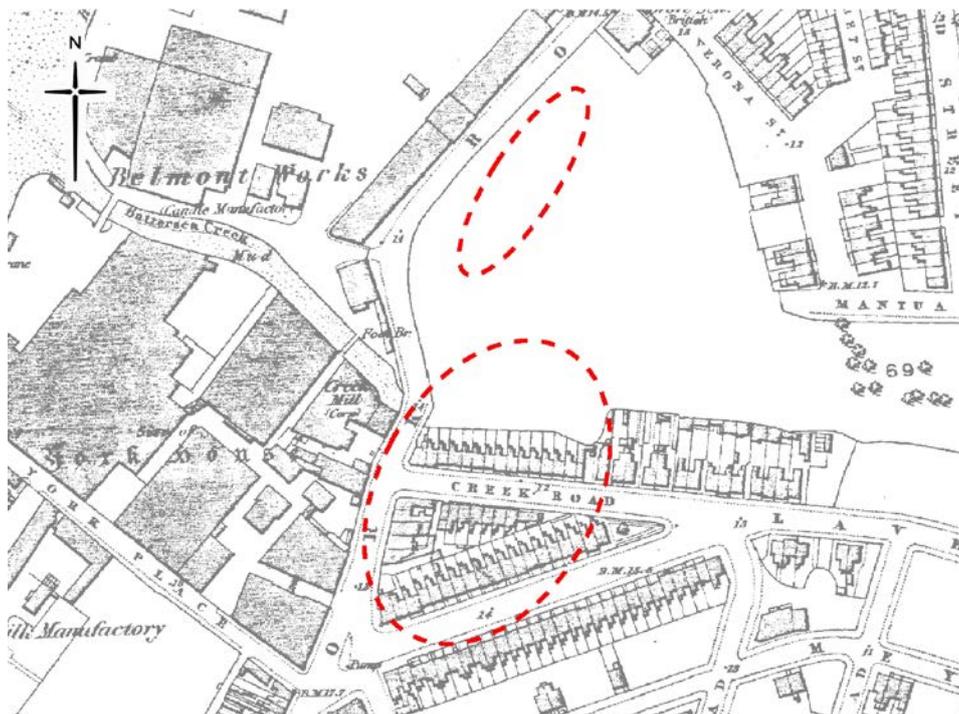
Vol 11 Plate E.2 Historic environment – Ordnance Survey 1st edition 25":mile map of 1862–95

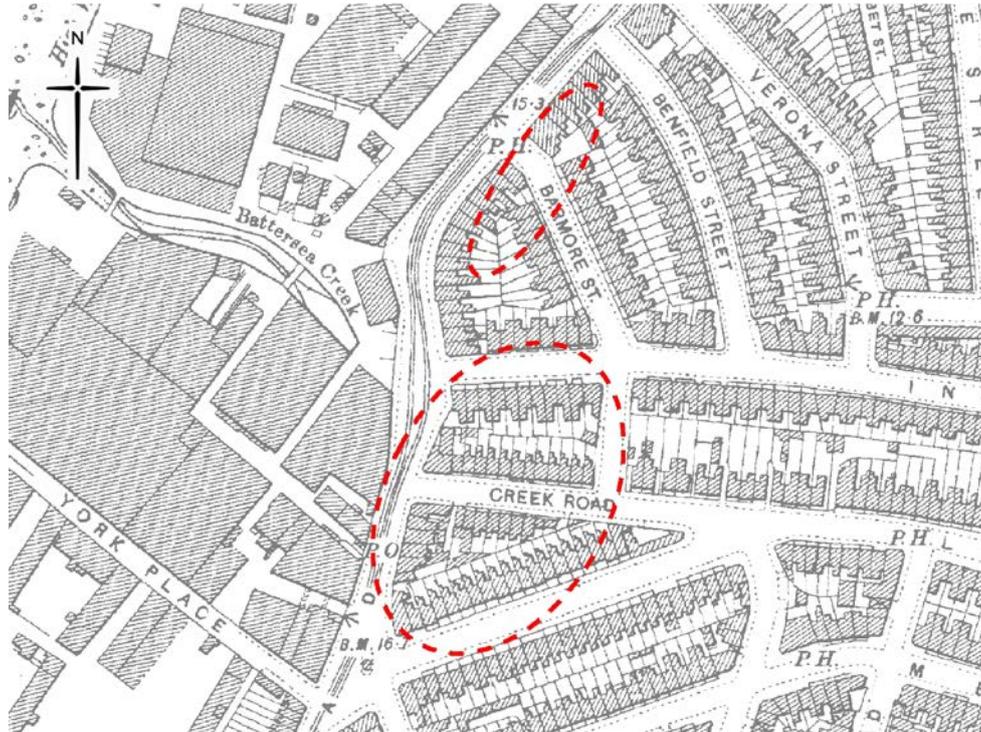
Vol 11 Plate E.3 Historic environment – Ordnance Survey 2nd edition 25”:mile map of 1896–98

- The 1896 OS mapping shows the silk factory to have been replaced by a starch factory and small engineering works, while the candle works includes soap manufacture and has expanded across the line of the creek into the site area.

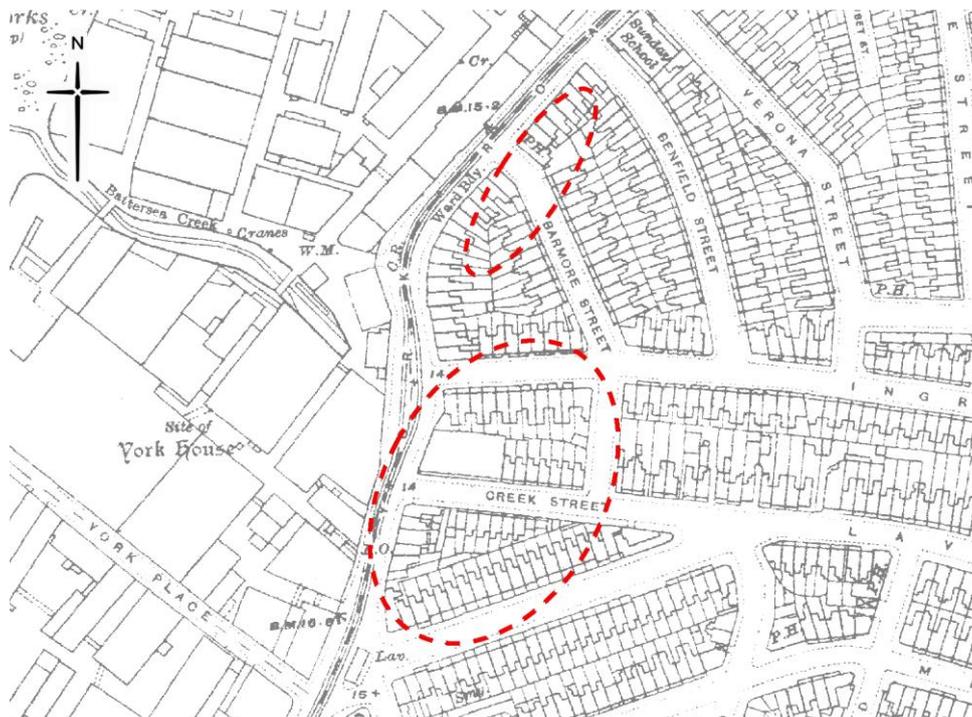
Vol 11 Plate E.4 Historic environment – Ordnance Survey 3rd edition 25”:mile map of 1909–20

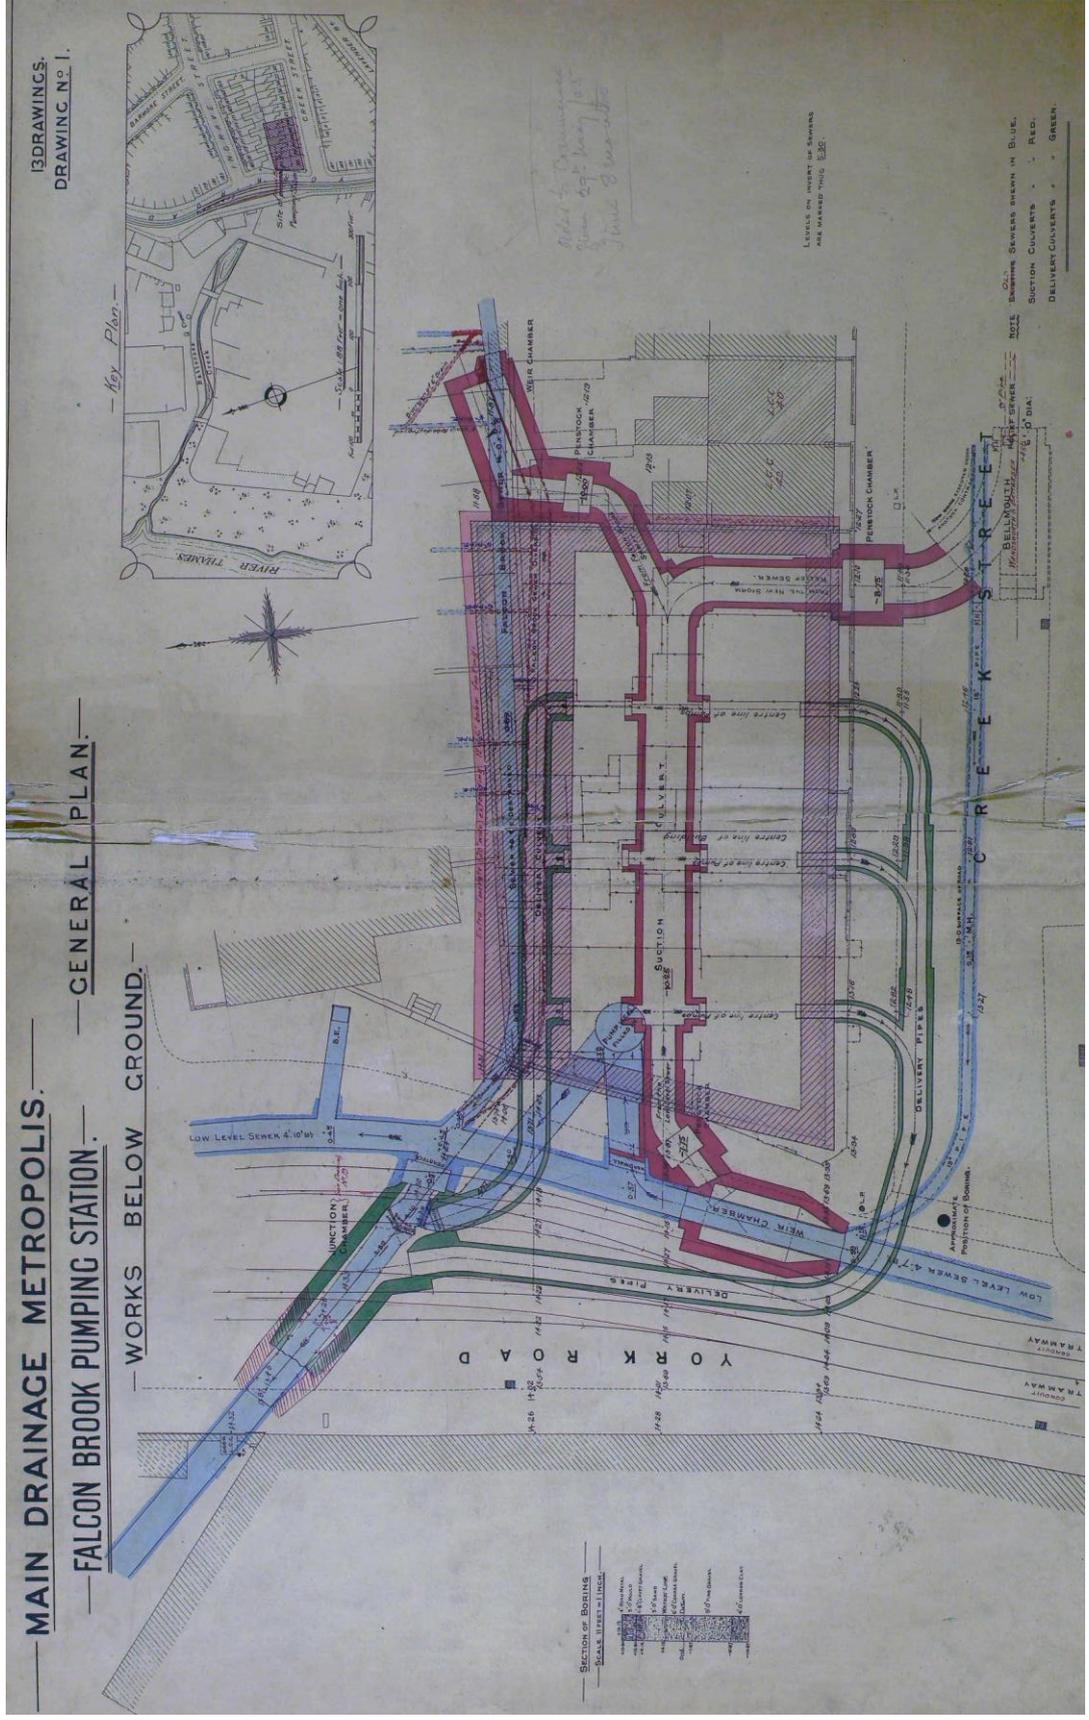
Vol 11 Plate E.5 Historic environment – Plan of the original (1905) pumping station (Thames Water; ‘Abbey Mills Books’ Book 0A Falconbrook Pumping Station Works Below Ground Contract No. 1 1905; Additional Pumping Power 1913)

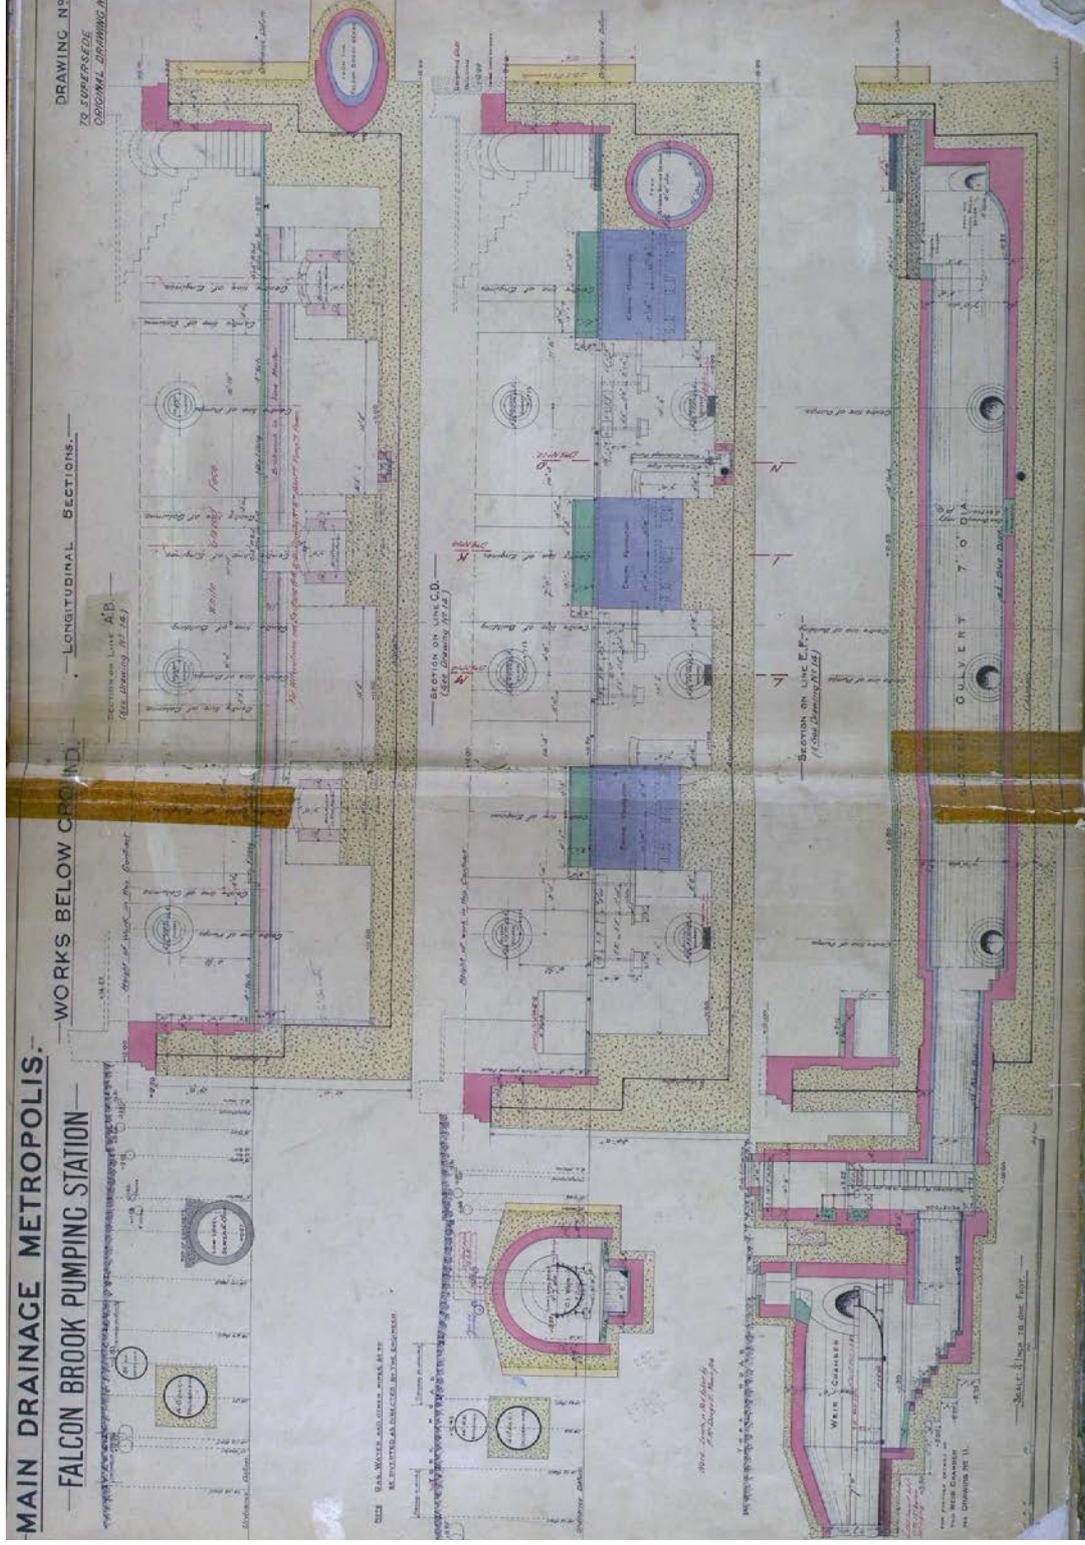
Vol 11 Plate E.6 Historic environment – Section through the original (1905) pumping station (Thames Water; ‘Abbey Mills Books’ Book 0A Falconbrook Pumping Station Works Below Ground Contract No. 1 1905; Additional Pumping Power 1913)

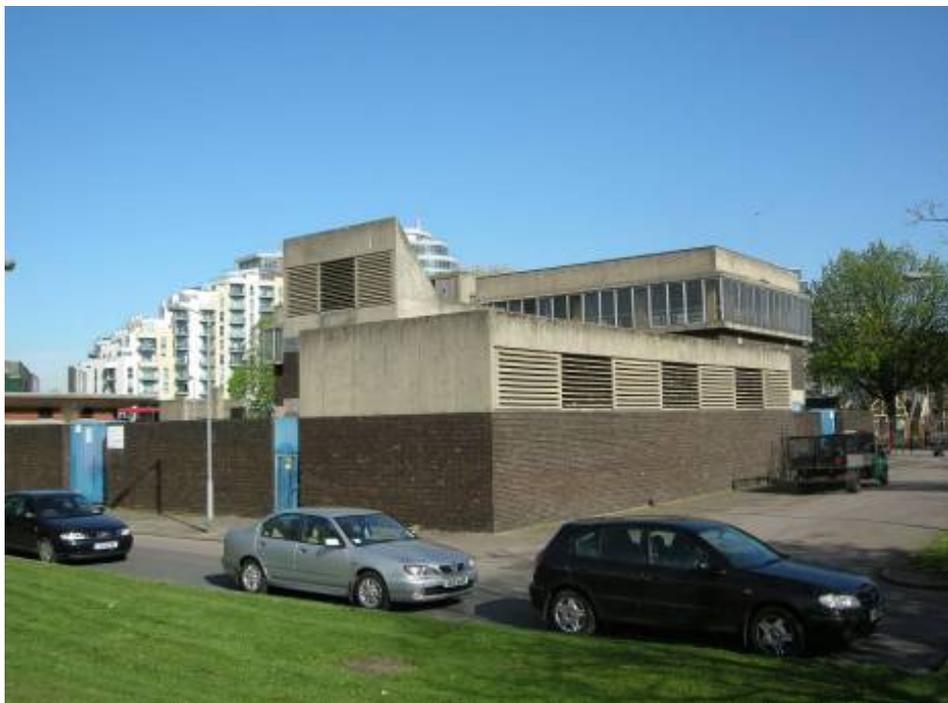
Vol 11 Plate E.10 Historic environment – Falconbrook Pumping Station

April 2011; standard lens; looking north (MOLA 2011)

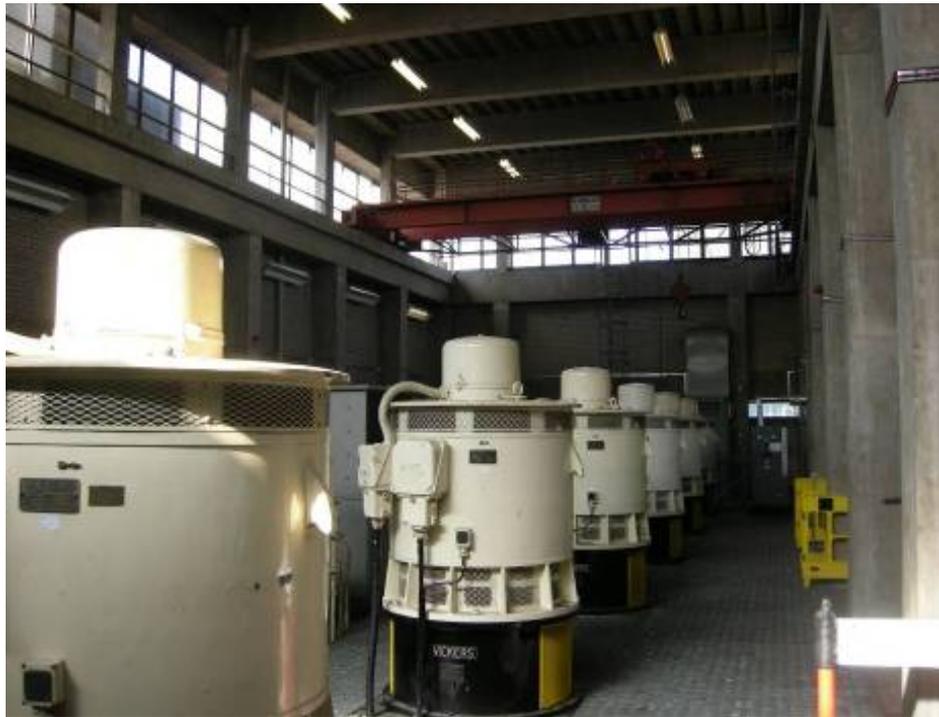
Vol 11 Plate E.11 Historic environment – Interior of the main pumping station building

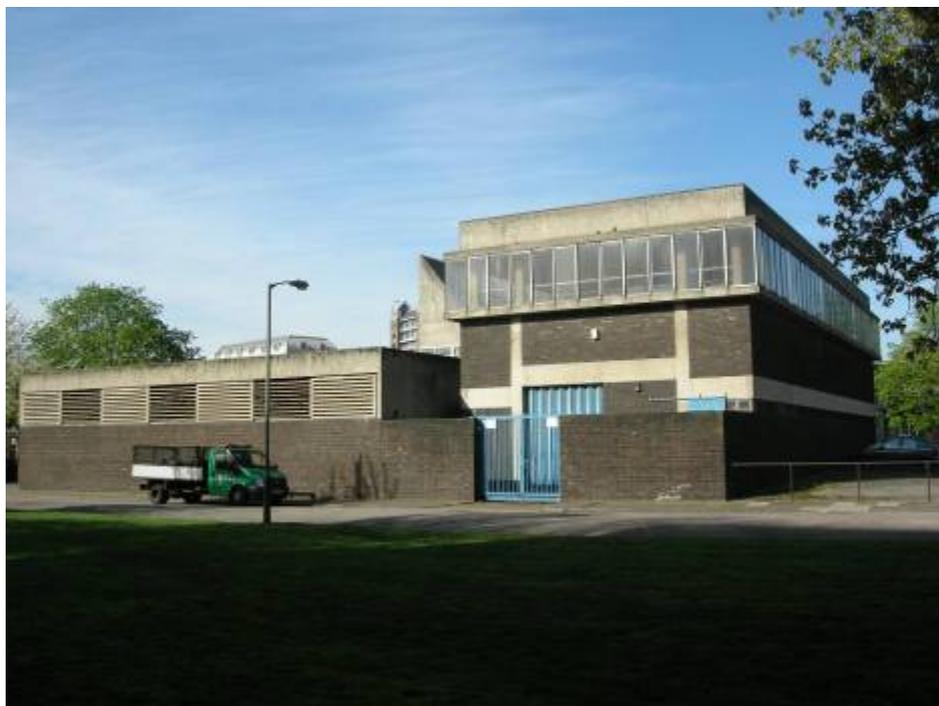
Vol 11 Plate E.12 Historic environment – Falconbrook Pumping Station compound

April 2011; standard lens; looking northwest (MOLA 2011)

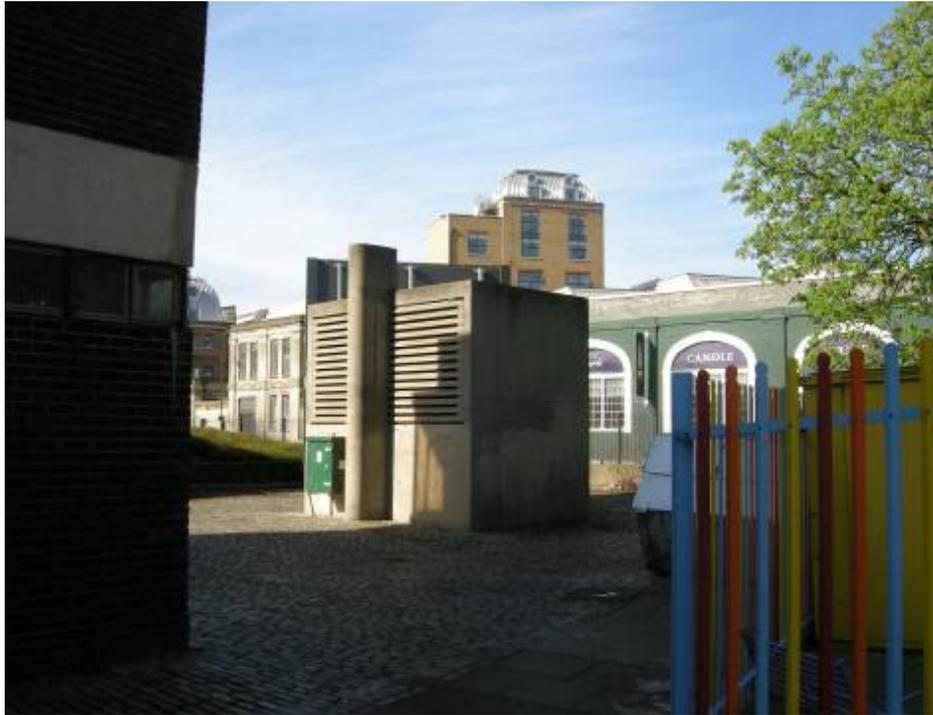
Vol 11 Plate E.13 Historic environment – View of 19th century cobbled surface within the site (HEA 1a)

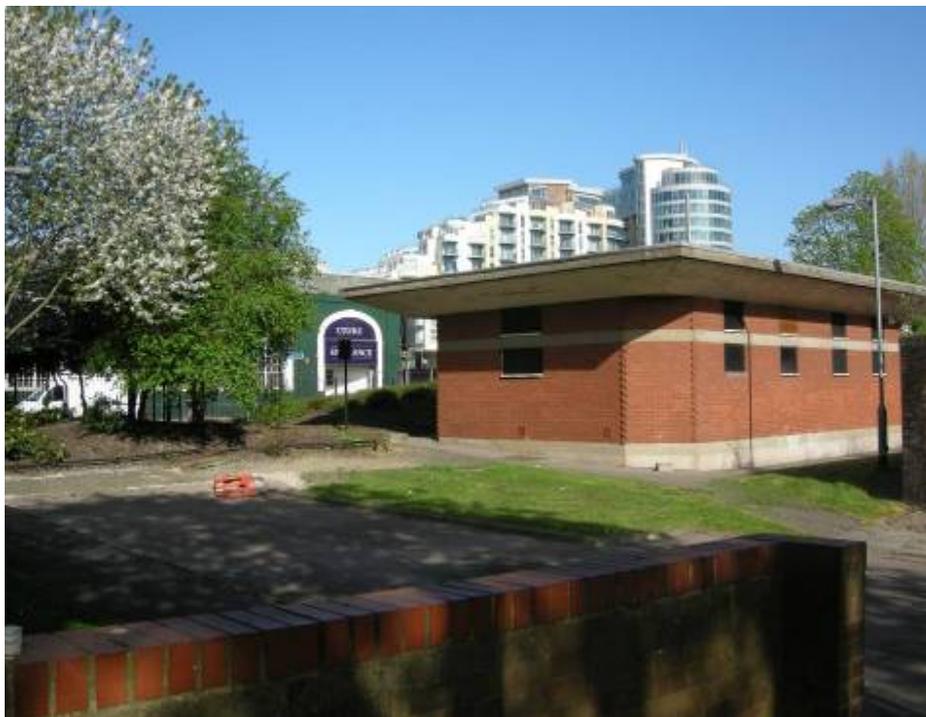
Vol 11 Plate E.14 Historic environment – View looking west of the late 20th century rectangular structure within the site

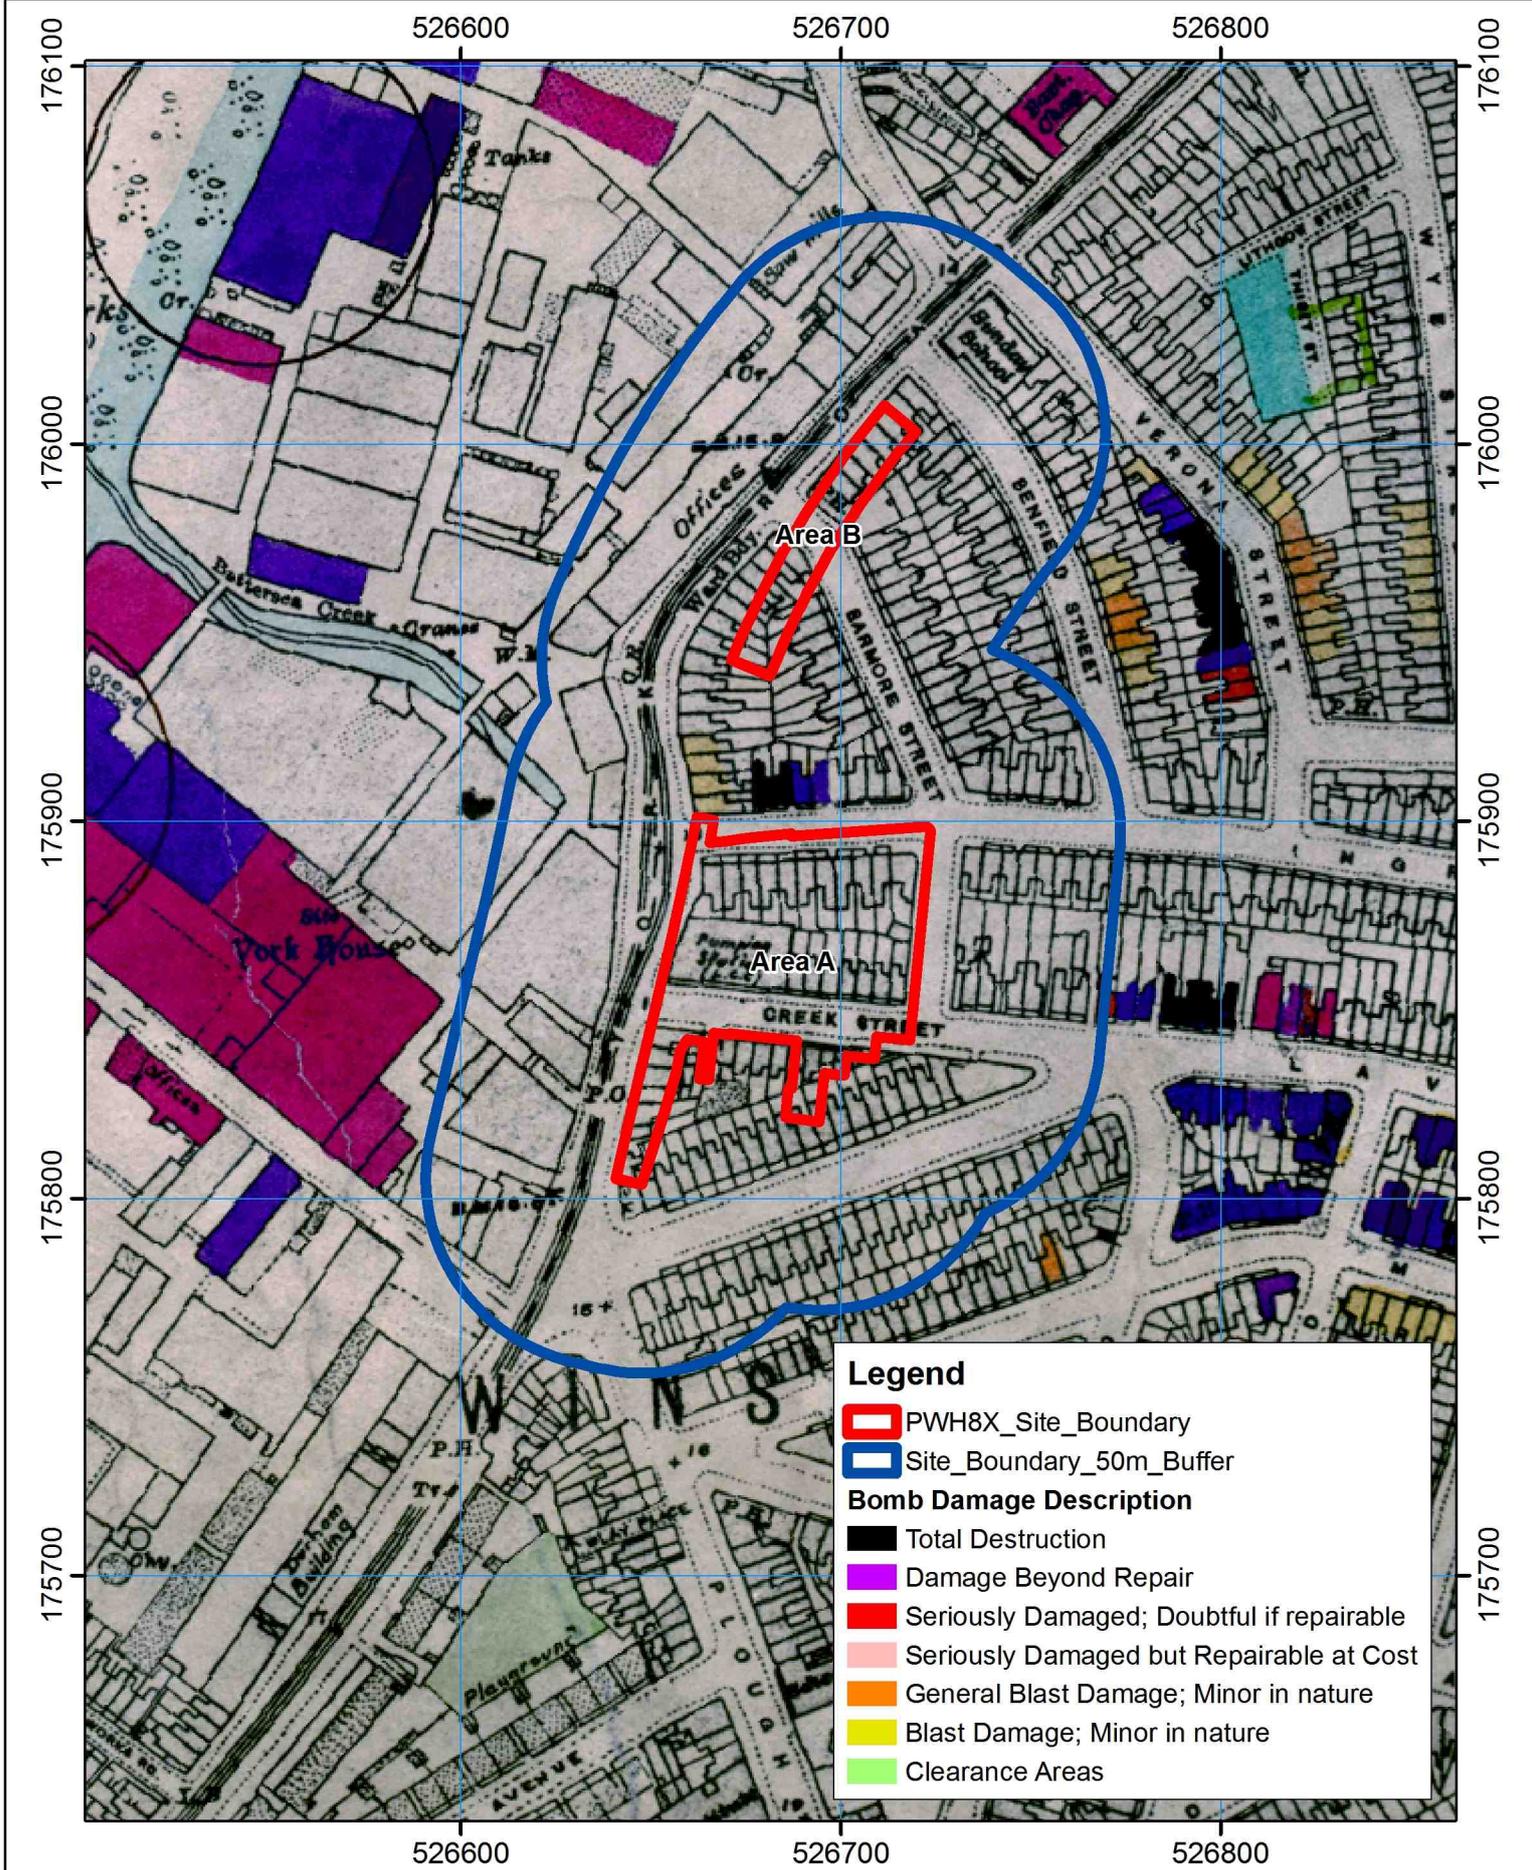
Figure 7

Thames Tideway Tunnel - Work Area PWH8X London County Council Bomb Damage Map

- Total Destruction
- Damage Beyond Repair
- Seriously Damaged; Doubtful if repairable
- Seriously Damaged but Repairable at Cost
- General Blast Damage; Minor in nature
- Blast Damage; Minor in nature
- Clearance Areas

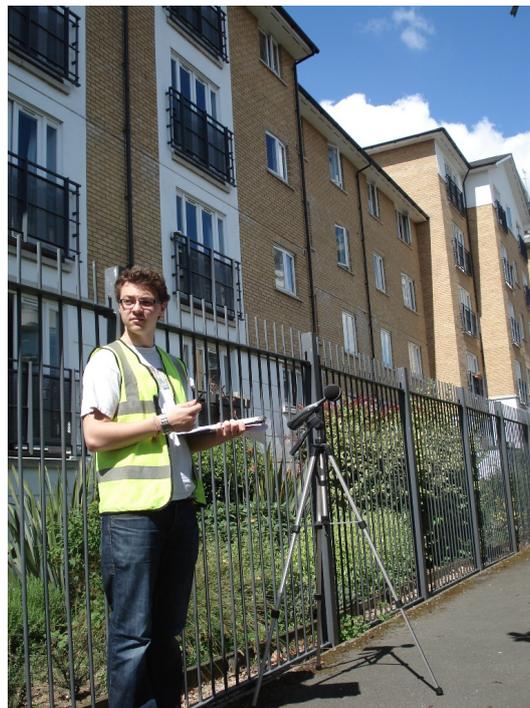
Vol 11 Plate G.1 Noise – measurement location FPS01

Note: Within private car park opposite Bridges Court, looking west towards residential dwellings (Prices Court)

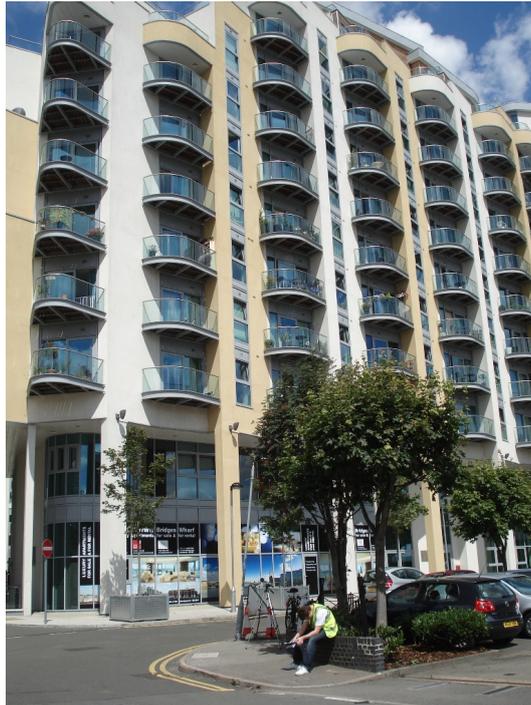
Vol 11 Plate G.2 Noise – measurement location FPS02

Note: On public footpath alongside Bridges Court, looking northwest towards Orbis Wharf

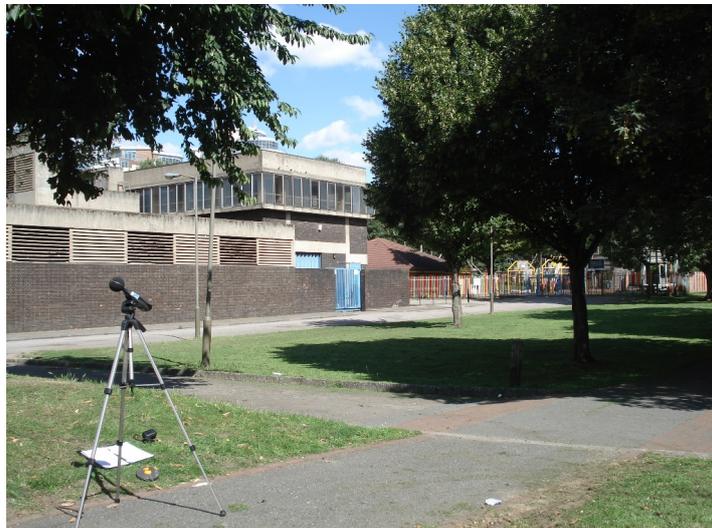
Vol 11 Plate G.3 Noise – measurement location FPS03

Note: Within eastern boundary of York Gardens, looking northwest towards Falconbrook Pumping Station

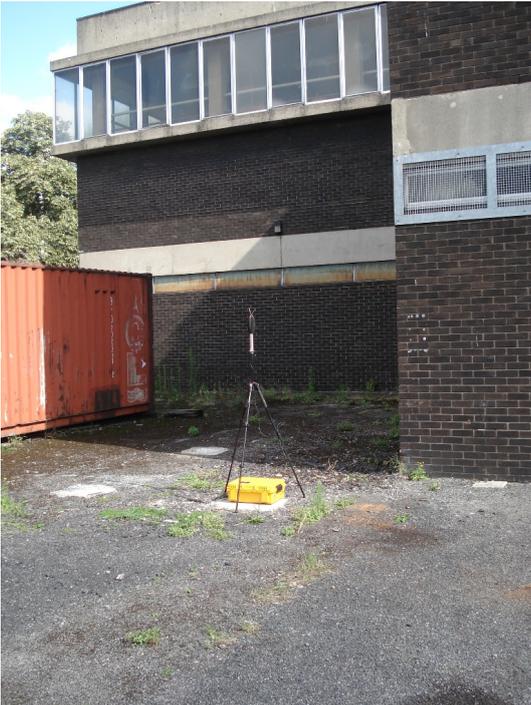
Vol 11 Plate G.4 Noise – measurement location FPS04

Note: Within private grounds of Falconbrook Pumping Station, looking north at main building

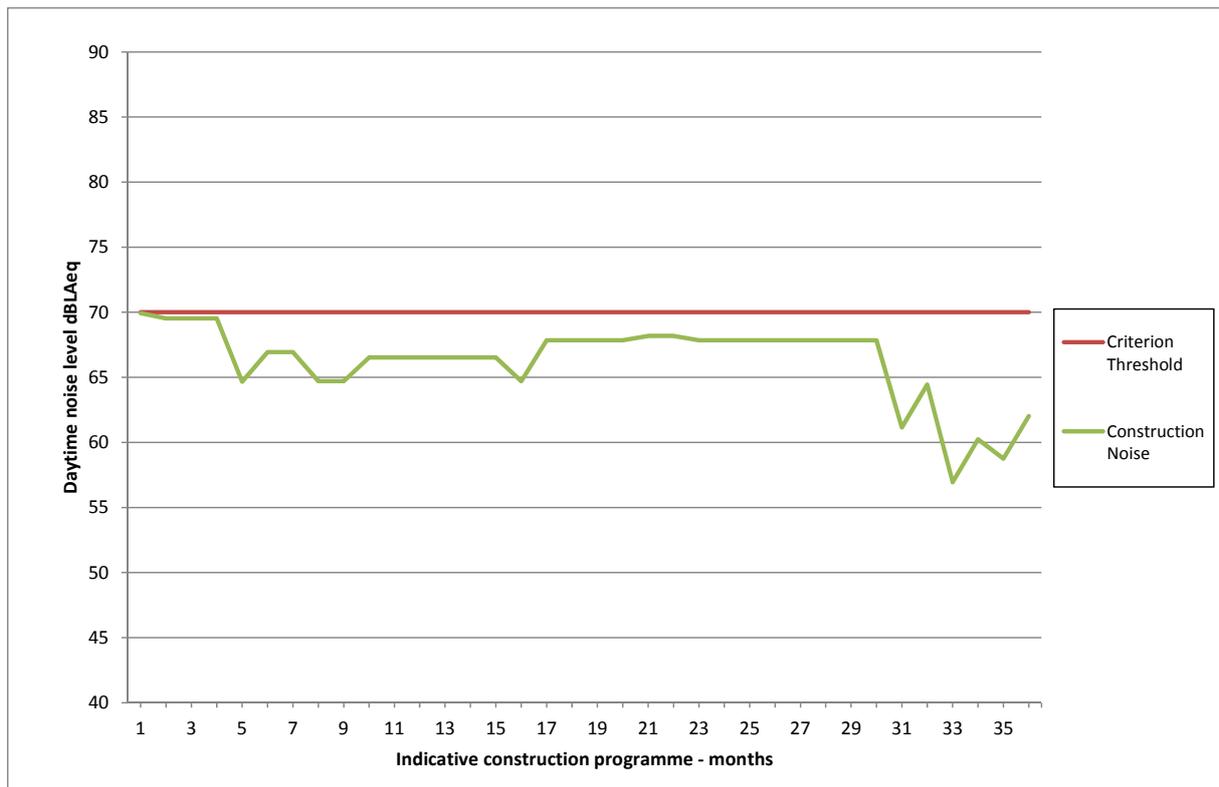
Vol 11 Plate G.5 Noise – Average monthly daytime noise level over duration of construction – Pennethorne House (FP1)

G.2.5 The predicted construction noise over time at each receptor is shown in the plates below. It should be noted that these representations are for the worst-case scenarios for noise exposure at the upper floors. For comparison with the construction noise, the plates also show either the potential significance criterion threshold for residential receptors, or the ambient noise level. This comparison is discussed in the main assessment text (see Vol 11 Section 9). The night-time noise levels have also been assessed for the short period of night-time works, these results are described in the main assessment text but not presented here.

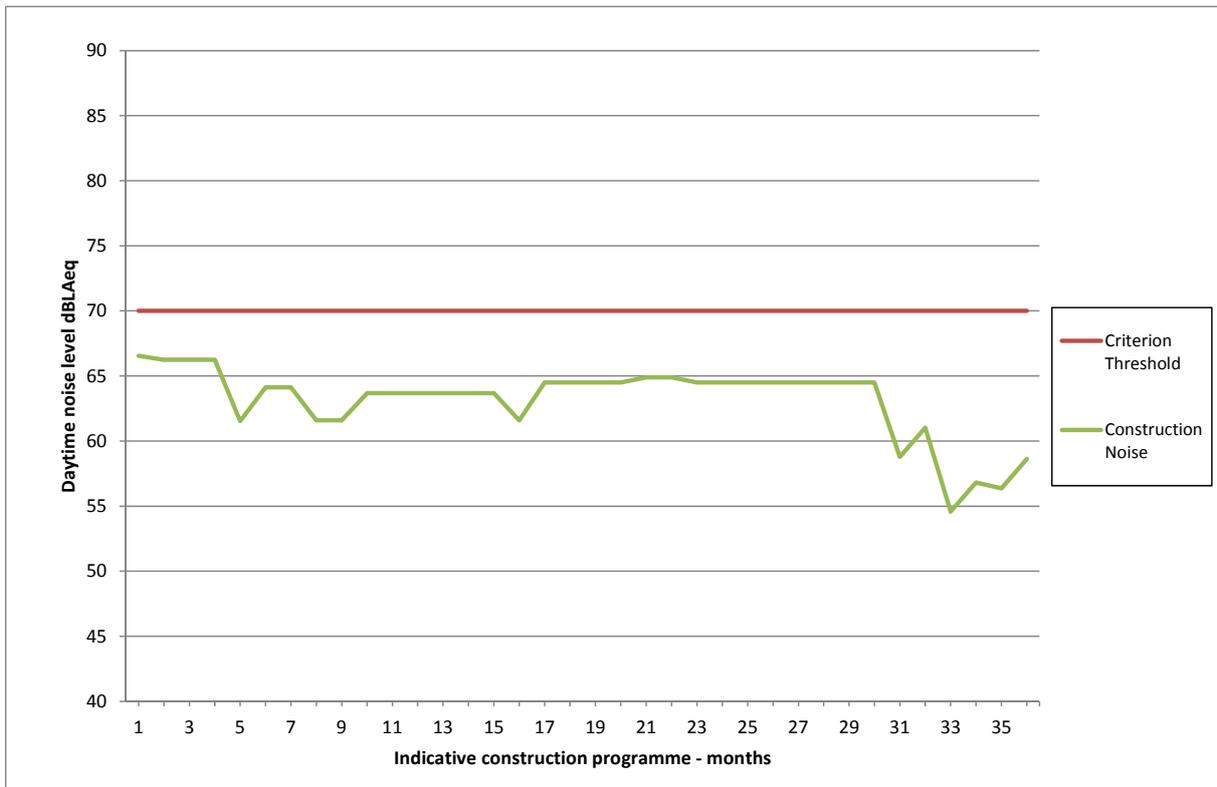
Vol 11 Plate G.6 Noise – Average monthly daytime noise level over duration of construction – Arthur Newton House (FP2)

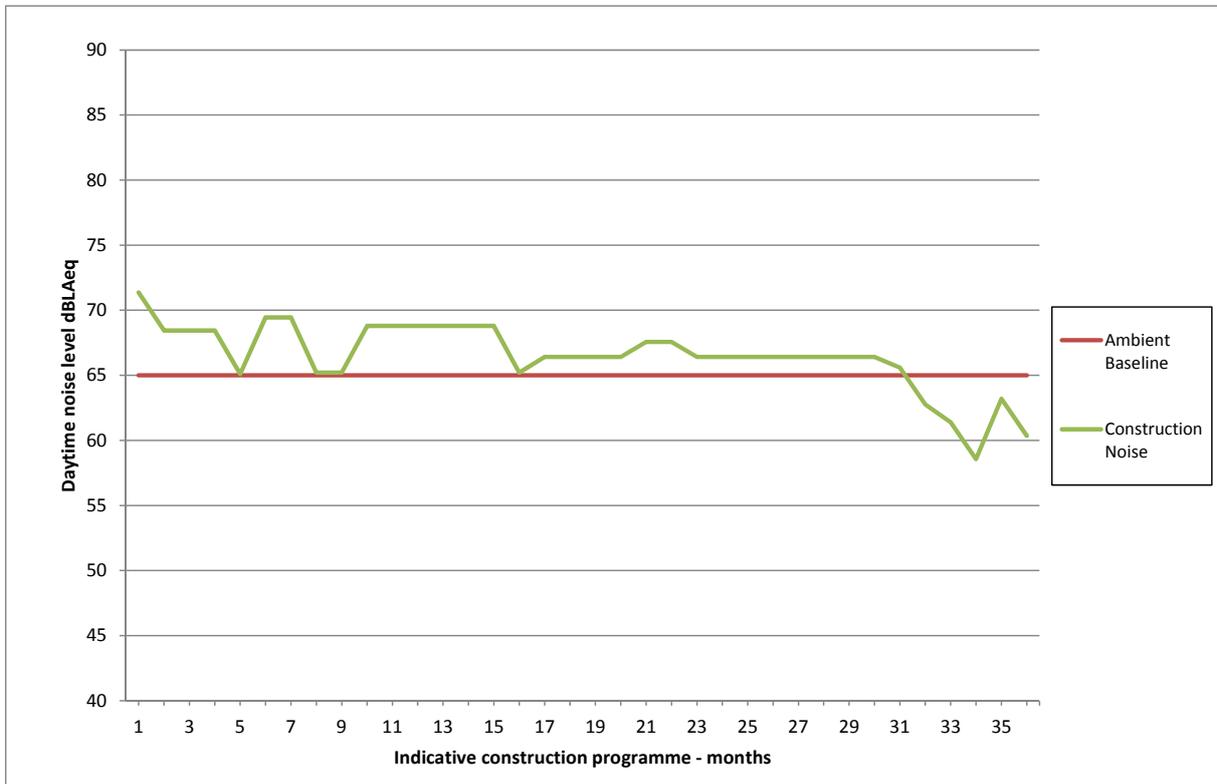
Vol 11 Plate G.7 Noise – Average monthly daytime noise level over duration of construction – York Gardens Community Centre and Library (FP3)

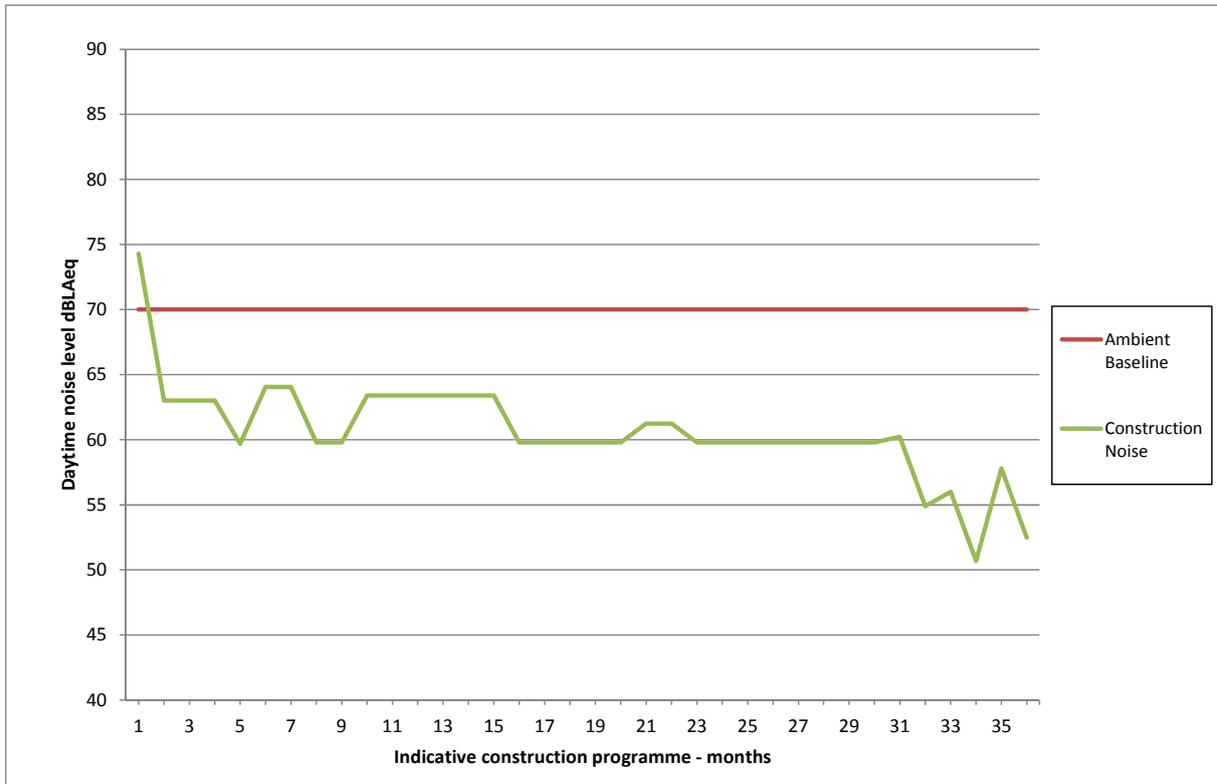
Vol 11 Plate G.8 Noise – Average monthly daytime noise level over duration of construction – Candle Maker (FP4)
