**Thames
Tideway Tunnel**

Environmental Statement

Doc Ref: **6.2.11**

Volume 11: Falconbrook Pumping Station appendices

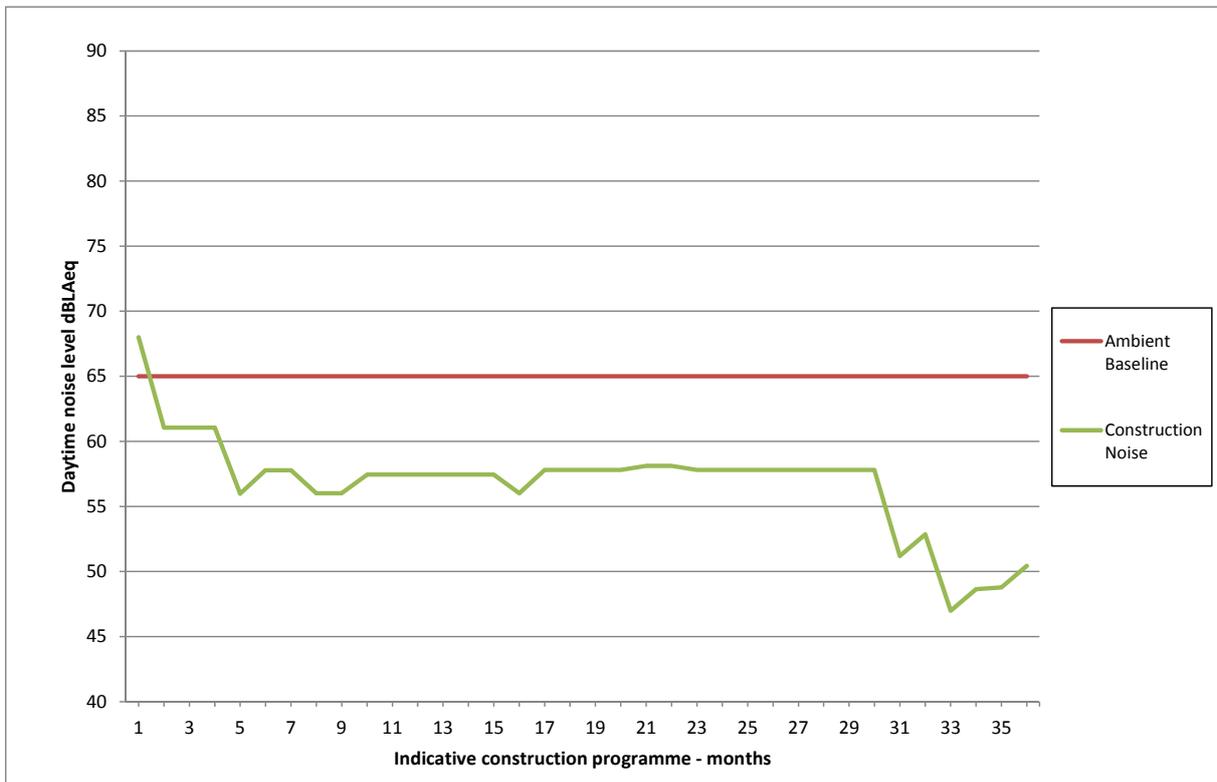
Vol 11 Plate G.9 Noise – Average monthly daytime noise level over duration of construction – Children’s Centre and Adventure Playground (FP5)

G.2.5 The predicted construction noise over time at each receptor is shown in the plates below. It should be noted that these representations are for the worst-case scenarios for noise exposure at the upper floors. For comparison with the construction noise, the plates also show either the potential significance criterion threshold for residential receptors, or the ambient noise level. This comparison is discussed in the main assessment text (see Vol 11 Section 9). The night-time noise levels have also been assessed for the short period of night-time works, these results are described in the main assessment text but not presented here.

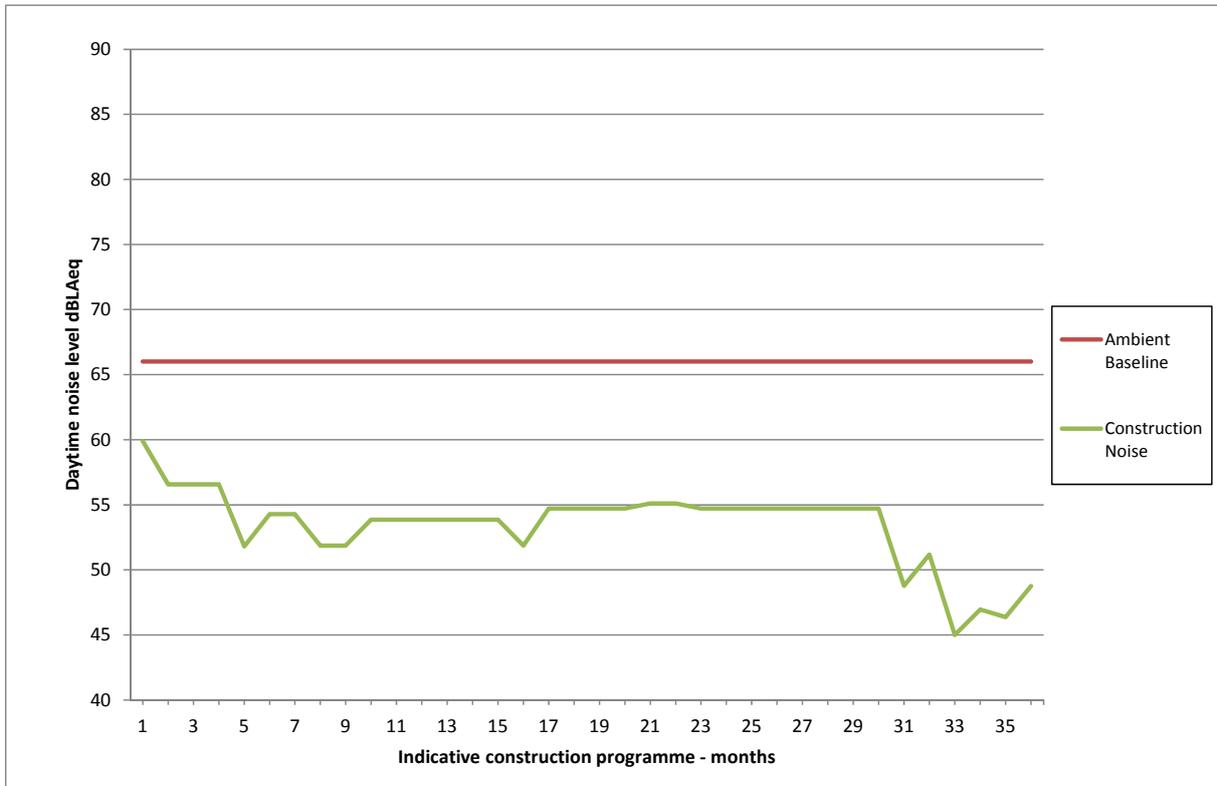
Vol 11 Plate G.10 Noise – Average monthly daytime noise level over duration of construction – 20 Lavender Road Surgery (FP6)

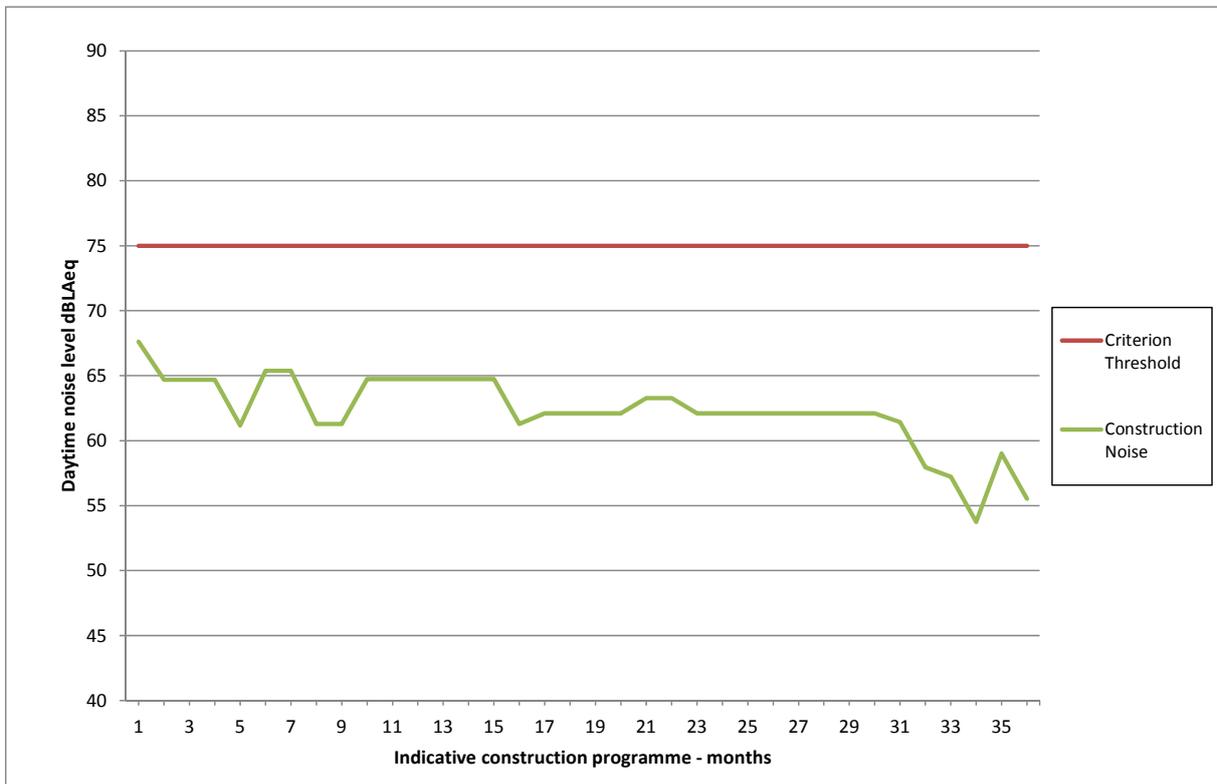
Vol 11 Plate G.11 Noise – Average monthly daytime noise level over duration of construction –Candlemakers Apartments (FP7)
