**AIR QUALITY MONITORING MONTHLY  
MONITORING REPORT  
FEBRUARY 2018**

**CARNWATH ROAD RIVERSIDE  
(CARRR)**

**TIDEWAY**

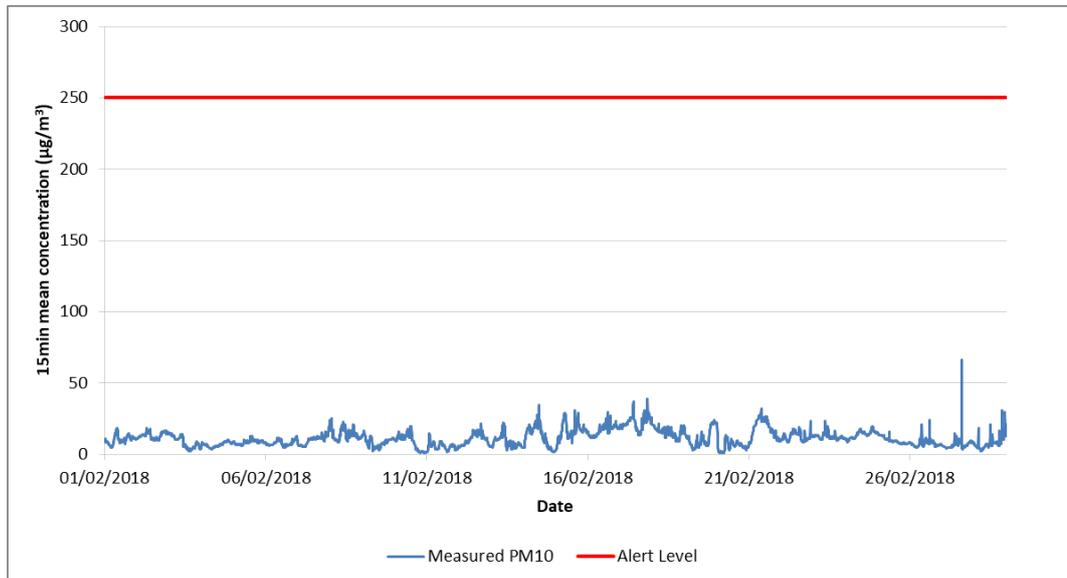
**Figure 1 Graph of 15-min PM<sub>10</sub> Concentrations at CARRR/AA/1: February 2018**

2.1.1 The measured concentrations recorded by the Osiris instruments located at Carnwath Road are shown in the Table 1 and Figures 1, 2, 3 and 4 below.

- Data capture for the month was 100% at sites CARRR/AA/1, CARRR/AA/2 and CARRR/AA/3 Data capture was 97.0% at CARRR/AA/5 due to temporary power loss;
- There were two exceedances of the 15-minute PM<sub>10</sub> alert level of 250 µg/m<sup>3</sup> at CARRR/AA/2;
- There was one exceedance of the 15-minute PM<sub>10</sub> alert level of 250 µg/m<sup>3</sup> at CARRR/AA/3; and
- There was one exceedance of the 15-minute PM<sub>10</sub> alert level of 250 µg/m<sup>3</sup> at CARRR/AA/5.

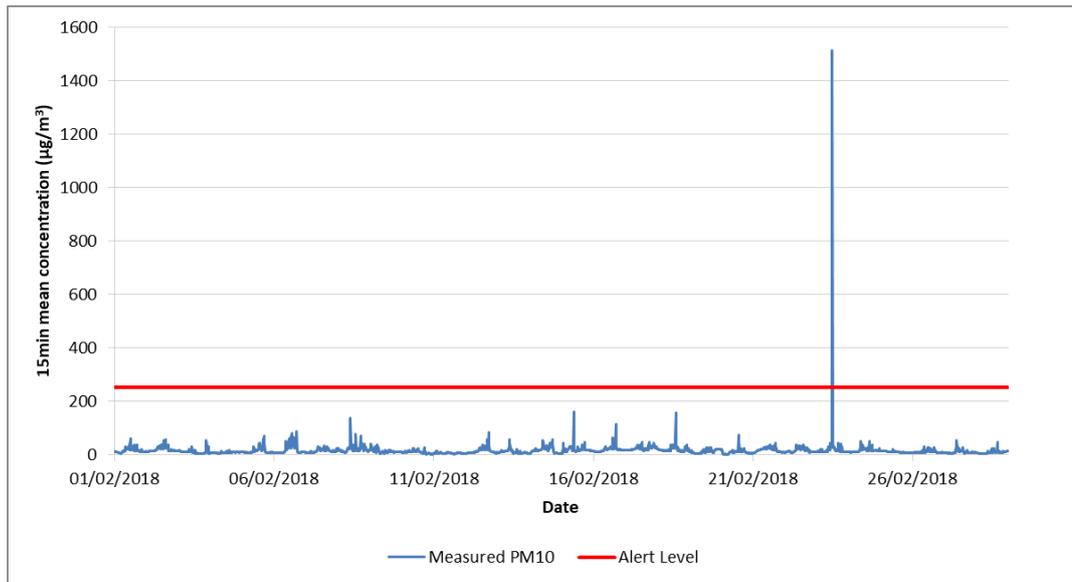
**Figure 2 Graph of 15-min PM<sub>10</sub> Concentrations at CARRR/AA/2: February 2018**

2.3.1 There were two exceedances of the 15-minute PM<sub>10</sub> alert level of 250 µg/m<sup>3</sup>, recorded at Osiris monitor CARRR/AA/2, one at monitor CARRR/AA/3 and one at monitor CARRR/AA5. A summary of this occurrence is shown in Table 2 below.

Alert ID	Osiris Monitor Location	Date	Time	PM <sub>10</sub> Conc. (µg/m <sup>3</sup> )	Source of dust
CARRR/AA/2_W8_1	AA2	23/02/2018	11:30	1014.9	No significant works occurring in this area of site at the time of the exceedances.

CARRR/AA/2_ W8_2	AA2	23/02/201 8	11:45	1512.2	Exceedance believed to have been caused by a vehicle not related to Tideway idling off-site.
CARRR/AA/3_ W6_1	AA3	05/02/201 8	16:45	277.4	Site activities at the time closest to the monitor was tidying (which included sweeping) of the visitor centre prior area to removal of the cabins from site.
CARRR/AA/5_ W7_1	AA5	16/02/201 8	12:45	280.4	Operatives were raising the sheet piles after concreting had been completed, to prevent them from becoming stuck once the concrete had cured. On completion of the lifting operation, wedges (metal and/or wood) were being banged in between the pile and the dividing wall between the blocks to keep the piles in place. This activity was damped down going forwards.

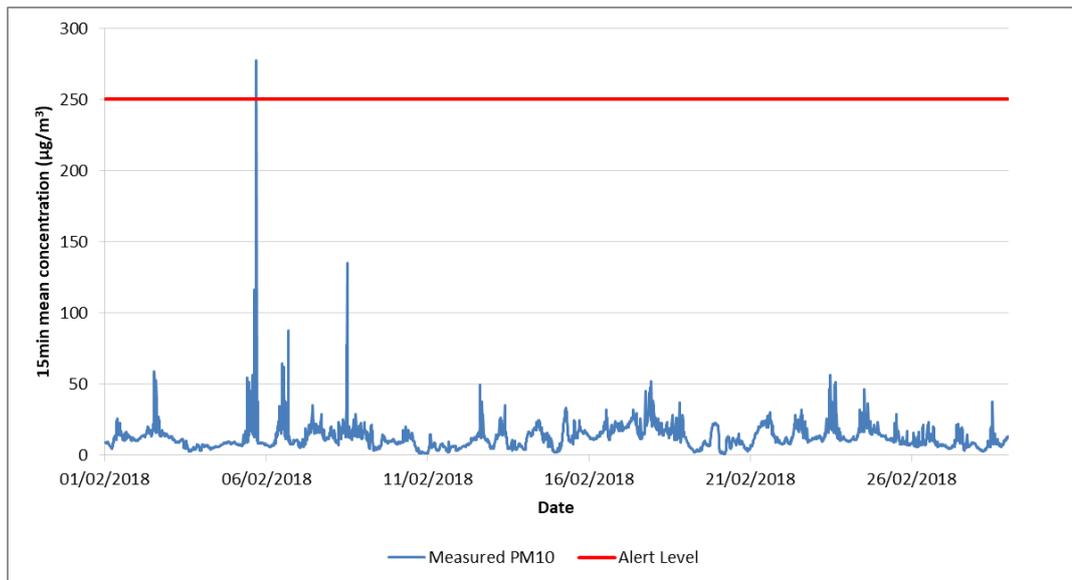
**Figure 3 Graph of 15-min PM<sub>10</sub> Concentrations at CARRR/AA/3: February 2018**

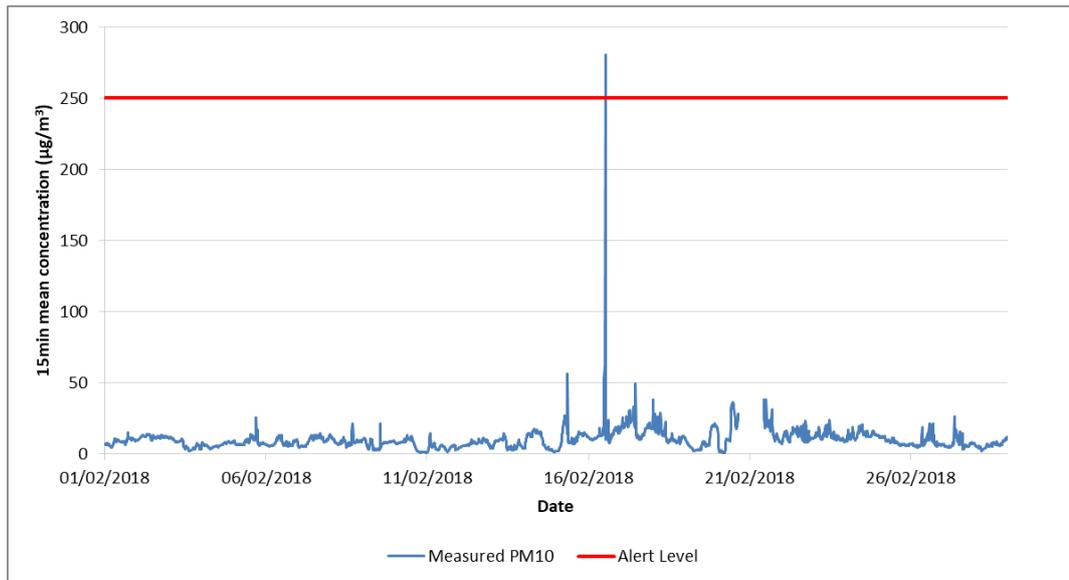
**Figure 4 Graph of 15-min PM<sub>10</sub> Concentrations at CARRR/AA/5: February 2018**

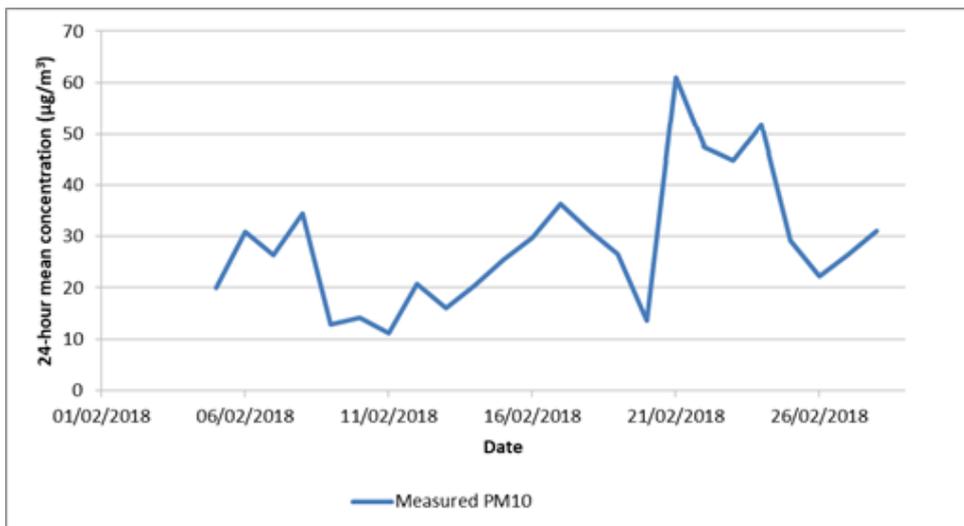
**Figure 5 Graph of 24-hour mean PM<sub>10</sub> (µg/m<sup>3</sup>) at Philpot Square: February 2018**

3.1.1 Summary statistics from the CMU on the corner of Philpot Square are shown in Table 3, Figure 5 and Figure 6.

3.1.2 The data capture for PM<sub>10</sub> was 85.7%. This was due to a fault on the PM<sub>10</sub> monitor. This was fixed on the 5<sup>th</sup> February 2018.

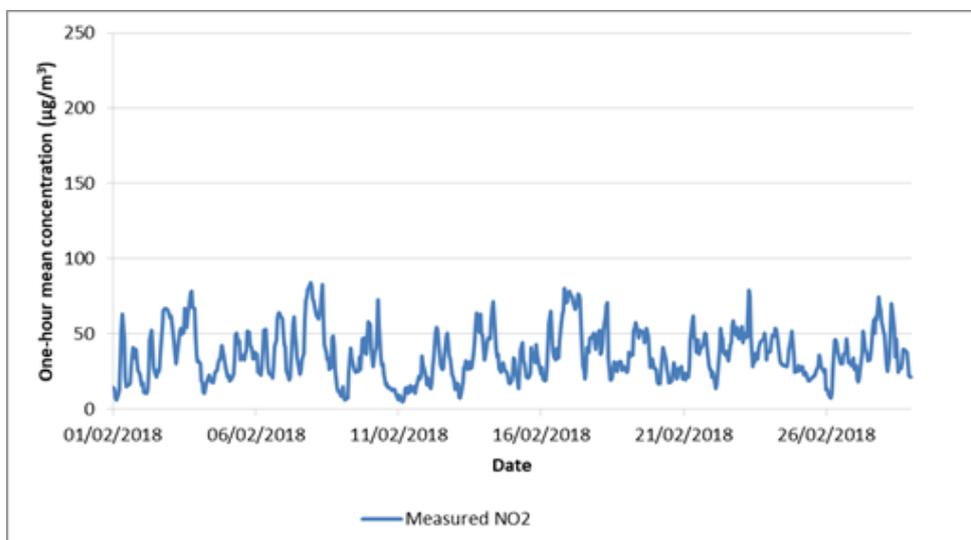
**Figure 6 Graph of 1-hour mean NO<sub>2</sub> (µg/m<sup>3</sup>) at Philpot Square: February 2018**

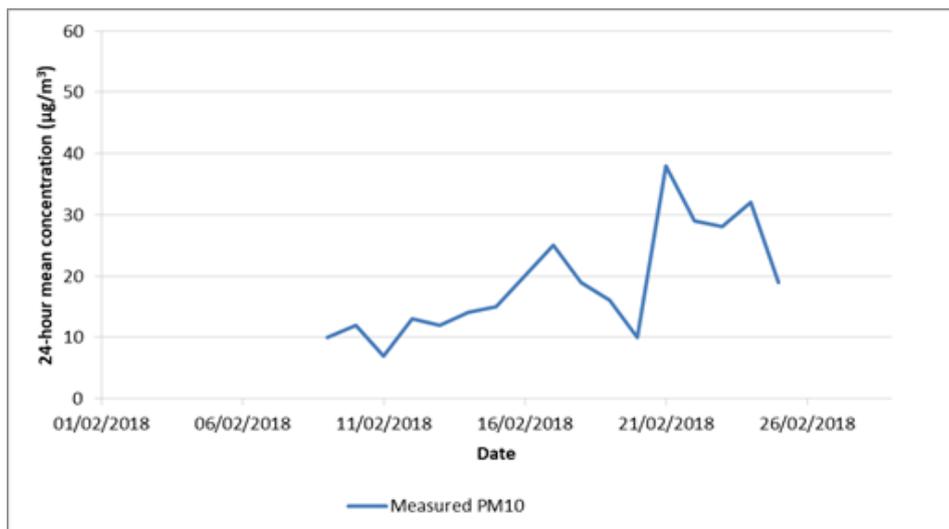
**Figure 7 Graph of 24-hour mean PM<sub>10</sub> (µg/m<sup>3</sup>) at Wandsworth Putney: February 2018**

- 4.1.3 The average PM<sub>10</sub> concentration at Wandsworth Putney during this period was 18.2 µg/m<sup>3</sup>, which was lower than the average concentrations at Carnwath Road set out in Table 3. Figure 7 shows two peaks in 24-hour mean concentrations on the 17<sup>th</sup> and on the 21<sup>st</sup> of February, which reflects trends observed at the Philpot Square CMU. This trend is part of a broader episode of high PM<sub>10</sub> observed towards the end of February by the LAQN.

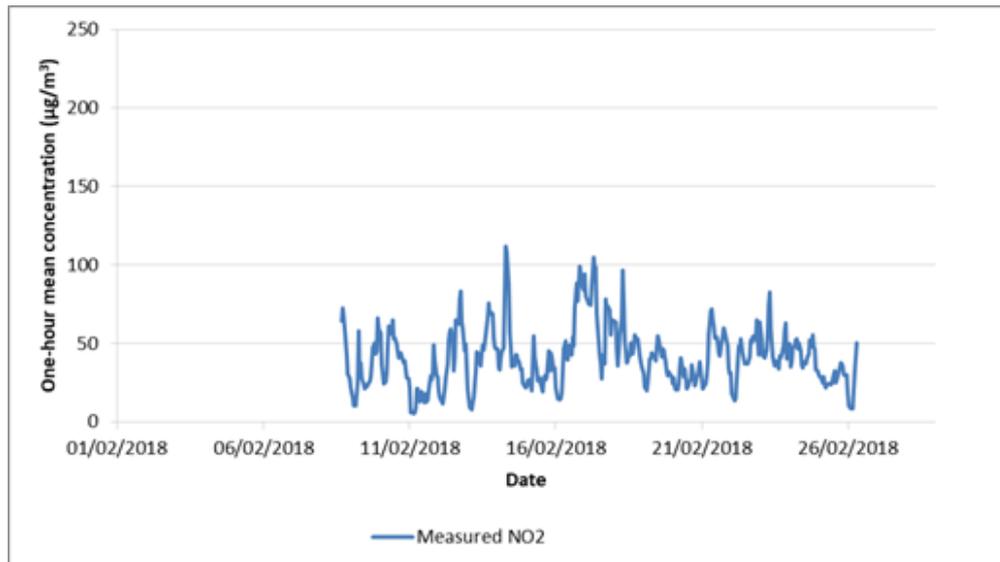
**Figure 8 Graph of 1-hour mean NO<sub>2</sub> (µg/m<sup>3</sup>) at Wandsworth Putney: February 2018**

- 4.2 The average NO<sub>2</sub> concentration at Wandsworth Putney during this period was 41.4 µg/m<sup>3</sup>, which was higher than the average concentration at the Philpot Square CMU set out in Table 3. The NO<sub>2</sub> concentrations plotted in Figure 8 show a lack of discernible trends, which is consistent with observations at the CMU at Philpot Square.

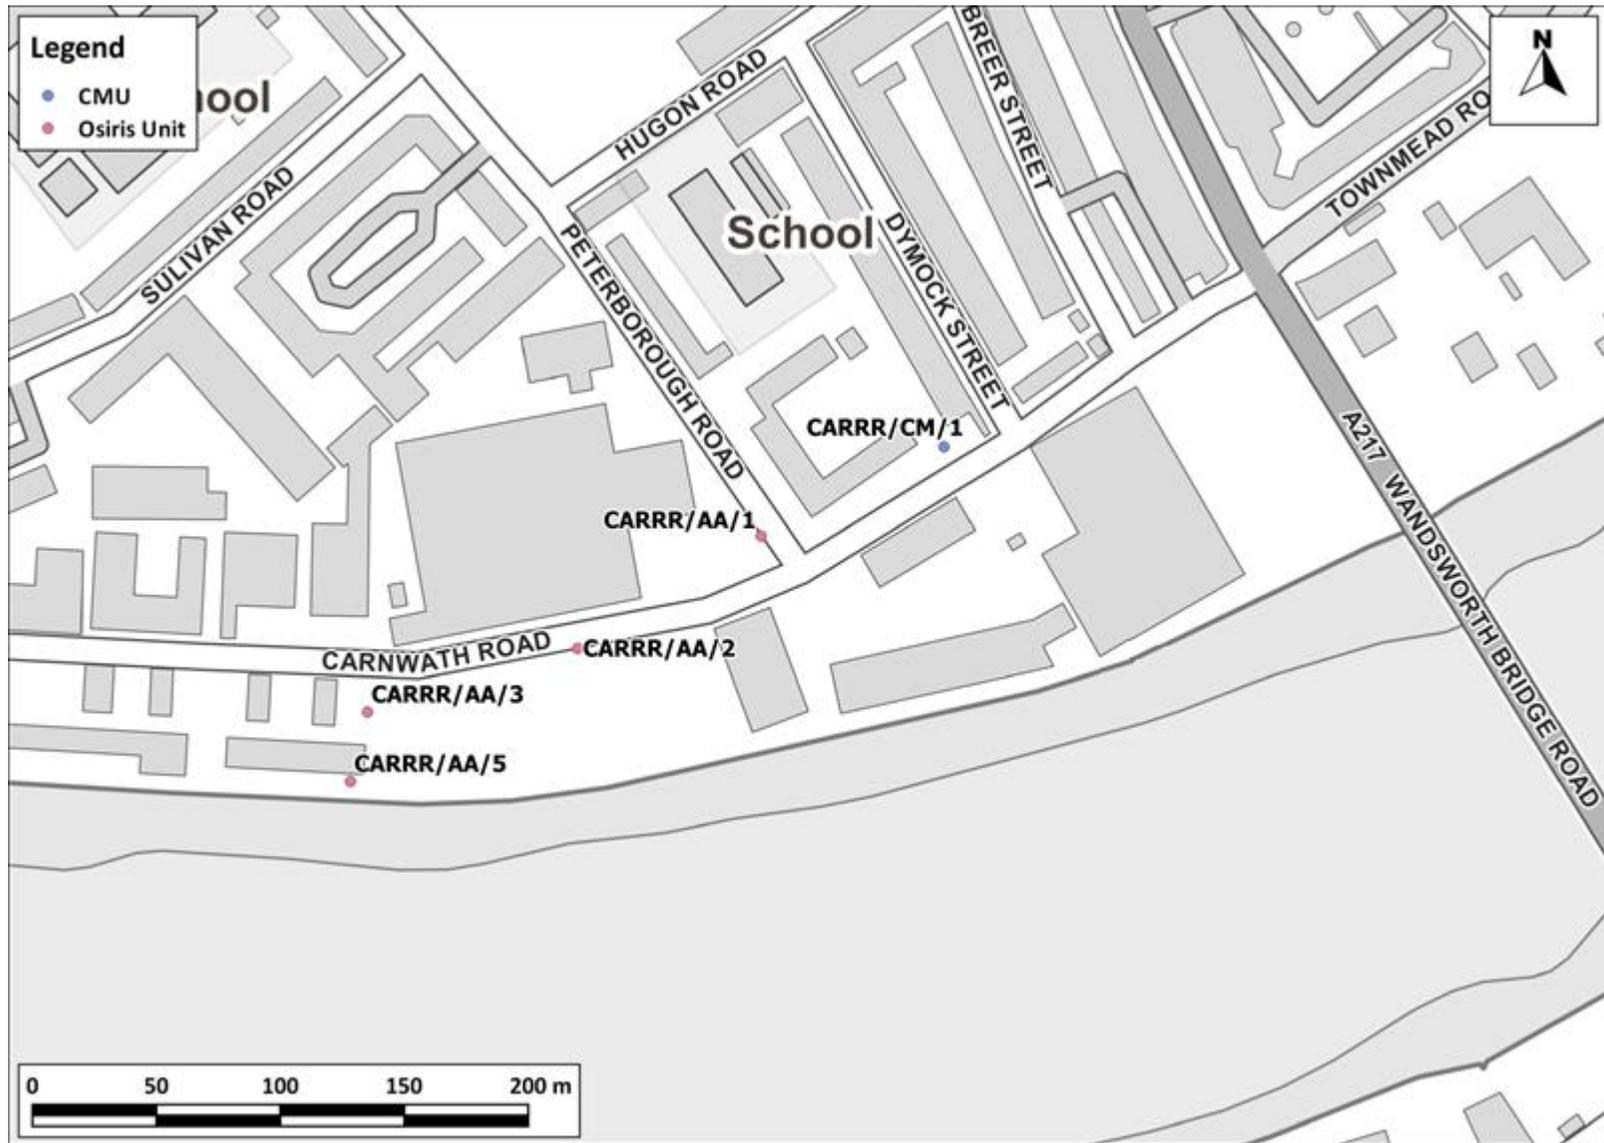
- B.1.1 There are five Osiris monitors installed at CARRR, in the following locations:
- CARRR/AA/1: Osiris monitor fitted to a lamppost on Peterborough Road. An anemometer (wind speed and direction sensor) is attached to this monitor.
  - CARRR/AA/2: Osiris monitor fitted to a lamppost on Carnwath Road.
  - CARRR/AA/3: Osiris monitor fitted to a lamppost on the redirected Thames Path west of the CARRR site.
  - CARRR/AA/5: Osiris monitor fitted to hoarding adjacent to works at River Wall 922.
- B.1.2 The figure below shows the locations of the five Osiris monitors at CARRR (CARRR/AA/1, CARRR/AA/2, CARRR/AA/3 and CARRR/AA/5).
- B.1.3 The location of the Continuous Monitoring Unit (CMU) at Philpot Square is shown as CARRR/CM/1.

Figure B.1 Osiris Air Quality Monitor Location Plan
